REPORT  
ON  
THE GEOLOGICAL STRUCTURE AND STABILITY  
OF  
THE HILL SLOPES AROUND NAINI TAL.

BY  
T. H. HOLLAND, A.R.C.S., F.G.S.,  
OFFICIATING SUPERINTENDENT, GEOLOGICAL SURVEY OF INDIA.

CALCUTTA:  
OFFICE OF THE SUPERINTENDENT OF GOVERNMENT PRINTING, INDIA.  
1897.

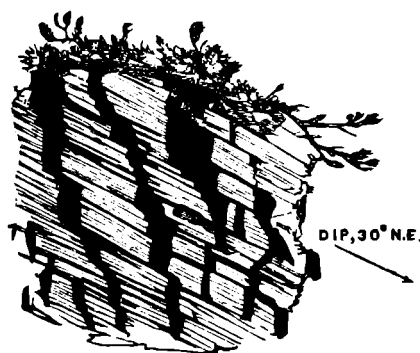
Fig. 1.—Slate, showing the opening of joints by movement along the bedding planes. Near Fine View.  $\frac{3}{10}$  nat. size.

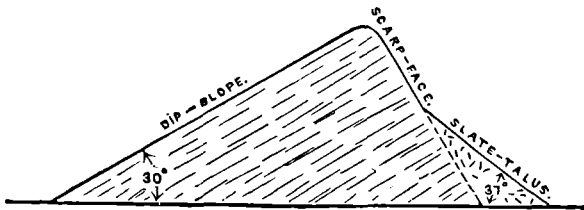
Fig. 2.

The northern slopes of Alma Hill afford an illustration of a further fact directly bearing on the question under discussion.

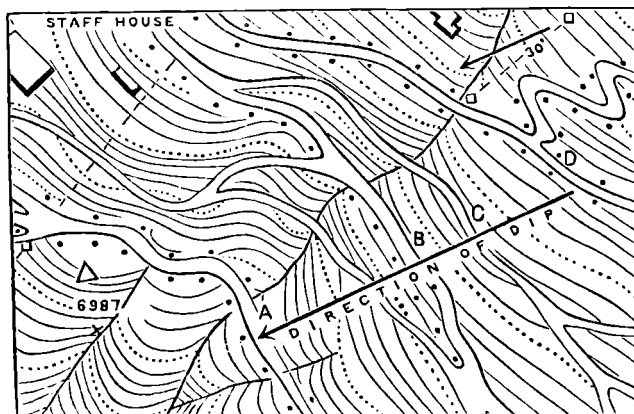
Fig. 3. Scale 20 in. = 1 Mile ; contoured at 10 feet vertical intervals.

105. Although, for reasons already indicated, the lateral lines of shearing will be less conspicuous than the cracks which open parallel to the strike of the strata, I agree entirely with Mr. Oldham in recognising such evidence in the ravine between St. Loe and the Staff House, where the drain built in 1880 has been considerably deformed by numerous cracks, all of which show an oblique transverse shearing of the drain as a whole. In a line with the direction of dip, above this particular point, the four roads, Upper Mall, road into St. Loe grounds, St. Loe Road and the Middle Mall, show marked depressions along a line running W.S.W.; that is, parallel to direction of the dip of the slates (A, B, C, D, fig. 3).

According to the evidence of Mr. Matthews these depressions did not exist when the roads were made, and being in a line with the portion of the drain referred to by Mr. Oldham as transversely sheared, may be taken as evidence of subsidence having taken place along the stratification planes of the slate.

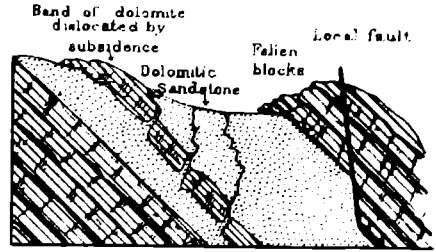
Fig 1 Collapse of strata by solution of carbonates from dolomitic sandstones

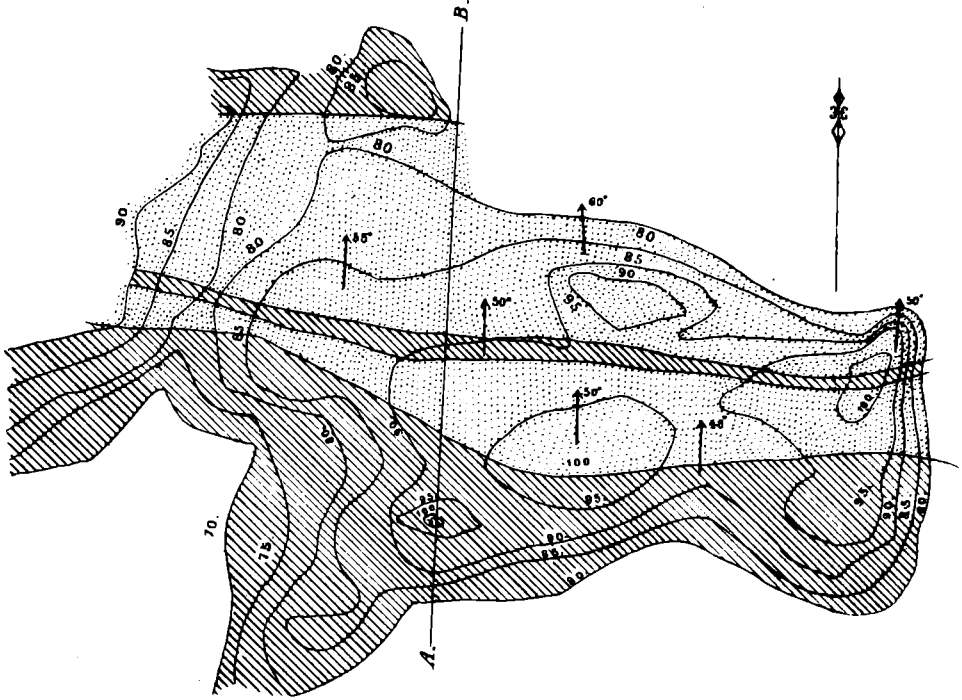
Fig 2 Contoured Map showing Geological features.  
 Contoured at 5 feet vertical intervals. Scale 80 ft = 1 in.  
 1, 3 & 5, Dolomite ..... [diagonal hatching]  
 2, 4 & 6, Dolomitic sandstones and marls ..... [stippled]  
 Dips in sandstones and marls ..... 50° ↘
