REPORTS OF LIETENANT-COLONEL C. H. HASWELL, R. E.,
ON THE FORTS ROADS ETC., IN THE GILGIT AGENCY.

Subject. Reports on Gilgit Forts.

REPORT
ON
GILGIT FORT

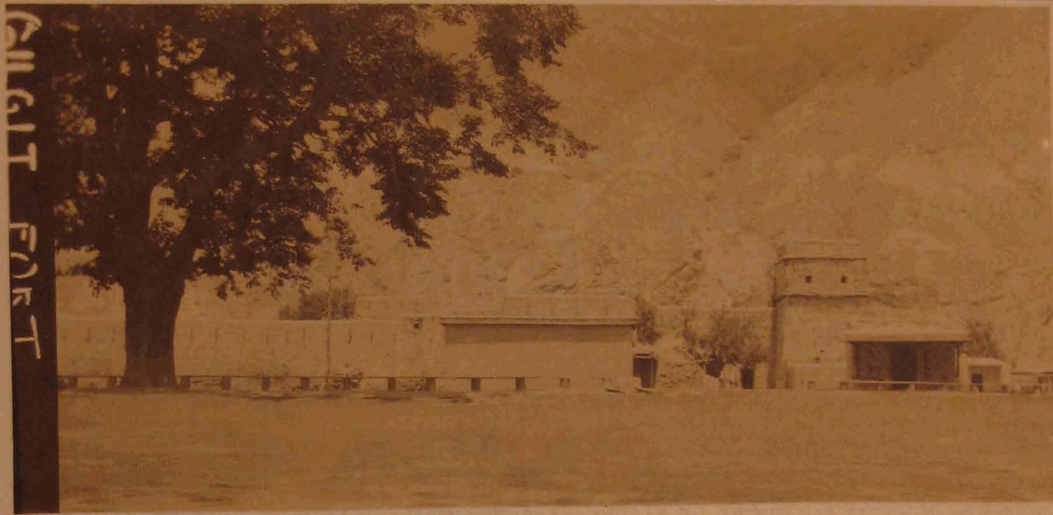
GILGIT FORT.

The fort is an old mud building, date of construction unknown. It consists of very thick walls, built of boulders in mud with brushwood binding and timber framework.

Gilgit requires no fort and this has already been accepted.

Just before the war the work of demolition was started and a portion of it demolished.

I now recommend that the remaining portion of the old fort be demolished and the ground entirely cleared.

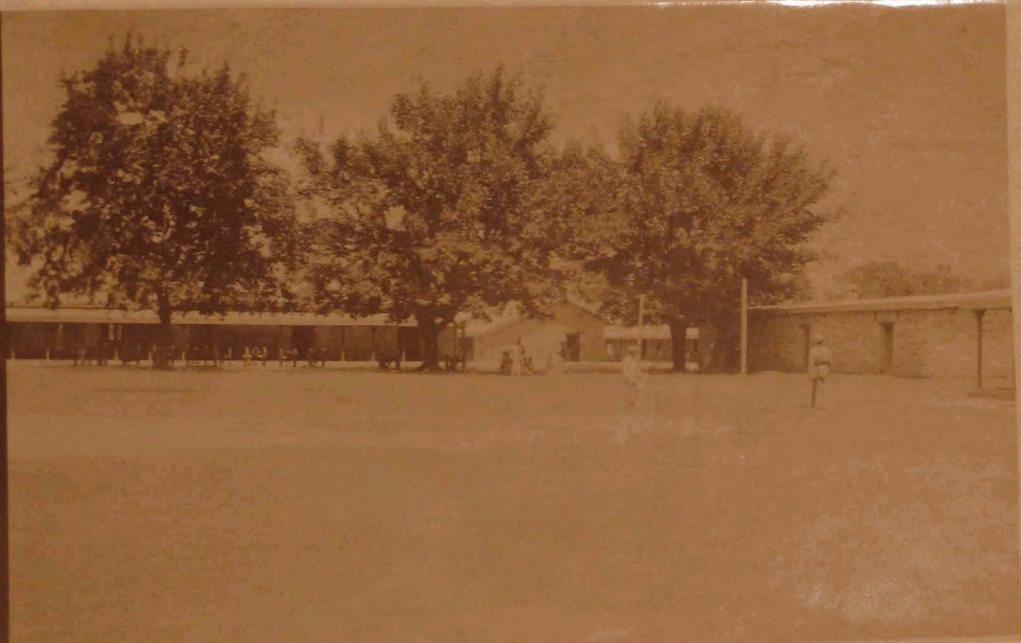
GILGIT LINES
Quarterguard

This ~~There~~ is a very good building. One room of quarterguard contains the .303 rifles for the use of the scouts.

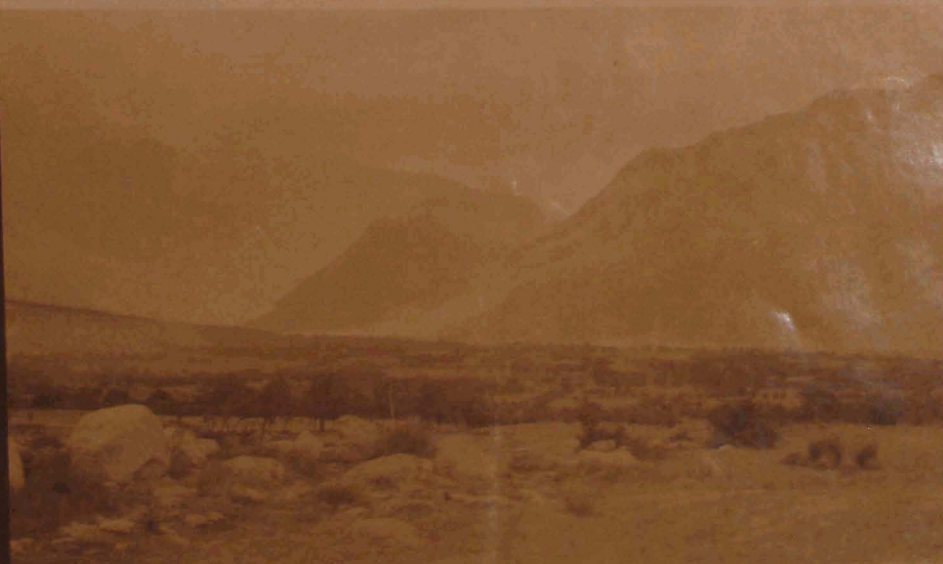
GILGIT

All that is required are camping grounds and these are plentiful. The valley at Gilgit is wide which can be seen from this photograph.

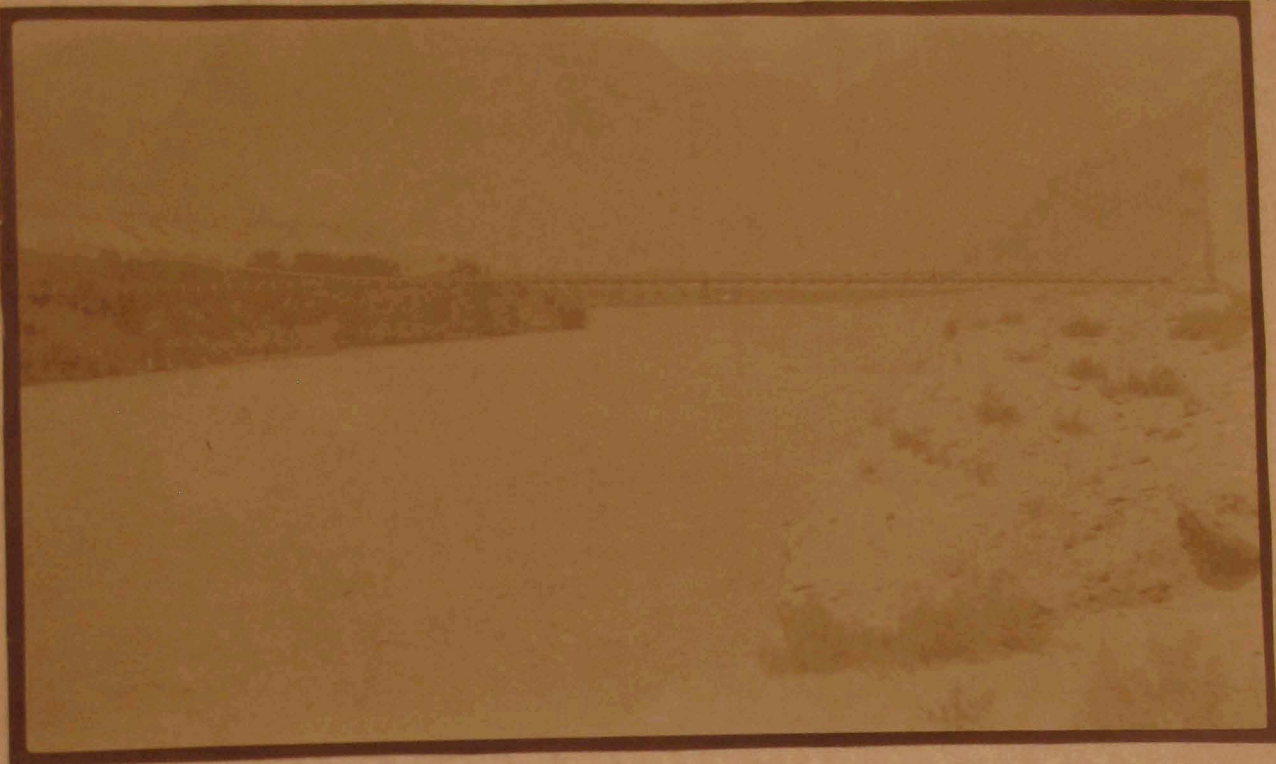
At Gilgit is a very fine suspension bridge of
500' span which crosses the Gilgit River and
carries the road to FUNZA and NAGAR.

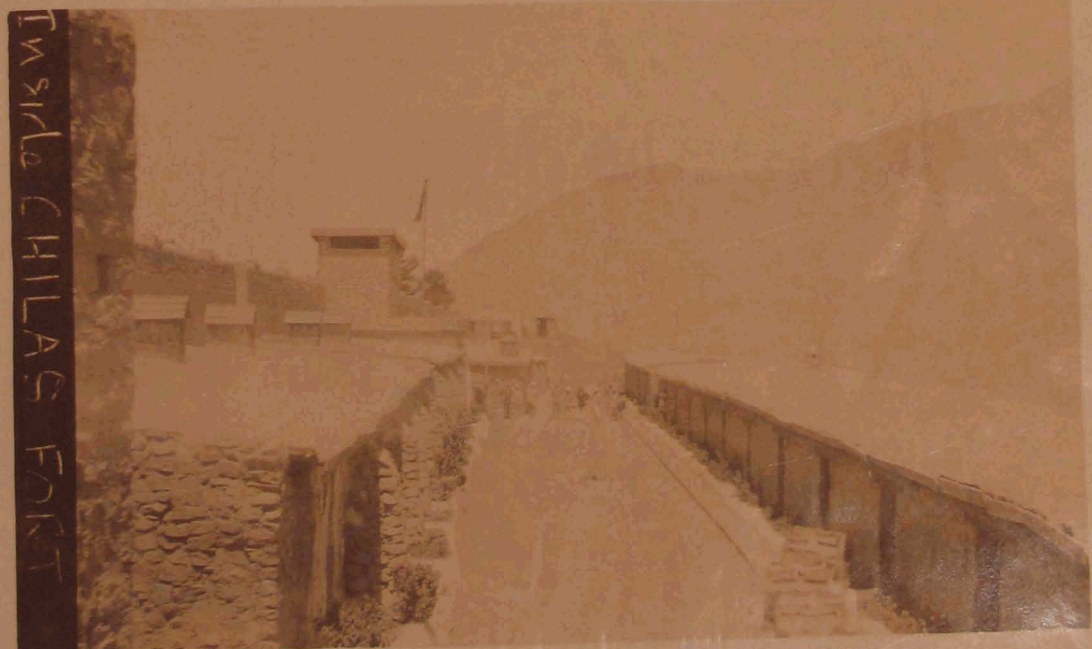
INSIDE CHILAS FORT

The roofs are mud on brushwood on Bullies supported by posts and Bressumers and are very old and in poor condition.

The floors are of mud which owing to there being no good clay in the district are bad.

A general view of the barracks in the Fort is shown by this photograph.

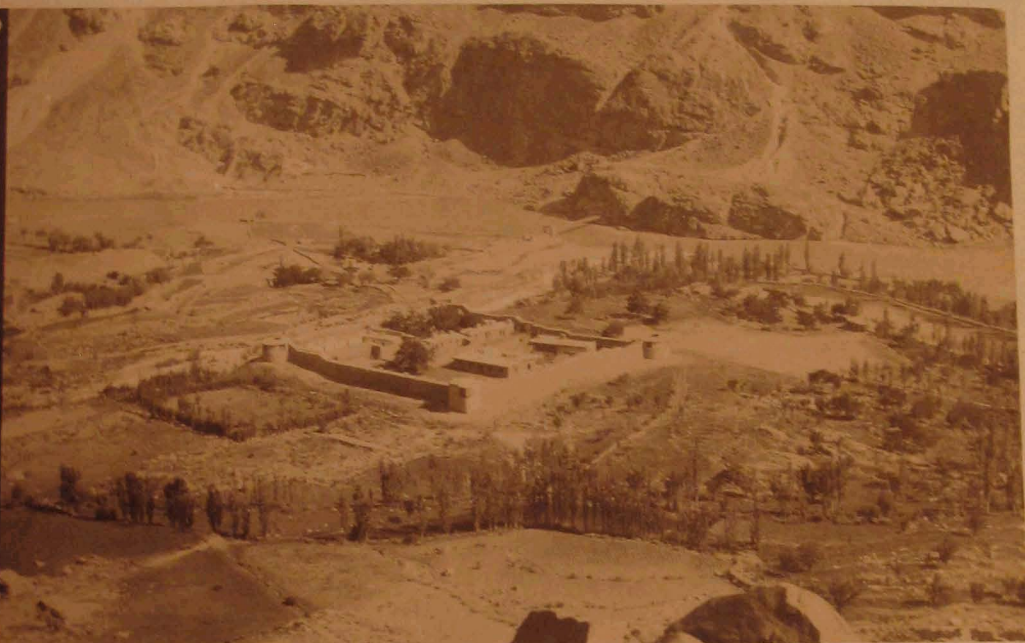
GUPIS F. Fort No. 134710

The attached plan shows the siting of the Fort with reference to the surrounding country, and photographs A & B are views of the fort taken from the blockhouses on the ridge above the fort and about 400 yards above it on the South East.

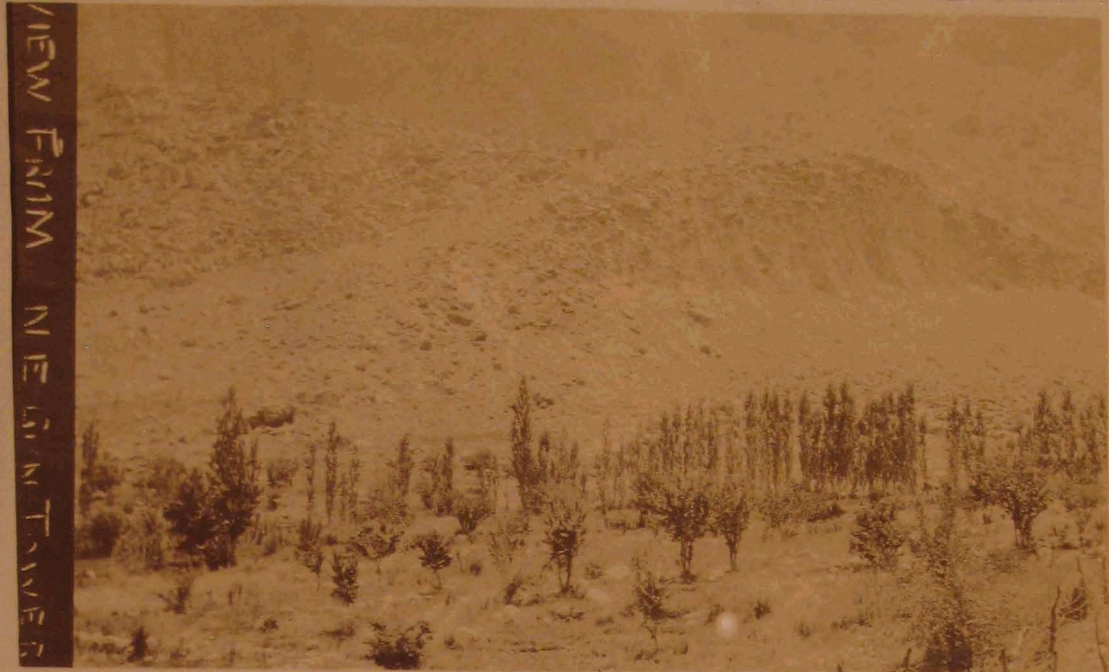
The Fort is commanded by a ridge on the South East at a distance of 300 yards. To deny this ridge to an enemy, two blockhouses have been constructed at distances of 300 yards and 500 yards from the Fort. Their positions are shown on the attached plan, and this photograph is a view of them taken from the Fort.

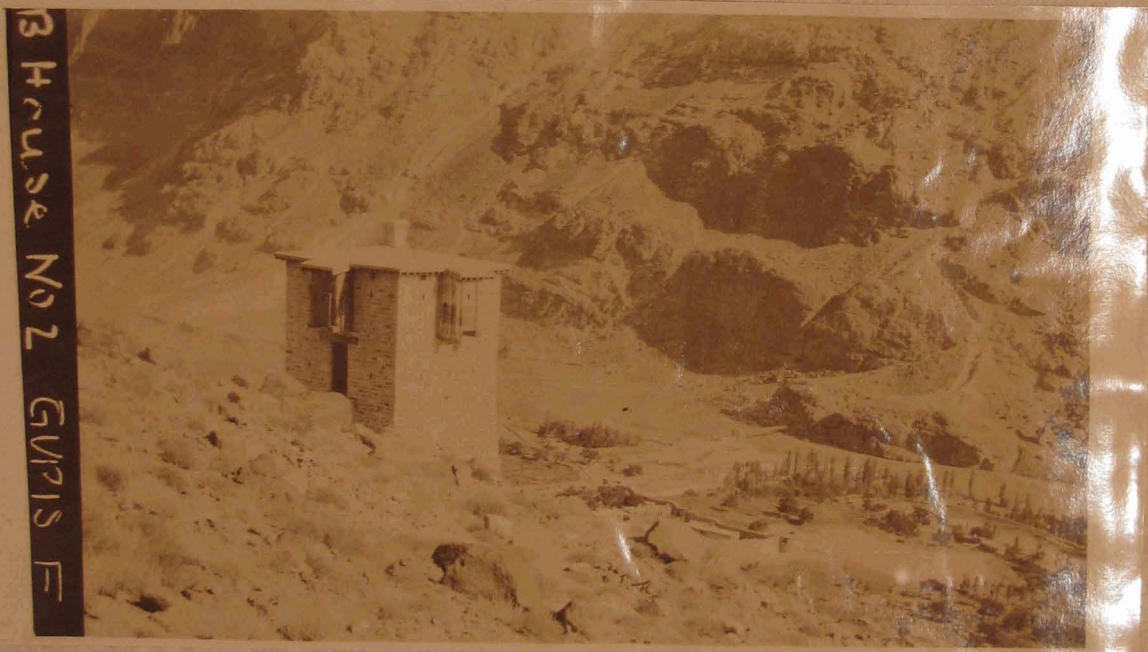
This photograph shows the Blockhouse and its relation to the Fort and also the way the Fort is commanded from the surrounding hills.

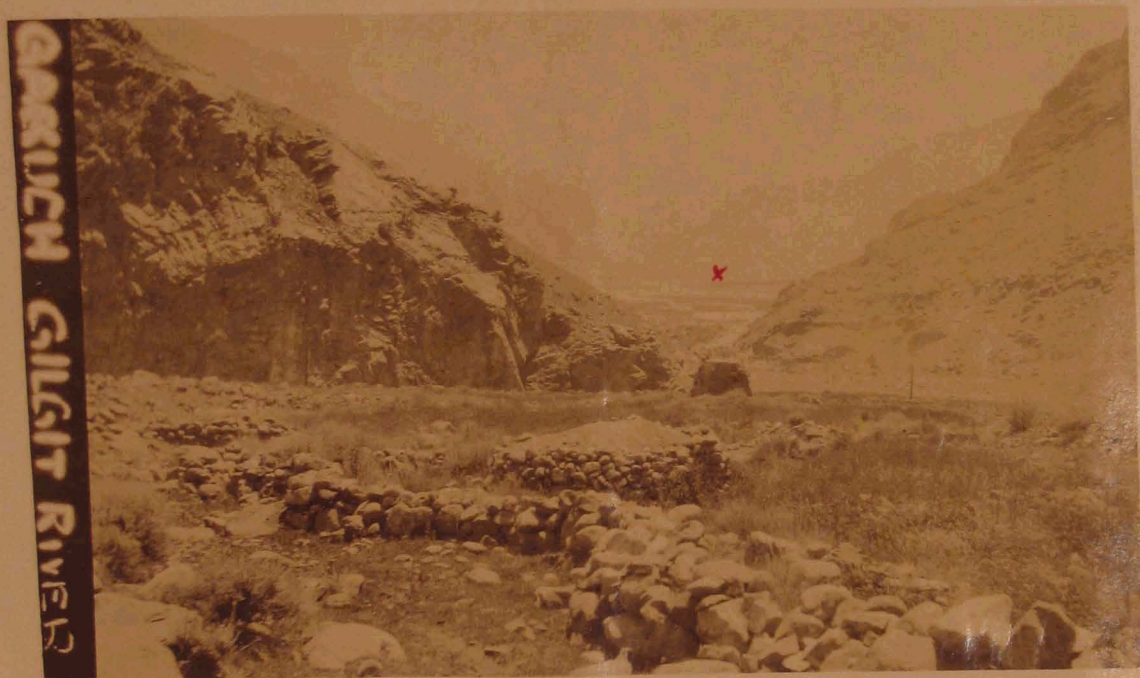
GAKUCH GILGIT RIVER

This photograph gives a rough idea of the Gakuch site.

The site for a Fort is marked roughly by a cross.

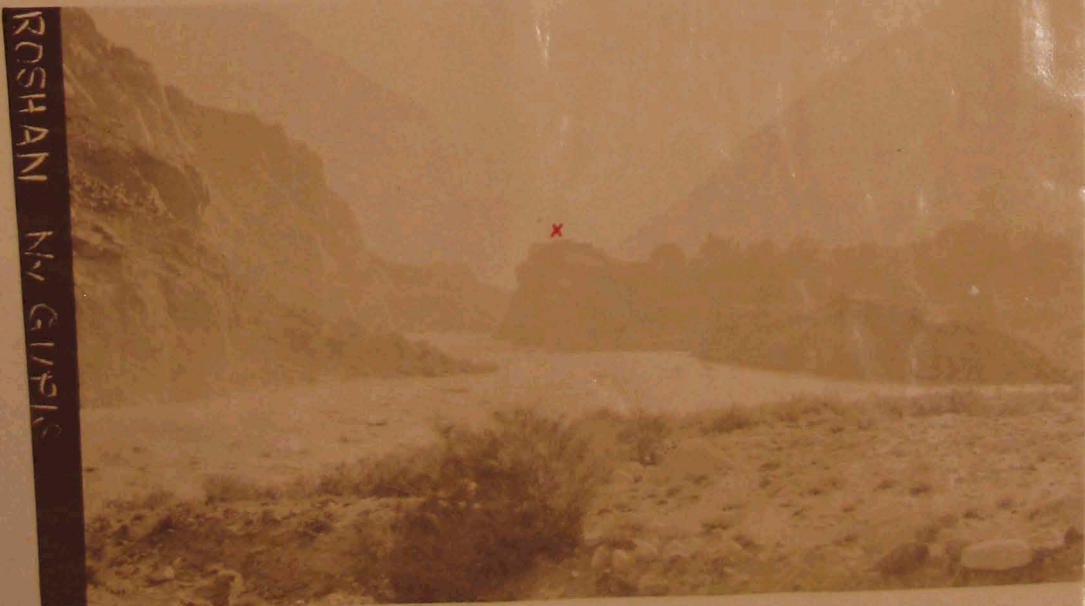
ROSHAN NW CUPIS

It has, I believe, once been suggested that a better site than Cupis would be the site of the old Fort at Roshan, but this photograph shows that a Fort constructed at Roshan would be very badly commanded from the hills on the left bank of the river.

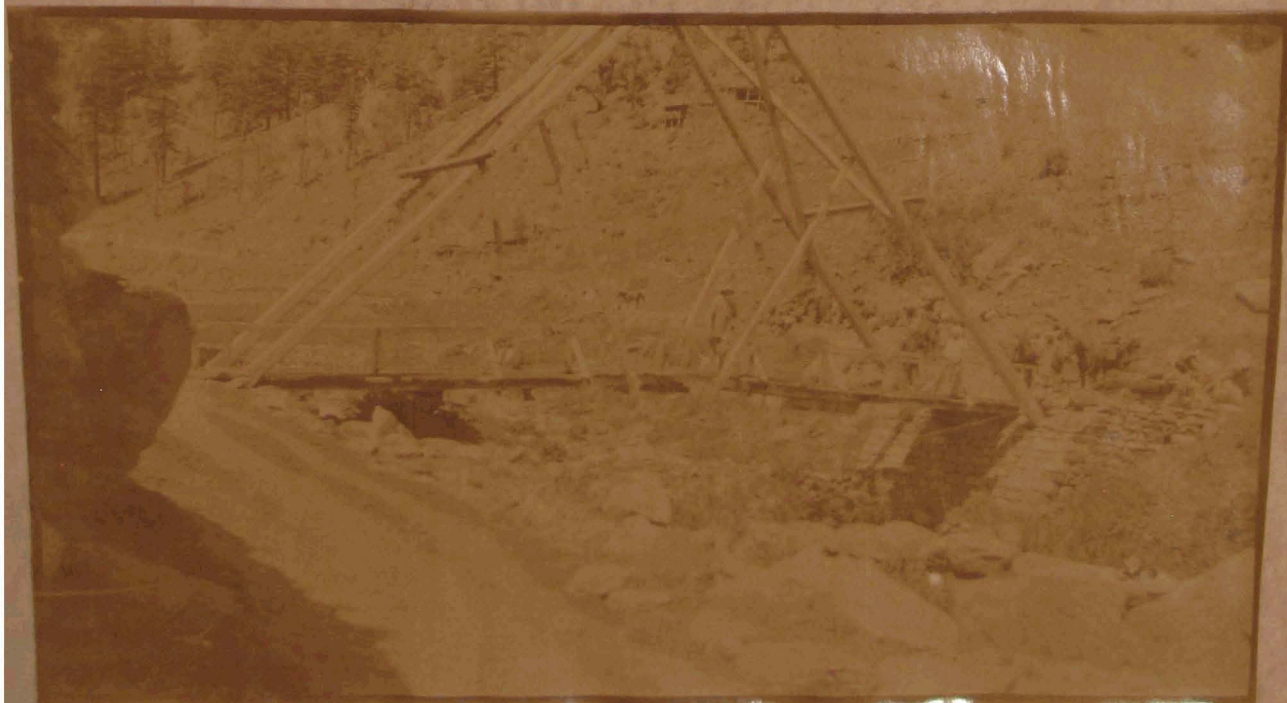
The photograph shows ^{an} ingenious type of single lock bridge with the roadway suspended by ~~slings~~ slings.

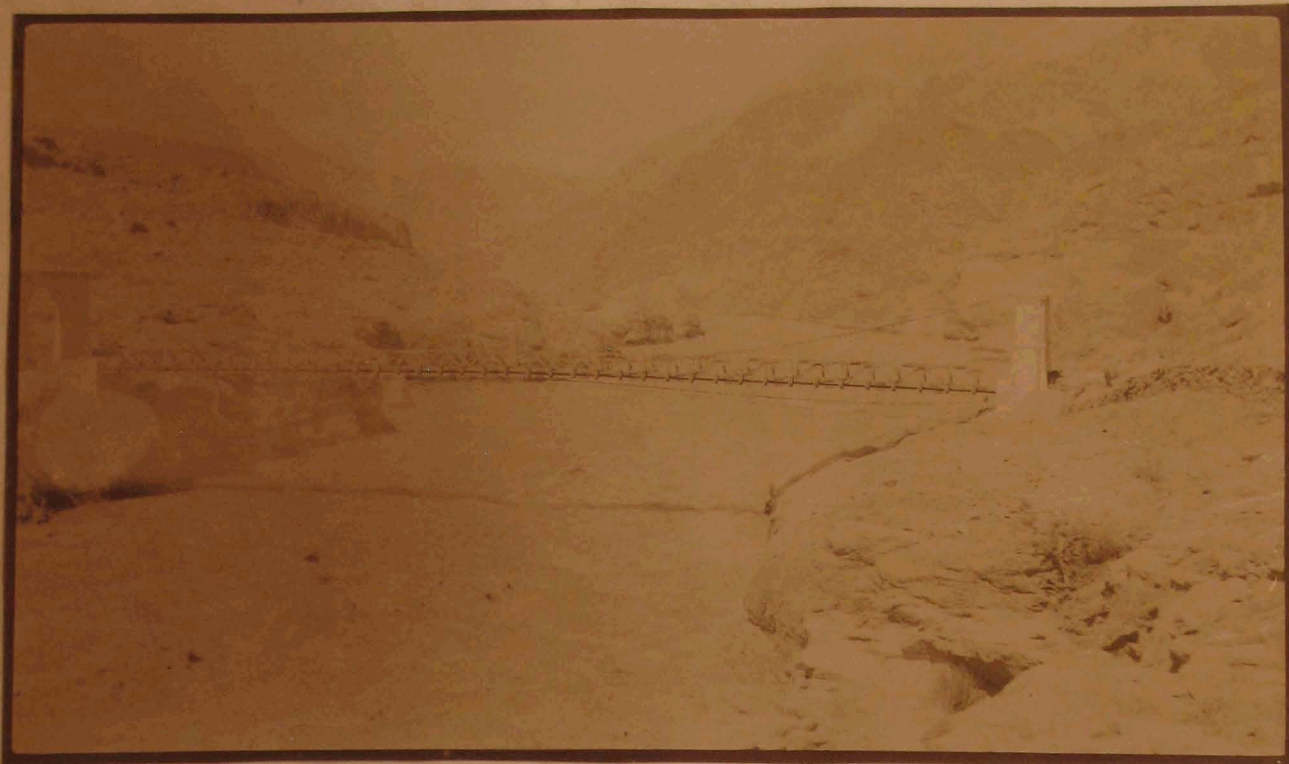
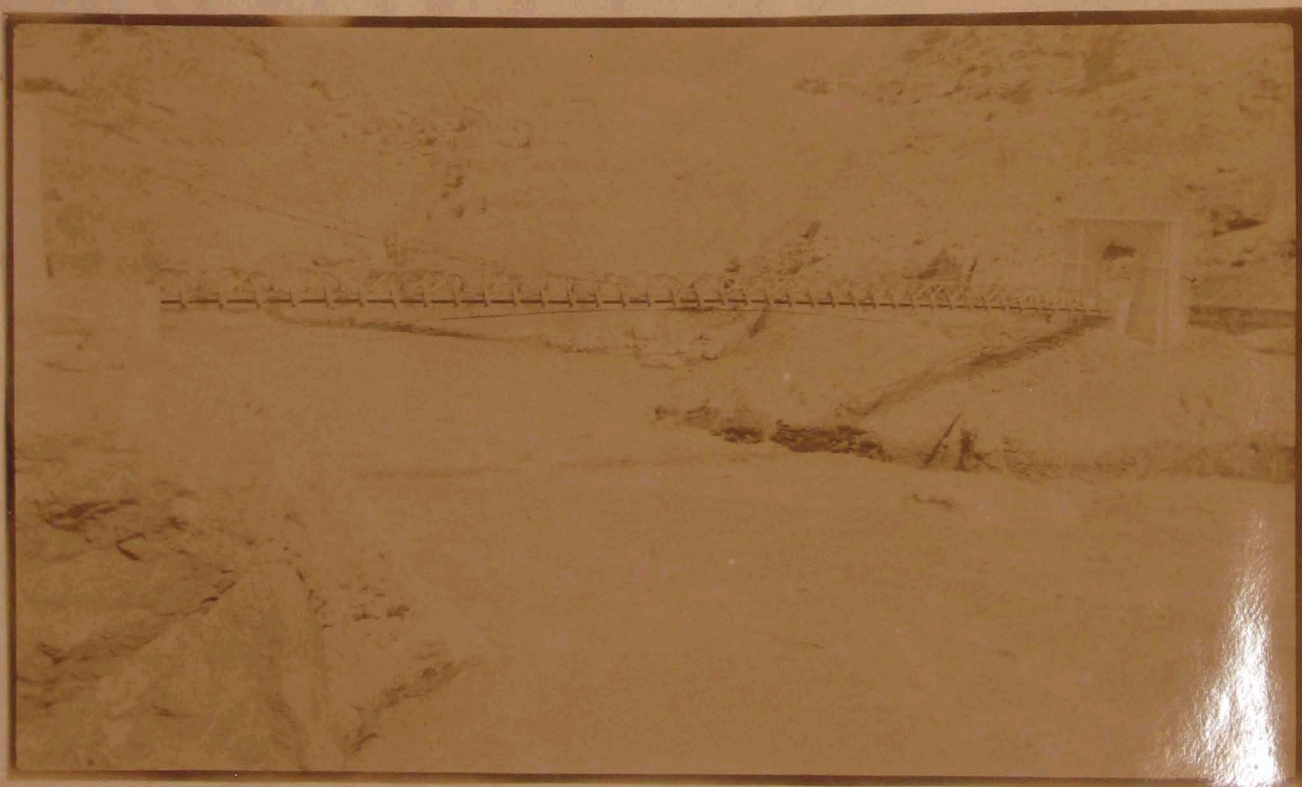
RAKHIOT BRIDGE

There are 14 $2\frac{1}{2}$ " cables on each side with a breaking strain of 30 tons. The stiffening girder has been bolted down to the masonry on each side and the masonry has pulled out in consequence. All masonry should be at least 9" clear of all wood and steel work.

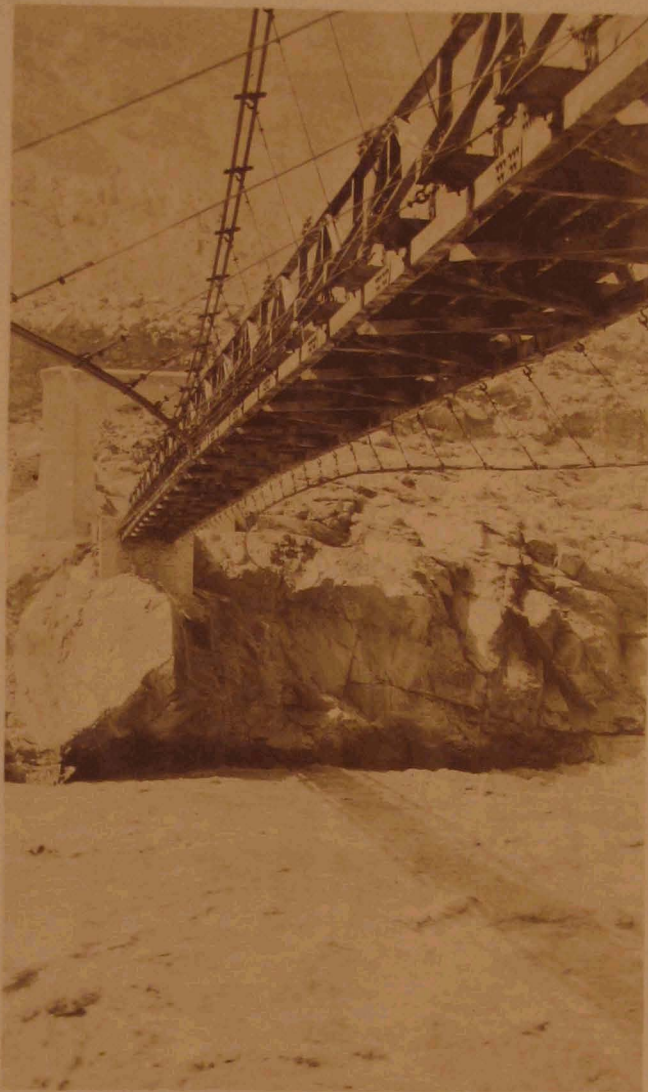
The above photo shows the wind girder which is a Warren Type, triangulated, and the wind cables. The wind cables have not pulled out from the anchorages due to contraction, as there is sufficient slack to allow for this.

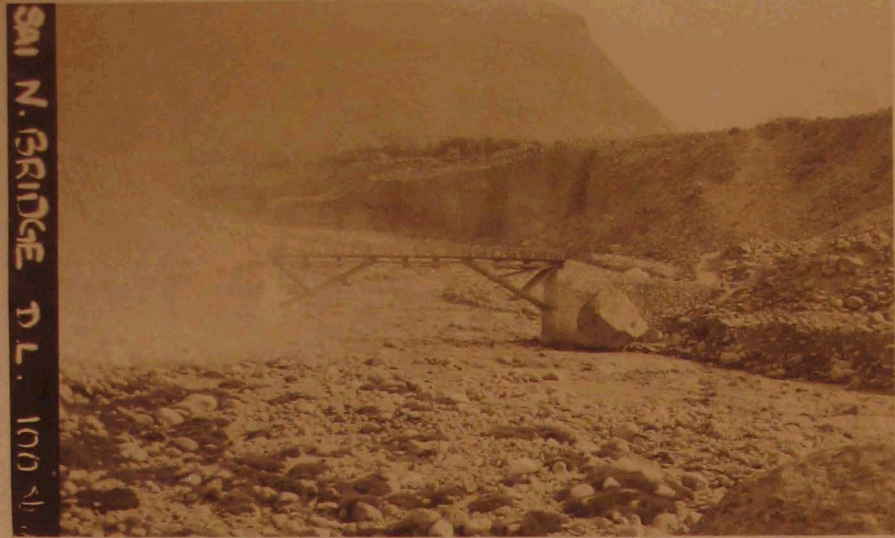
SAN N. BRIDGE D.L. 100 ft.

The Photograph shows the bridge over the Sai Nullah which is the boundary between the Imperial ~~and~~ and ~~Nullah~~ the state Roads.

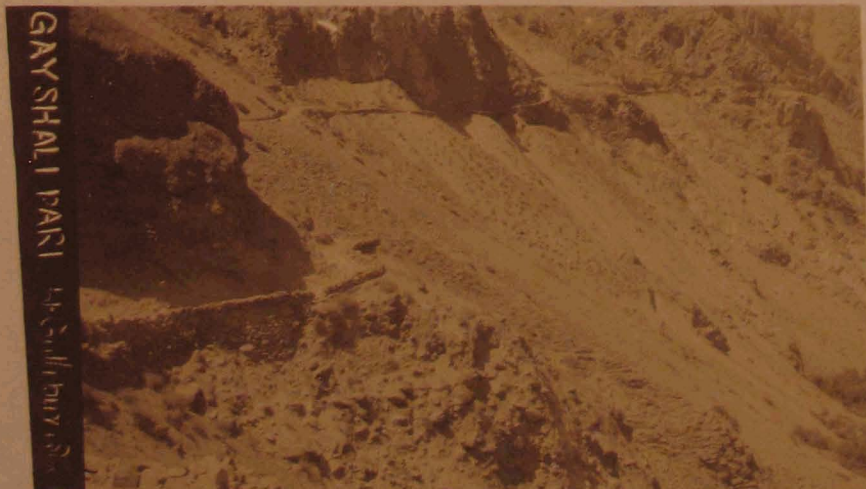
GAISHAYLI PARI 4000 ft.

This pari is very bad and dangerous. The grades are very steep and the hill side is very difficult. The road in places is completely washed away whenever there is any rain. It is difficult for camels and will require more rock cutting and ~~reg~~^{and} grading in places, to make it safe is impracticable.

In my opinion it would be a far better plan to take the road across the river to the left bank, by a bridge at Gullipur. There is a very excellent site for a bridge immediately below the Gullipur Rest House about 300' span. The road will then go along the left bank as far as Hamochal Village in Mile 29, where the river is very narrow and there are rock foundations for a bridge. The Road will then recross to the R Bank and rejoin the old road. By taking the road on the Left Bank three bad paris will be avoided where the road is washed away every time it rains. The country on the ~~River~~^{Left} Bank is very easy for road construction. The Dalnati Bridge will not be required on the old road and could be moved to one of the new sites.

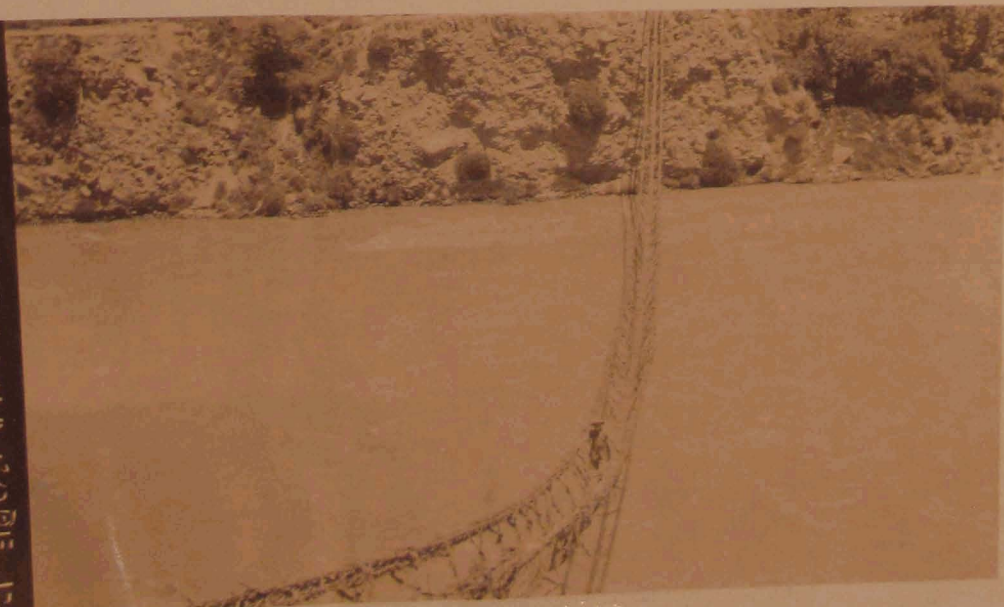
DEANE ON SHER KILA ROPE BRIDGE

By building a bridge over the river at Gullipur the big village of Sher Kila would be given communication with the main road. Sher Kila is the headquarters of the Rajah of Punial and is a very important village. The only communication there is at present is the Rope Bridge as shown in the Photo

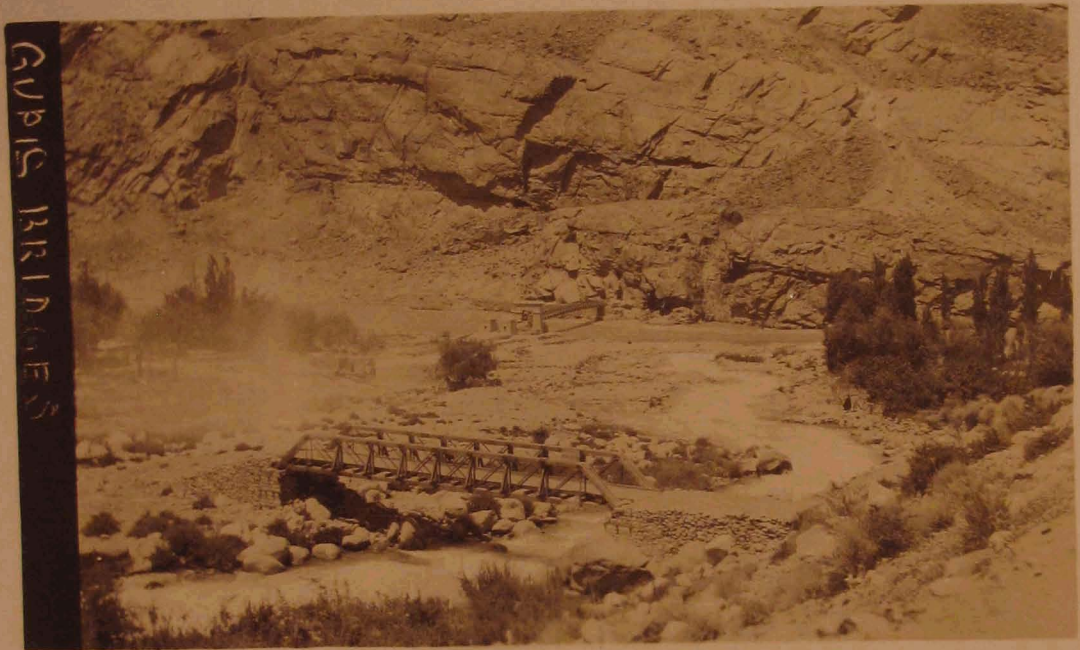
The road is generally in very good condition from Gilgit to Gupis. The Gupis Nullah is crossed by a very good type of combined ~~wood~~ ^{wood} and flat bar iron girder which is shown in the Photograph. From Gupis the river takes off to Yasin and crosses the river by the Suspension bridge shown in the Photograph.
