UTTARKASHI EARTHQUAKE

OCTOBER, 20, 1991

GEOLOGICAL SURVEY OF INDIA
SPECIAL PUBLICATION NO. 30
1992

SPECIAL PUBLICATION NO. 30

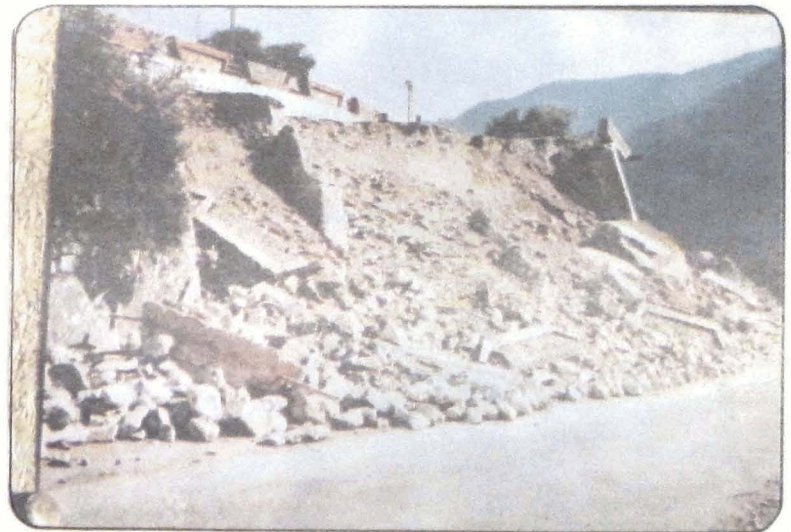
Photo 1 *Rock fall cum debris slide initiated in quartzites upslope of the road about a km before Maneri. Note uprooting of a telephone pole in the toe portion of the slide.*

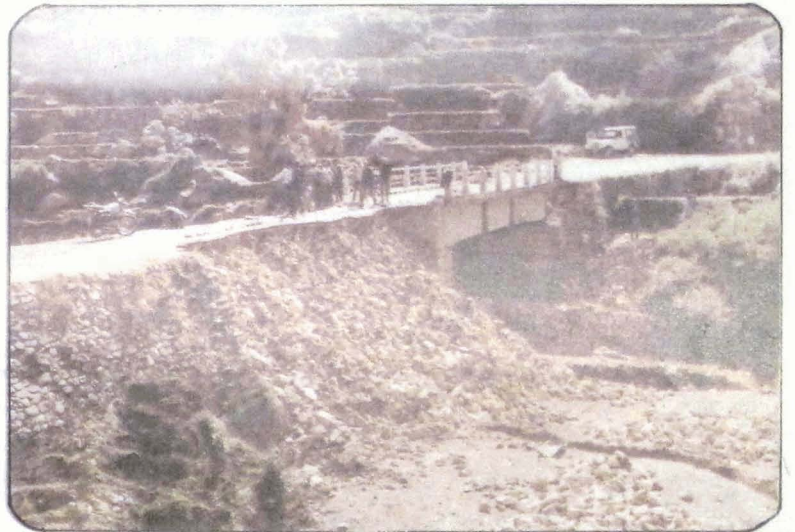
Photo 6 *Failure of the valley side portion of block top road near Mannpur.*

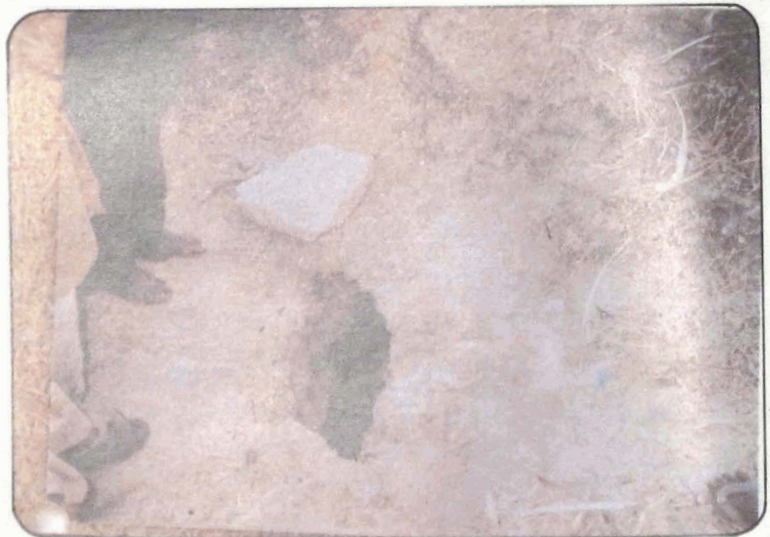
Photo 9 *Dislodgement of rock blocks near Gorthi village. Partial collapse of the short wall of a village house in the background.*

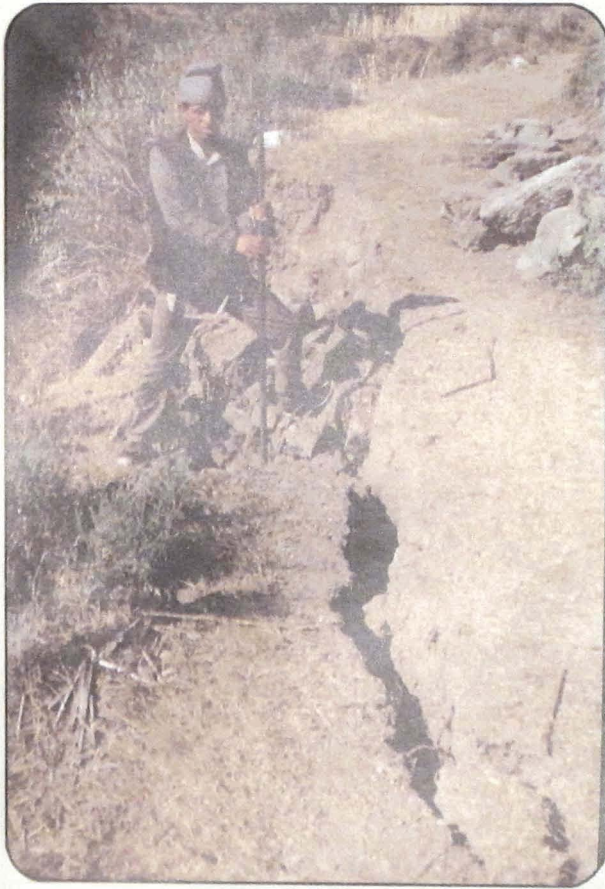
Photo 11 *Open fissures in oberburden material showing 50 cm. valley side slumping, 6 km. upstream of Uttarkashi on the road to Maneri.*

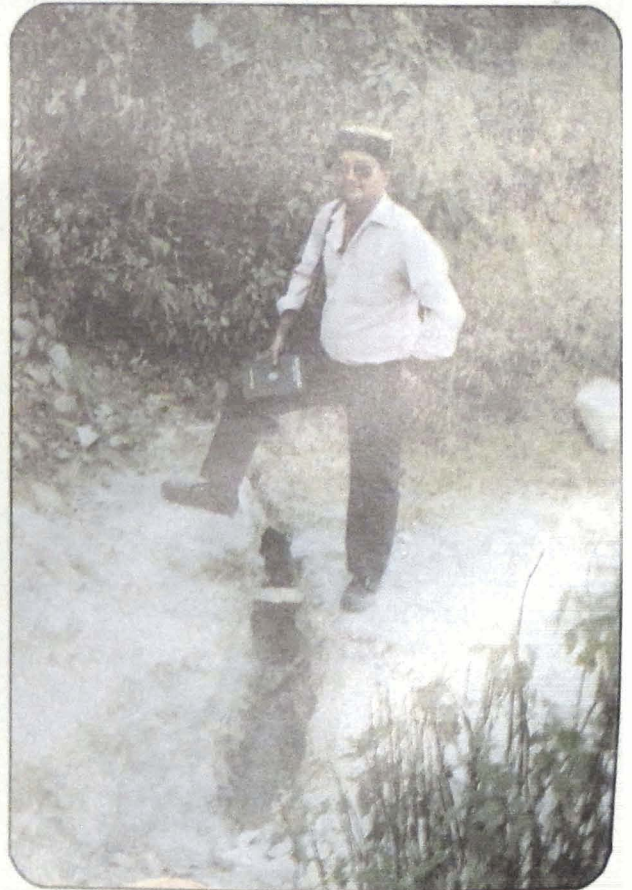
Photo 12 *NE-SW trending fissure on the debris covered slope on the Saura Byala Tipri mule track.*

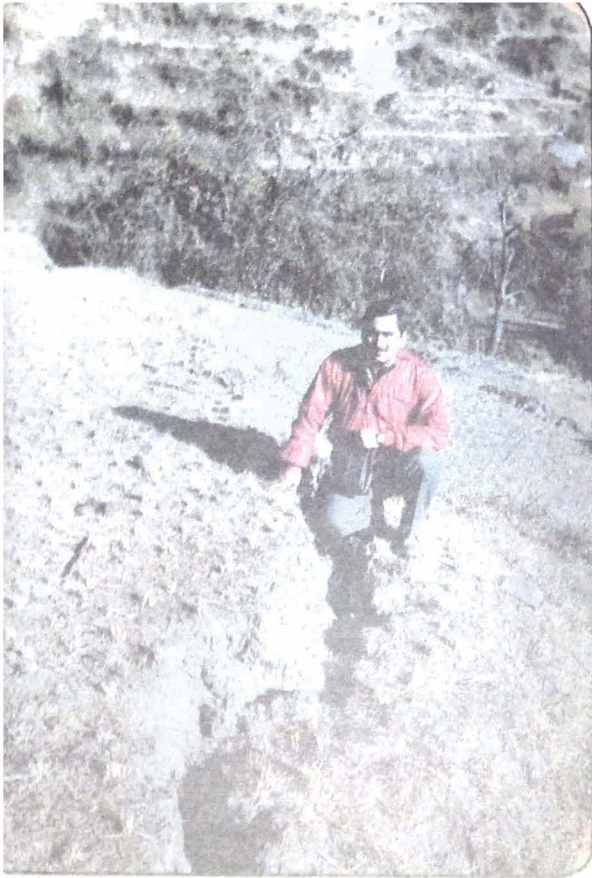
Photo 12 A *50 cm. open crack trending NNW-SSE along Manerijamak foot track.*

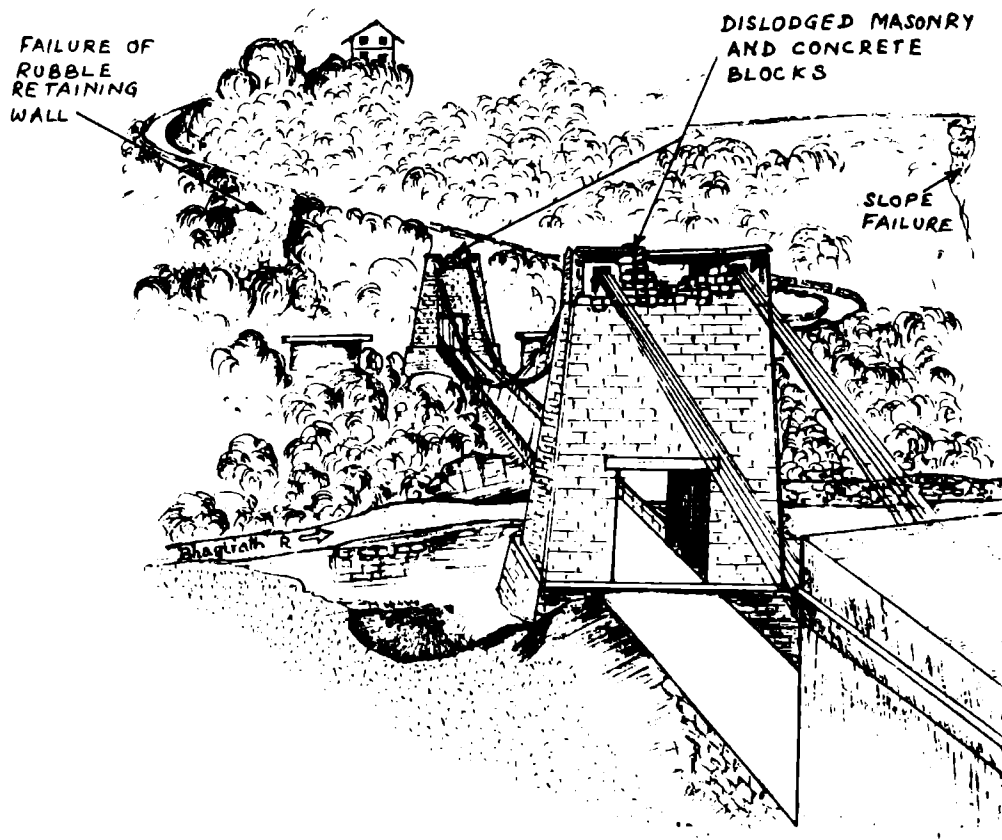
The single span, 100m long foot suspension bridge at Lata, aligned in NW-SE direction has suffered similar damages as that at Siror but the intensity of ground motions here appears to be more. The masonry tower at the left bank has collapsed in the top portion and the concrete slabs enclosing the cables are slightly dislodged (Fig.5). All the cables are intact and the bridge is fully serviceable.

Fig 5: SKETCH OF LATA SUSPENSION BRIDGE SHOWING DAMAGES TO THE ABUTMENT TOWERS (SKETCH BY P. PANDE)

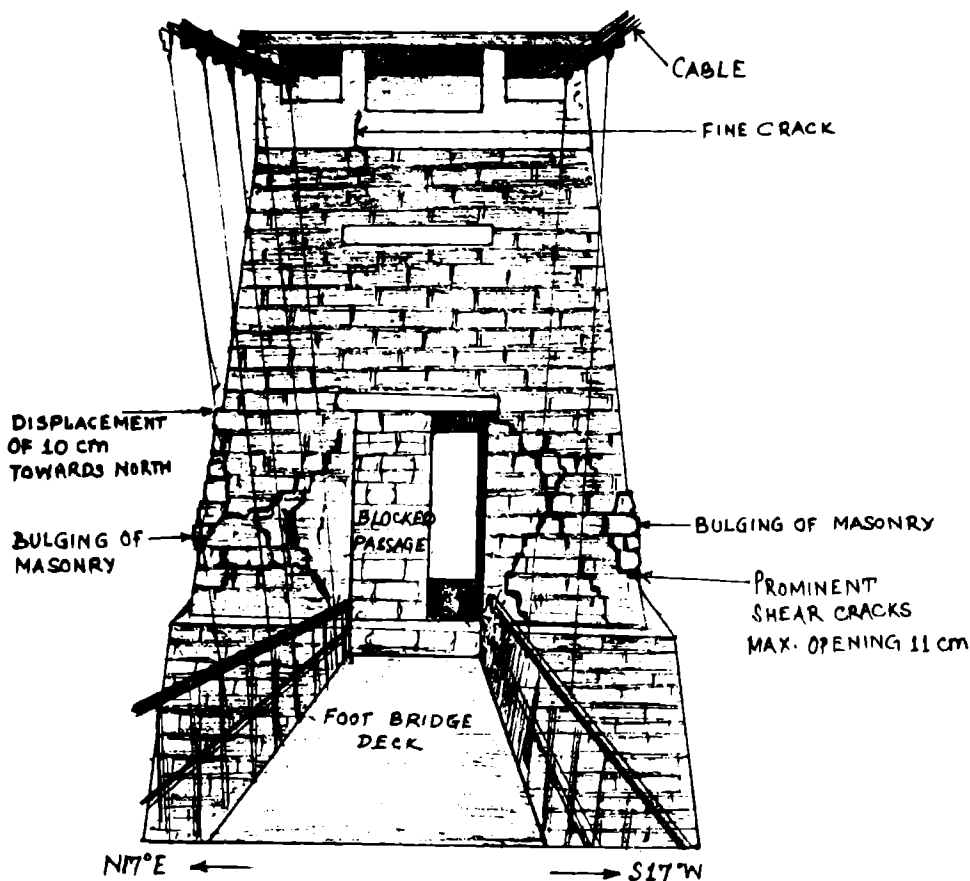
The 76.20m long Dedsari suspension bridge, constructed in the year 1979 has been analysed in detail. The foot bridge has survived the earthquake but has been damaged to some extent. The left abutment suspension tower constructed of masonry has developed prominent shear cracks on the N17°W-S17°E trending faces (Fig.6). The cracks which extend to a height of 3m from the ground have maximum opening of 11cm. A fine, vertical crack extending for about 1m is also seen at the top portion of the tower. The upstream, WNW-ESE trending face of the tower shows a displacement of the order of 10 cm and bulging.

Fig. 6 : SHEAR CRACKS IN THE LEFT ABUTMENT TOWER, DEDSARI SUSPENSION BRIDGE (SKETCH BY P. PANDE)

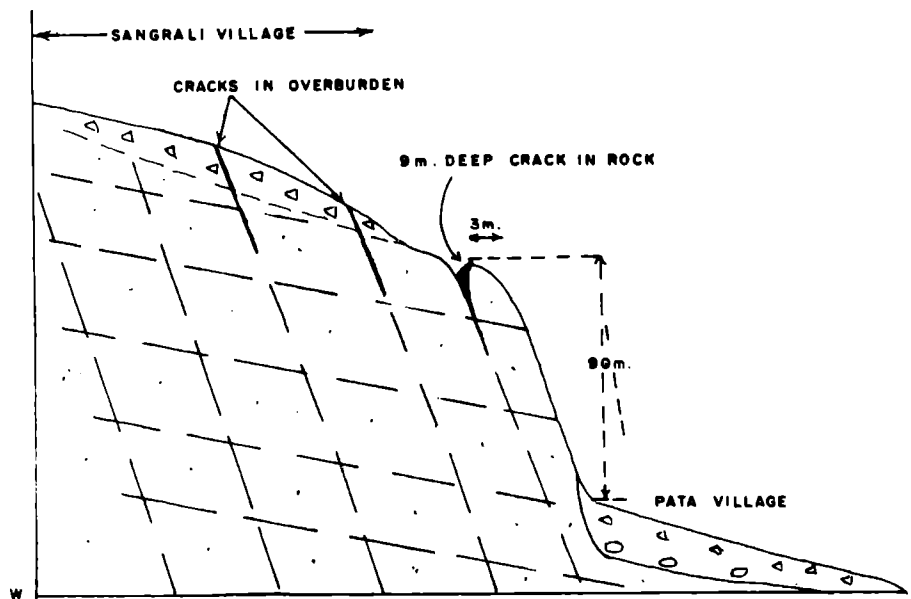
and has been measured to a depth of 9m (Photo 10). At an isolated location the width of this opening is about 50cm. This crack is oriented in the N-S direction i.e. parallel to the cliff face. Because of the earthquake the unsupported side i.e. the cliff face has lead to the opening of rock blocks along pre-existing joint surfaces which are probably the controlling features for development of the cliff face. A sketch demonstrating the mechanism of formation of this crack is enclosed as Fig.7.

The strong ground motions have dislodged or displaced some of the rock blocks or wedges, particularly those located near the scarp face, thereby giving rise to the appearance of ground cracks (Fig.7).

Fig. 7: CRACKS IN SANGRALI VILLAGE.

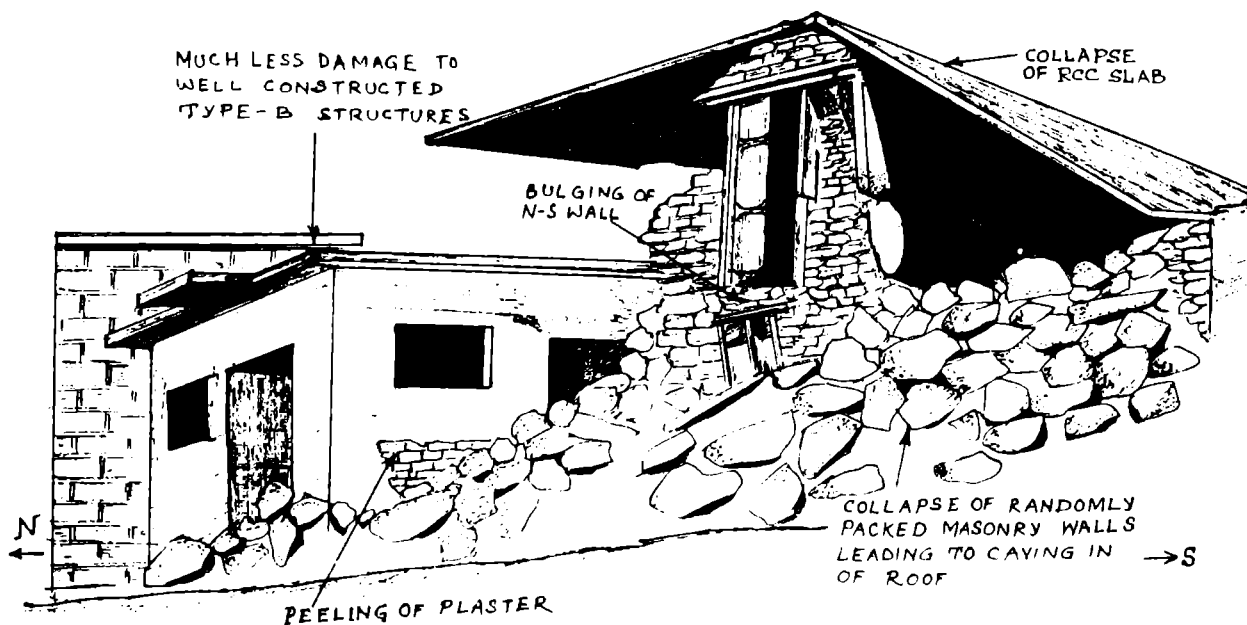
The poorly constructed mud masonry walls of the village dwellings have partially or totally collapsed in a number of cases. At places, the RCC slab or slate roof resting on such walls have also caved in (Fig.8). Almost all the standing walls have developed deep, open cracks, rendering them unsafe for habitation. In general, type A constructions have suffered grade 3 & 4 damages and type B structures grade 1 damage. The dry masonry walls used as field boundaries have failed at places.

Fig. 8: SKETCH SHOWING EXTENT OF DAMAGES TO TYPE 'A' AND TYPE 'B' CONSTRUCTIONS IN SAURA VILLAGE (SKETCH BY P. PANDE)

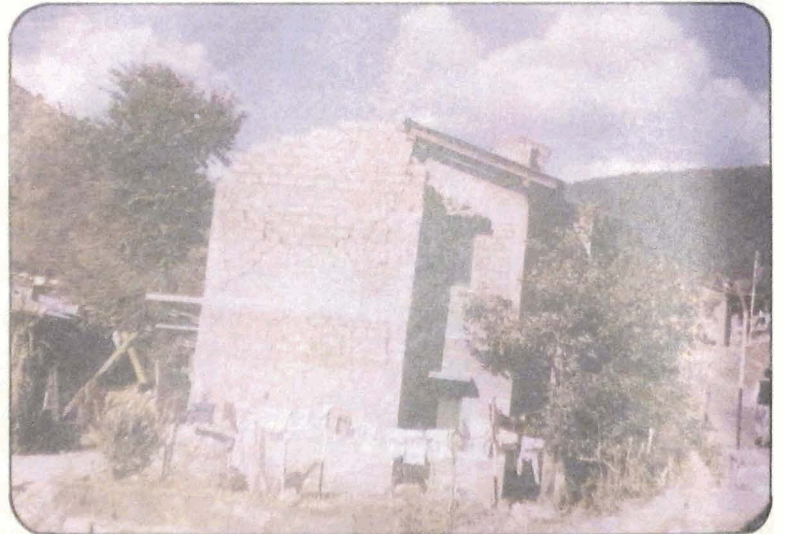
Photo 22 *Collapse of pillar and beam of the verandah of a house in Police Lines, Uttarkashi.*

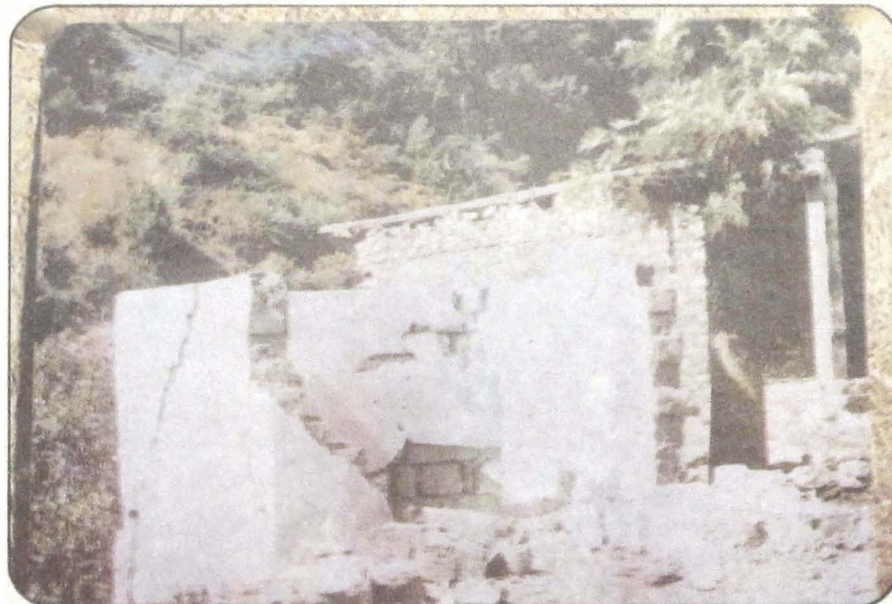
Photo 25 *Shear cracks in the E-W aligned side wall of a house in Gangeri village.*

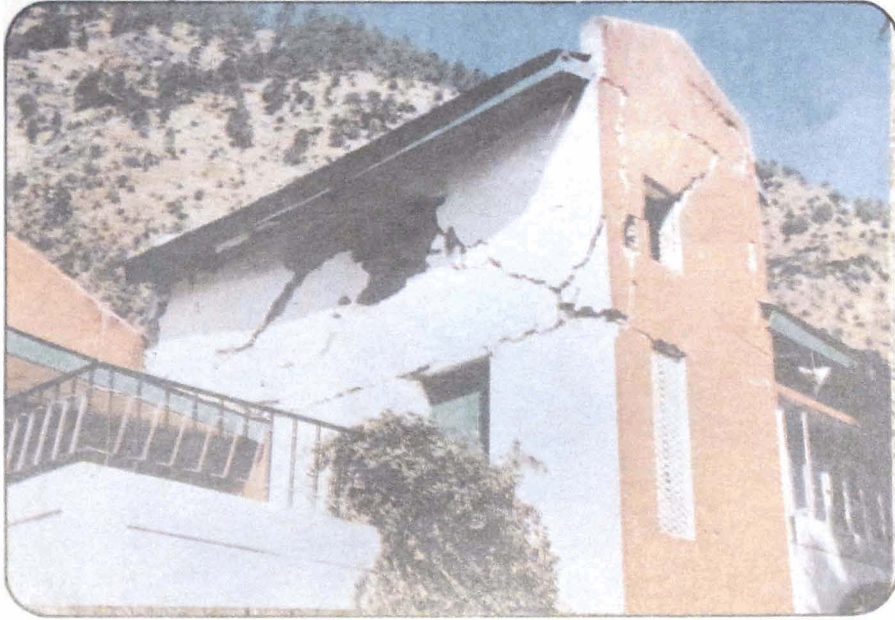
Photo 26 *Damages in a low height structure in Gangeri village. (Photo NGRI).*

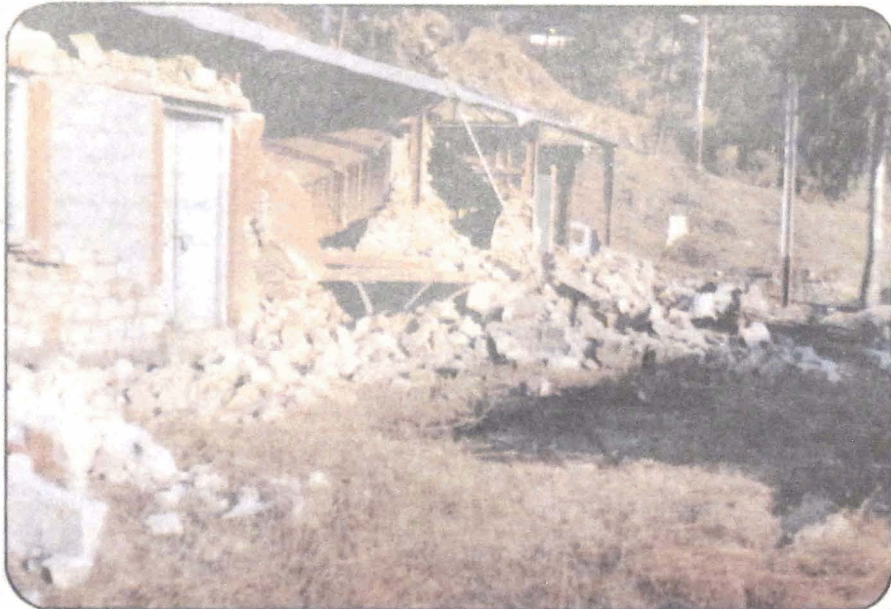
Photo 27 *Heavily damaged first floor of the Maneri Inspection house with shear cracks in both long and short walls.*

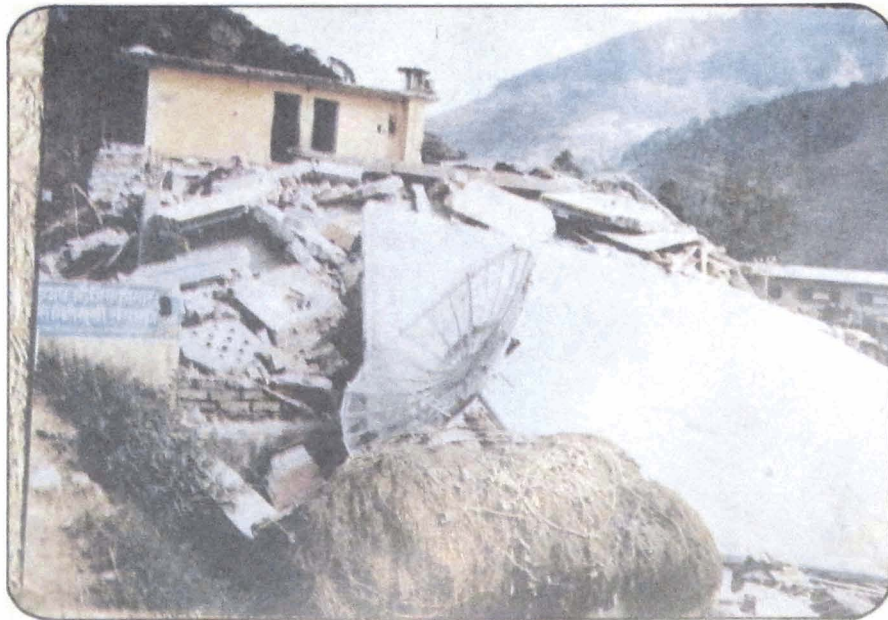
Photo 29 *Wall collapses in the first floor of the project engineer's office in Maneri colony.*

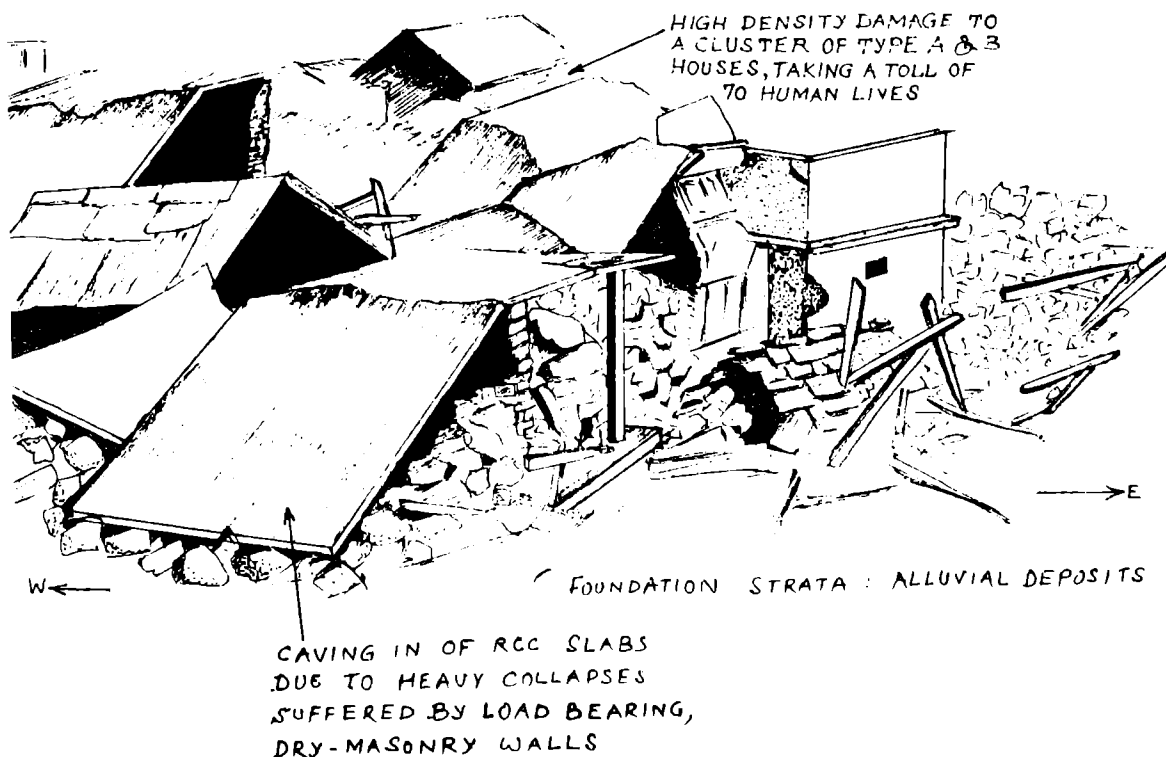
The village is located on a high level alluvial deposit of an abandoned channel, on the left bank of river Bhagirathi, at a distance of 0.5 km south east of Maneri dam. Jamak bore the maximum brunt of the 20th October earthquake, where 70 persons got killed and almost all the remaining were injured. The intensity of ground motions was so high that nearly 90% of the dwellings were either razed to the ground or suffered heavy damage, making them unfit and unsafe for habitation. The village thus bears a deserted look with all the inmates having moved to the neighbouring fields in make shift hutments (Photo 45).

Fig. 9 : DAMAGE IN JAMAK VILLAGE (SKETCH BY P. PANDE)

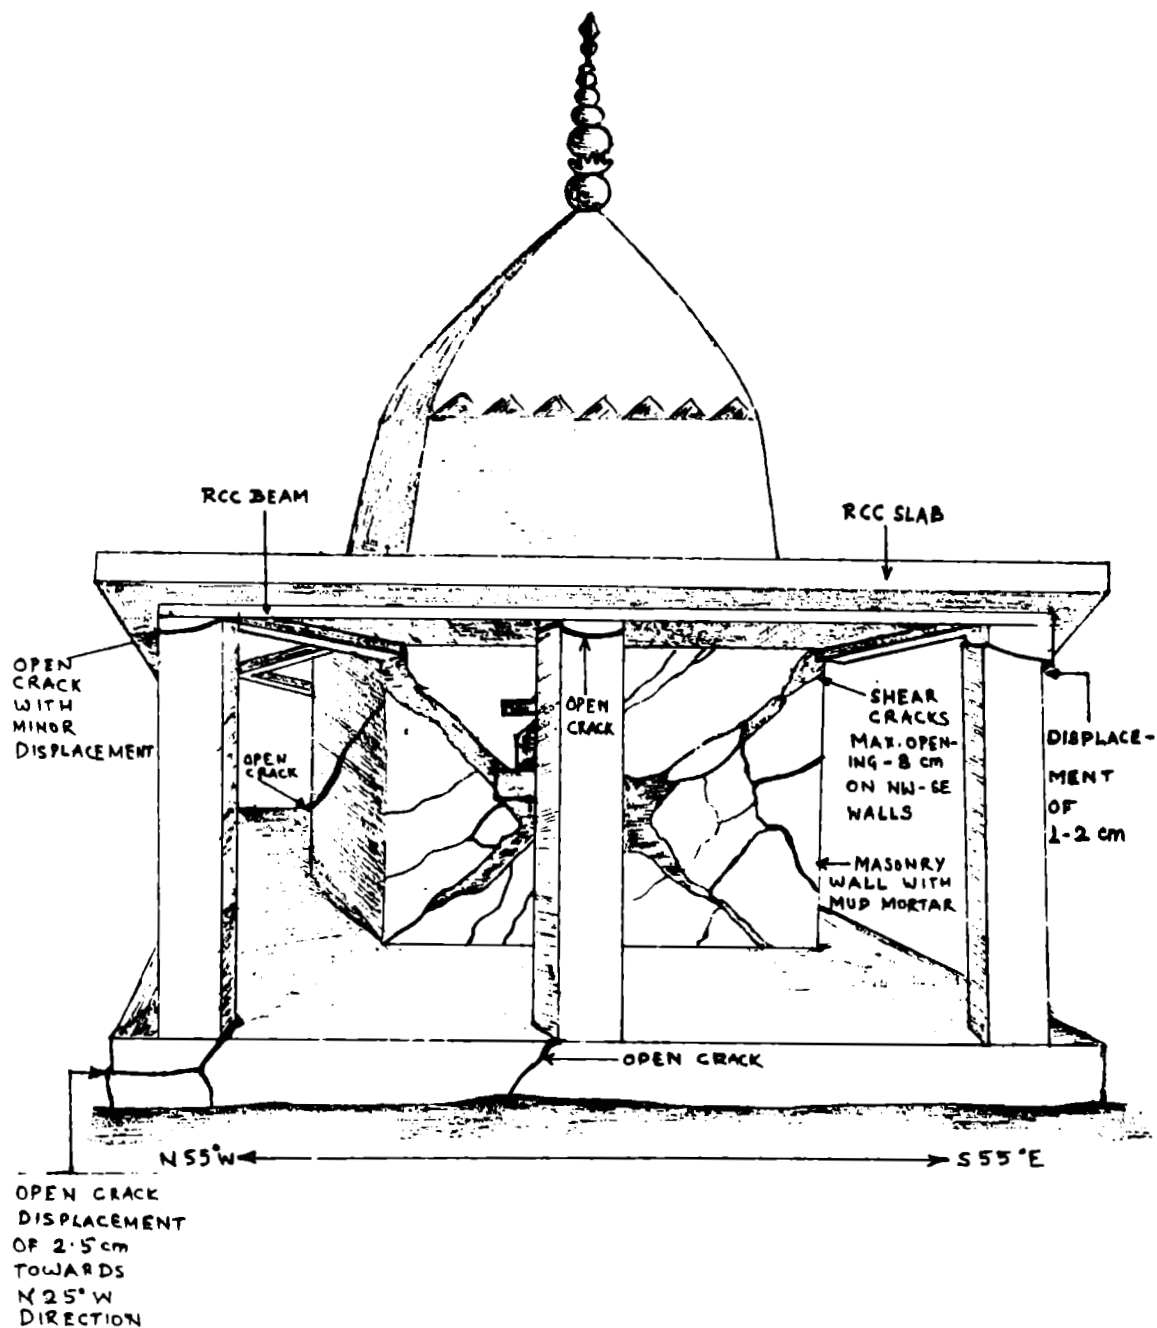
The N65°W-S65°E trending faces of the sanctum walls have developed prominent cross shaped shear cracks. The columns have invariably sheared near the beam contact. A displacement of the order of 2cm towards N15°E direction has been measured in one of the corner pillars. Open cracks have also appeared in the floor, particularly around pillar contacts.

Fig. II : DAMAGE TO KALINAG TEMPLE, DEDSARI VILLAGE (SKETCH BY P. PANDE)

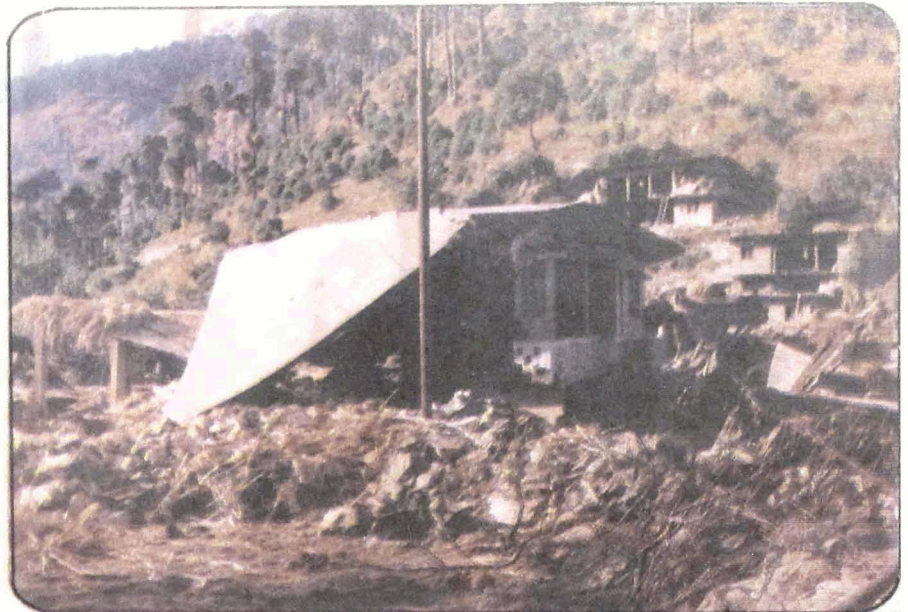
Photo 45 *Devastated Jamak village.*

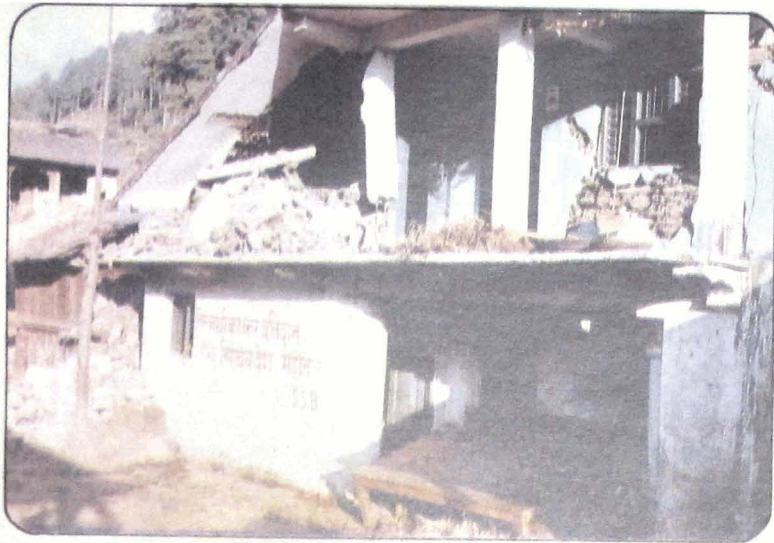
Photo 51 *Partial to complete collapse of houses in Dedsari village. Note an intact house made of timber logs and planks.*

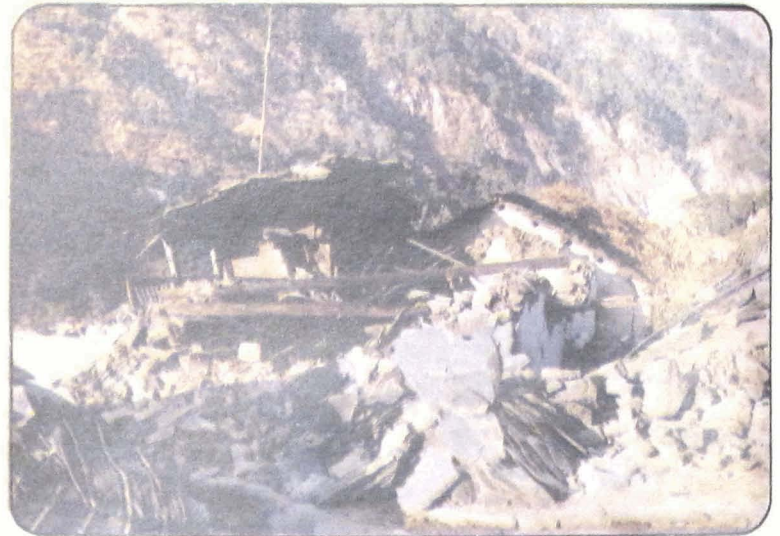
Photo 52 *Partial collapse of the first floor of a house in Dedsari. Note damages to RCC pillars and open shear cracks.*

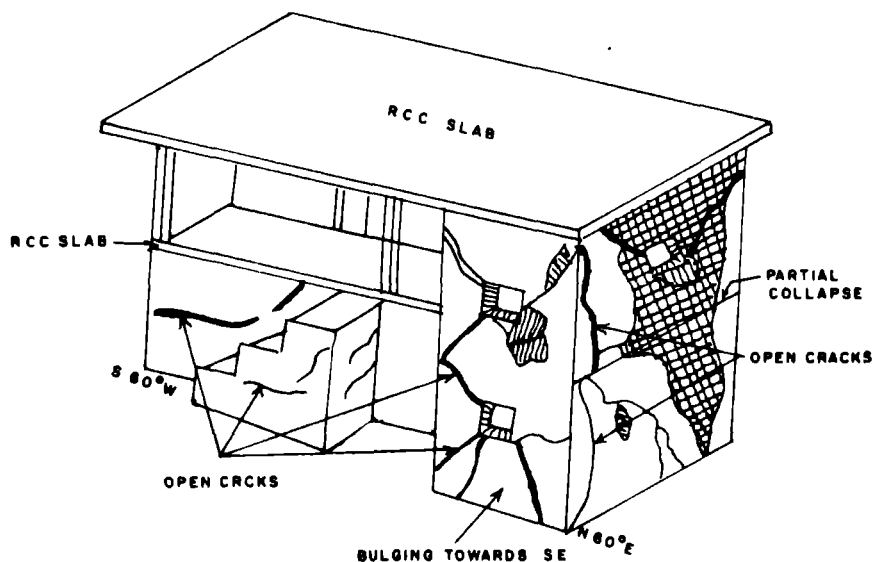
Fig. 17: HOUSE OF SAHDEV SINGH AND GYAN CHAND, PALA

The house of Sahdev Singh and Gyan Chand has its long wall aligned in $N60^{\circ}E-S60^{\circ}W$ direction (Fig.17 and Photo 62). It is a stone masonry house with RCC slab roof. The house is double storeyed with the stair case located outside. The southeastern wall has suffered damage in the form of open cracks (upto 5 cm) which are more pronounced near the windows and extend towards the edges. Bulge towards SE was also noticed below the window in this wall. Similarly, the projections on this wall like stair case have also suffered cracks. The NE wall (aligned $NW-SE$) has suffered more damage in the form of partial collapse and development of open cracks. The collapse is more pronounced at upper portion of building as compared to lower. Similar damage, but of lesser intensity has been noticed in a number of houses.

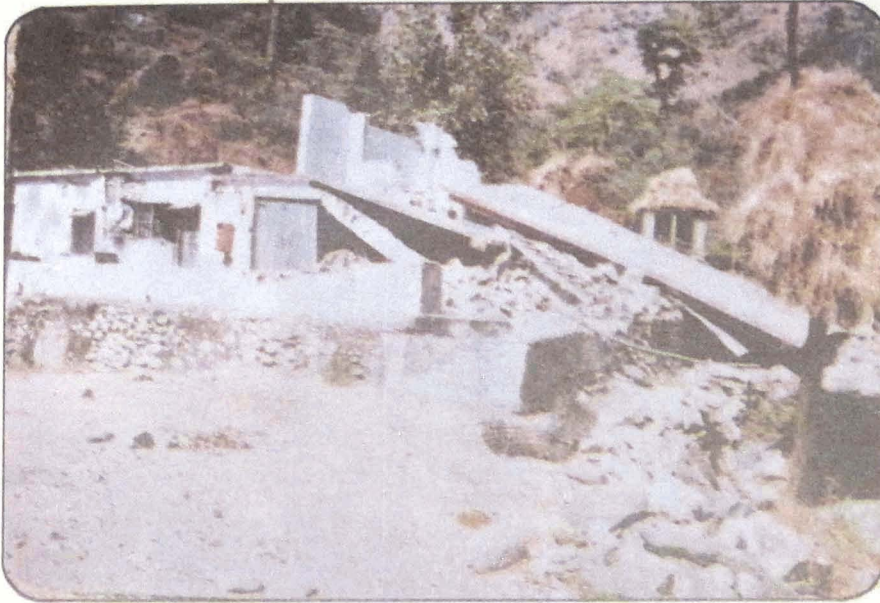
Photo 59 Collapse of wall and slided RCC slab, Bhatwari village.

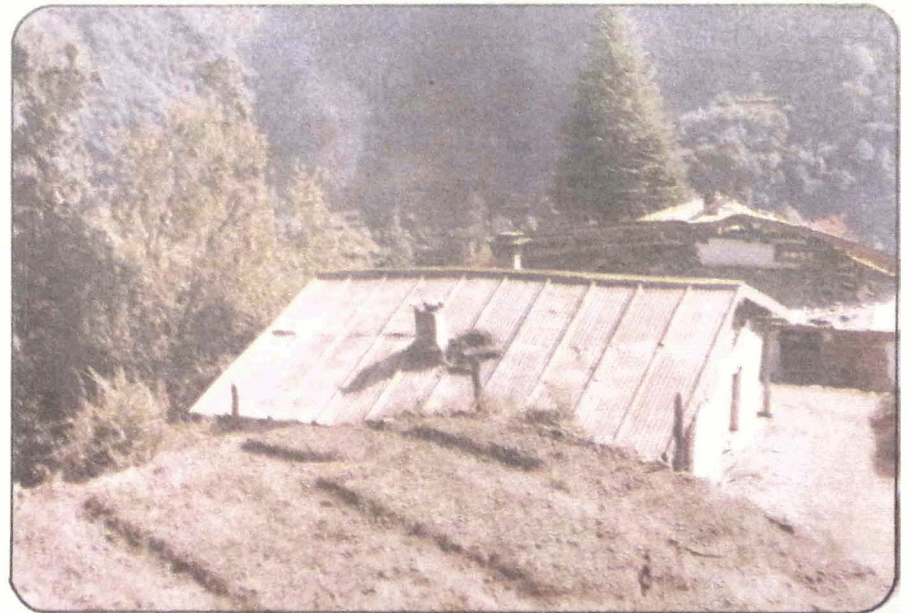
Photo 60 Damaged PWD Rest house building, Bhatwari. Chimney slab of the out house thrown on G. I. sheet roofing.

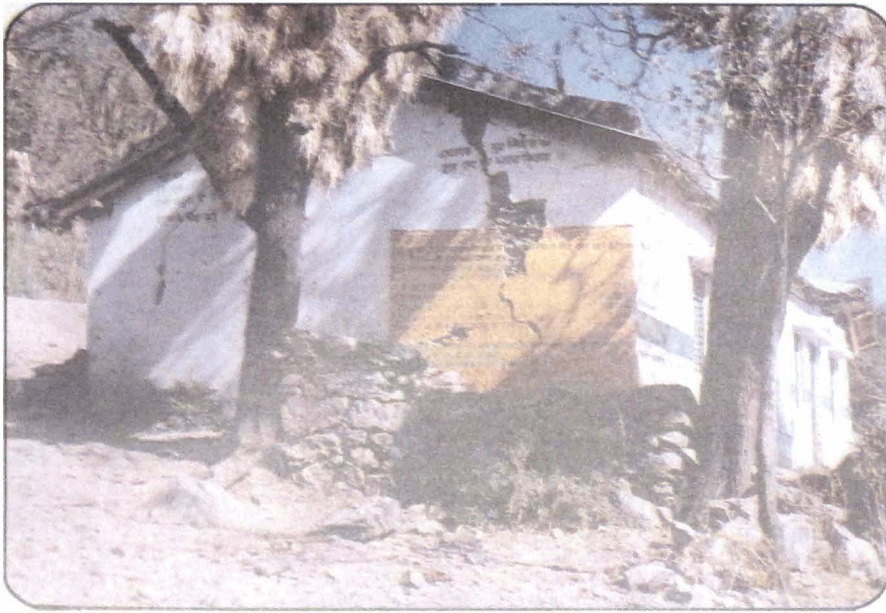
Photo 61 *Shear cracks in the side wall of Pala school building made in mud masonry.*

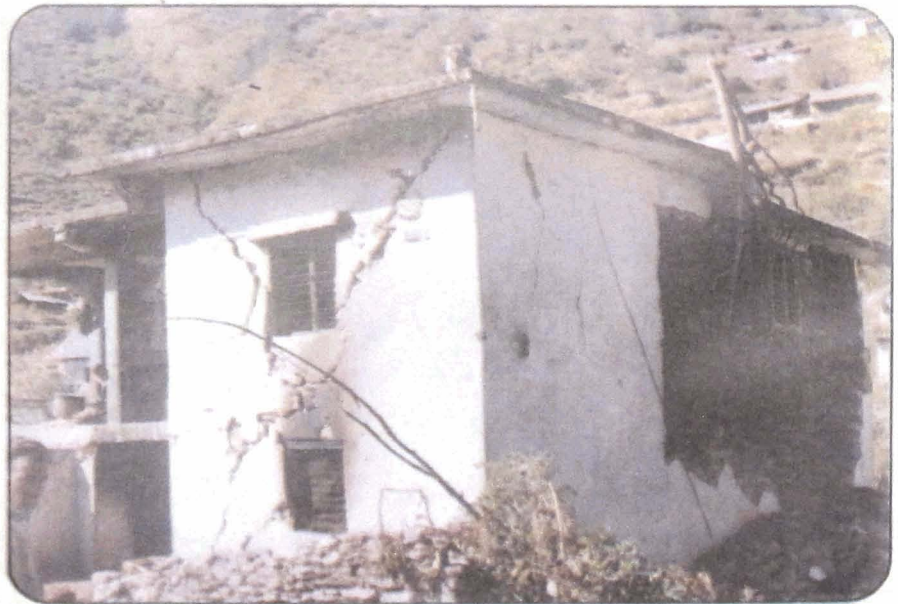
Photo 62 *Open shear cracks in NE-SW wall and partial collapse of NW-SE wall in the house of Sahdev Singh of village Pala.*

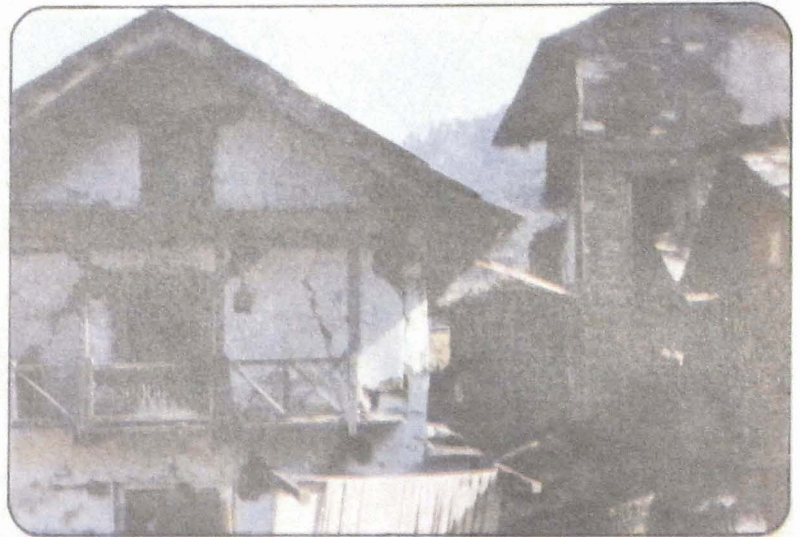
Photo 64 *View of an old conventional house with wooden beams and columns displaying gaping shear cracks in Siror village.*

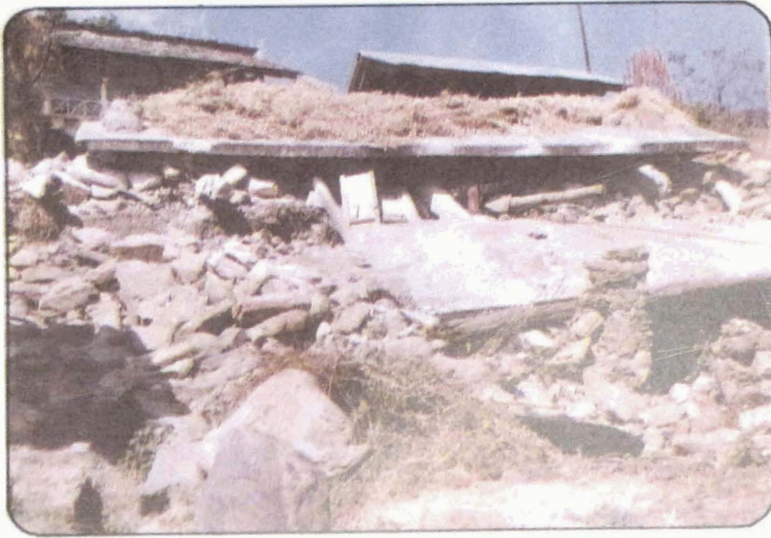
Photo 66 Collapse of houses with RCC slabs in Mannpur village. Note relatively lesser damage to the conventional houses in the background.

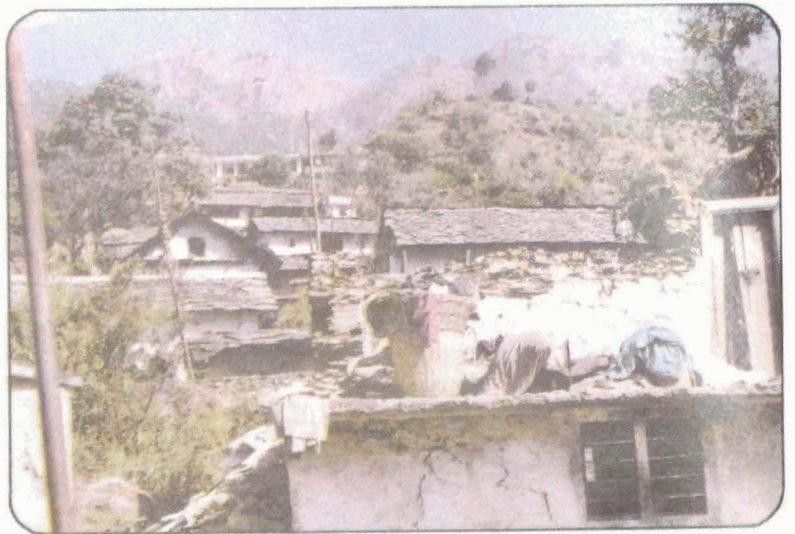
Photo 67 General view of Mannpur village displaying damages.

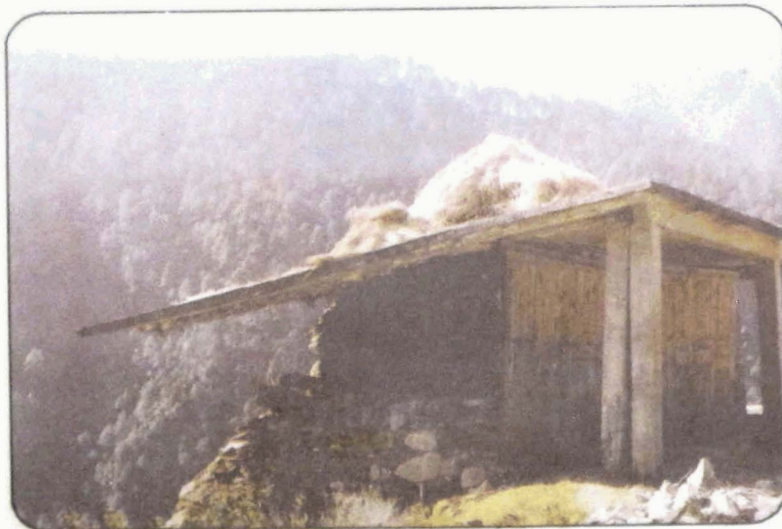
Photo 68 Sagging and collapse of RCC slab supported on mud masonry walls in a house in Thalan village.

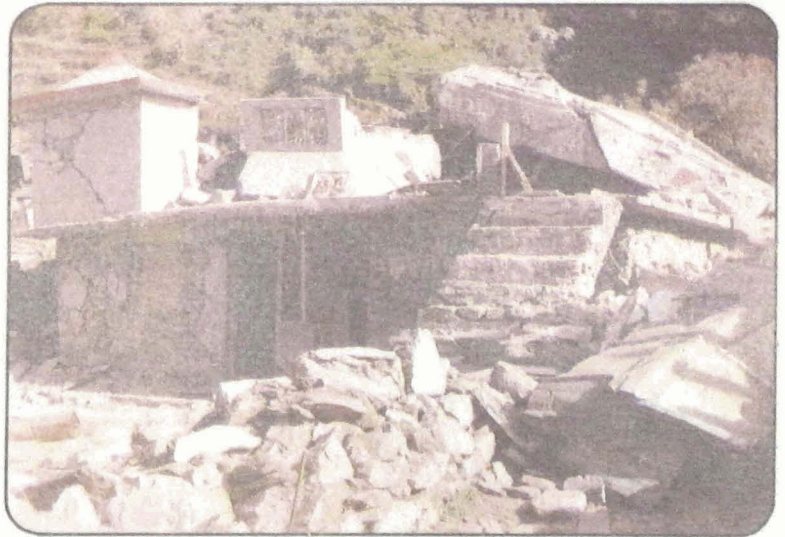
Photo 70 *Collapse of first floor of a house in Byala Tipri village with deep open cracks in the ground and first floor. (New construction).*

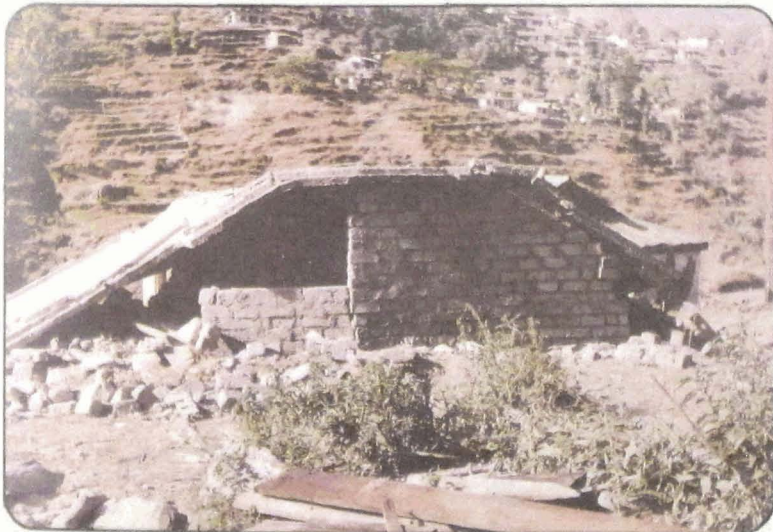
Photo 71 *Partially collapsed end walls have resulted in a hut-like shape of the RCC roof slab in Byala Tipri village.*

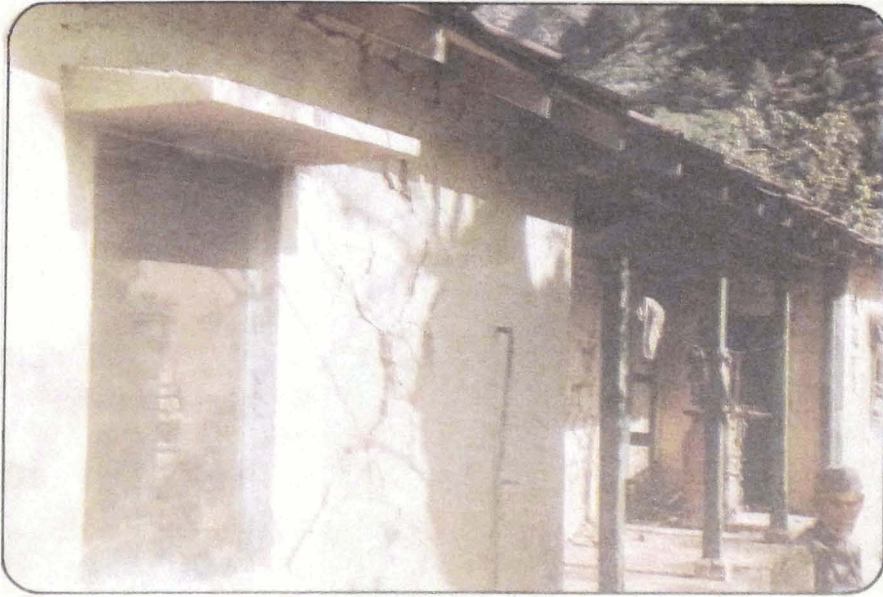
Photo 77 *Open shear cracks in the out house of PWD rest house at Lambgaon.*

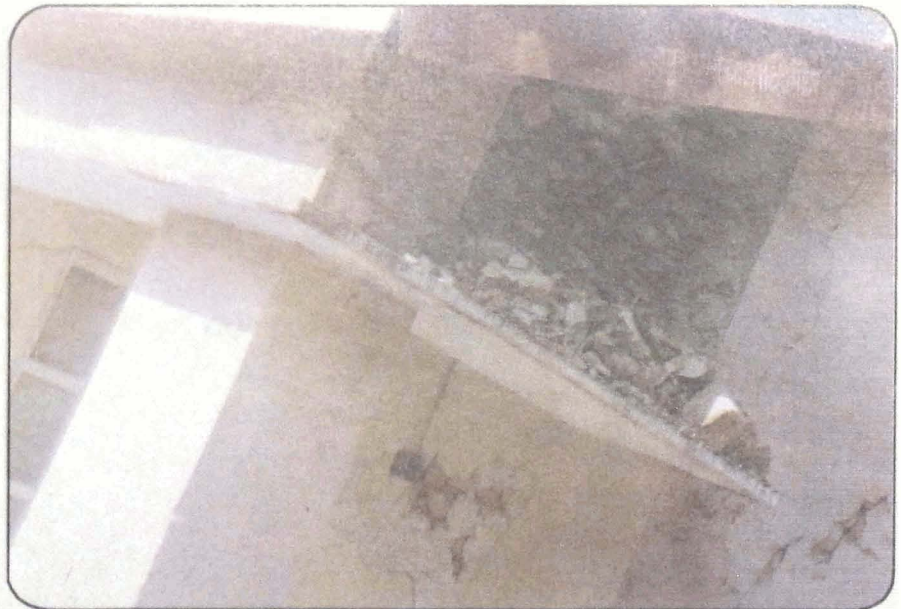
Photo 78 *Damage to side walls of the PWD rest house at Lambgaon.*

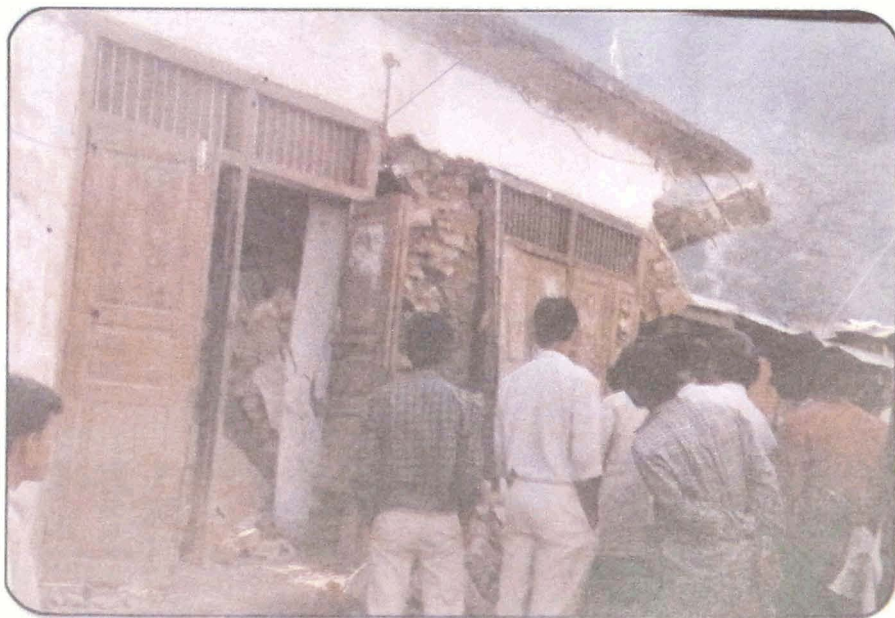
Photo 79 *Collapse of shops in Lambgaon market.*

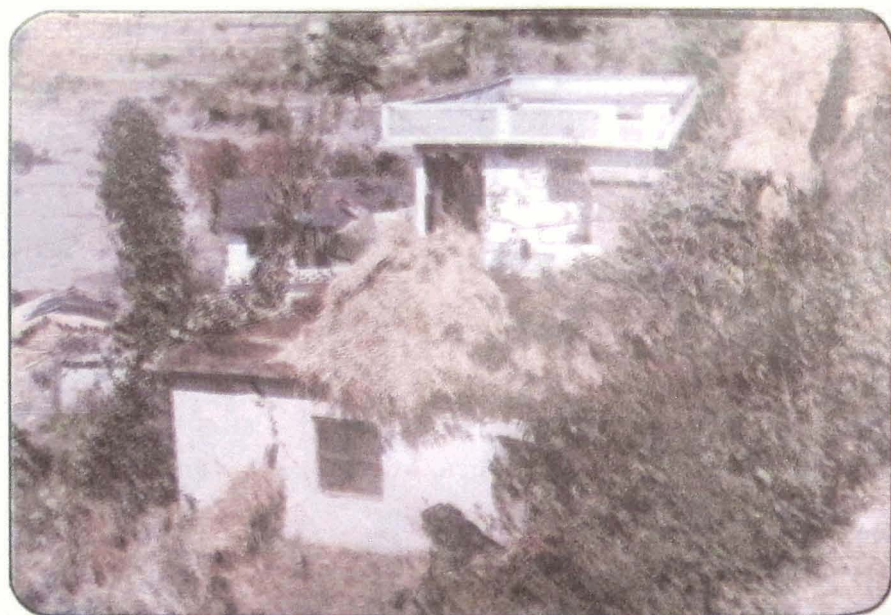
Photo 80 *Shear cracks in a house in Thati Kuthur village.*

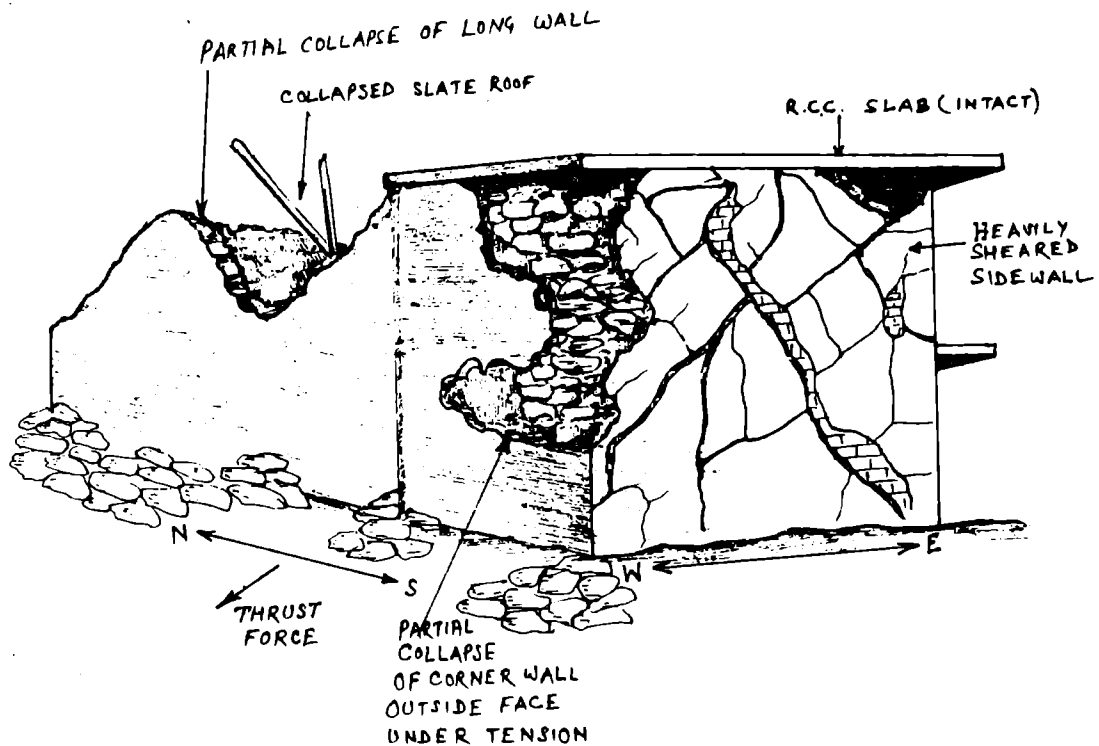
Two buildings of the village have been analysed in detail. The first building has its side walls aligned in E-W direction and the long walls in N-S direction (Fig.29). The southern part of the house has RCC slab as roofing where as the northern portion has the conventional slate roofing. The side wall has developed very prominent shear cracks some of which have wide openings (Photo 83). The masonry at the slab junction has collapsed at places. The long wall has suffered partial collapse towards the western side. The south western corner of the building shows partial collapse of the outside face of the masonry wall under tensional force.

Fig. 29 : PATTERNS OF DAMAGE TO A HOUSE IN GORTHI VILLAGE TEHRI DISTRICT, (SKETCH BY P. PANDE).
