UTTARKASHI EARTHQUAKE

OCTOBER, 20, 1991

GEOLOGICAL SURVEY OF INDIA
SPECIAL PUBLICATION NO. 30
1992

SPECIAL PUBLICATION NO. 30

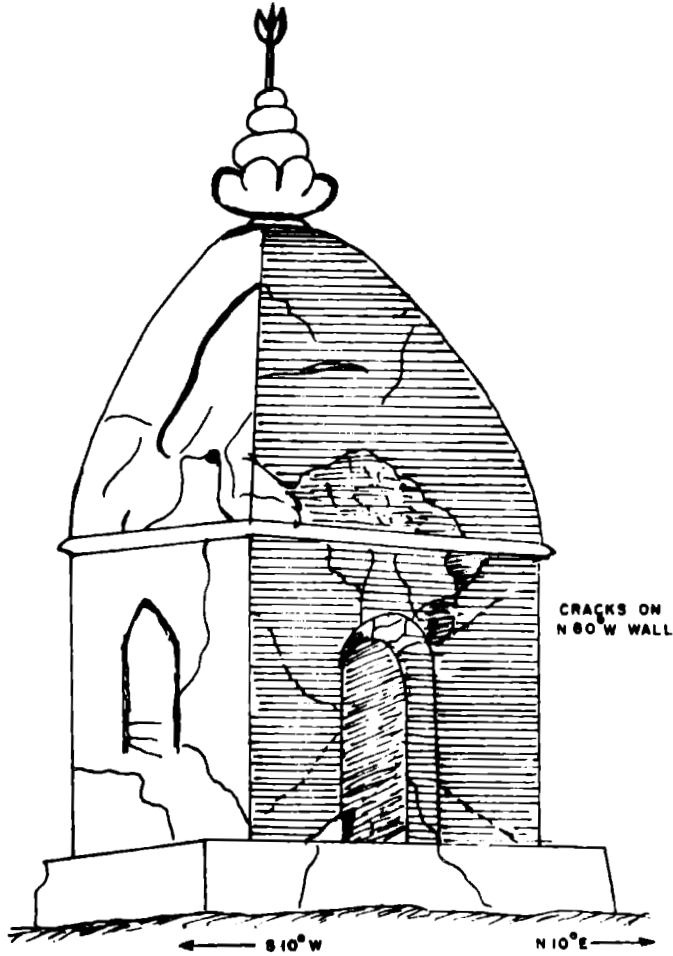
FIG. 31: SHIV TEMPLE, JAKHOLI. SHEAR CRACKS ON WALL ALIGNED $N 10^{\circ}E - S 10^{\circ}W$. KALASHA SHIFTED TOWARDS $N 30^{\circ}E$ BY 2 CM.

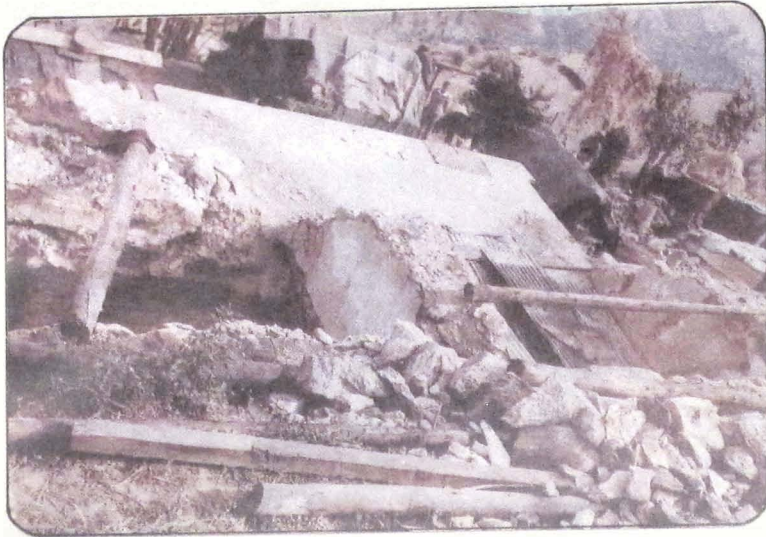
Photo 81 *Complete collapse of houses in Gorthi village.*

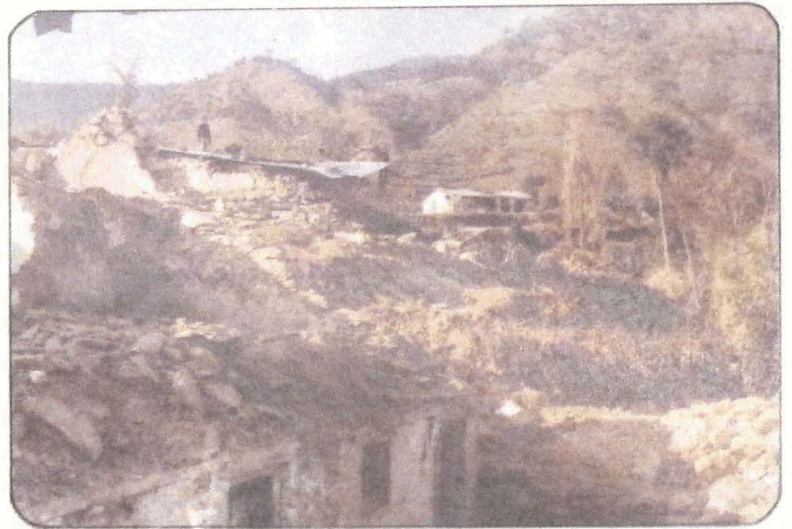
Photo 82 *General view of damages in Gorthi village.*

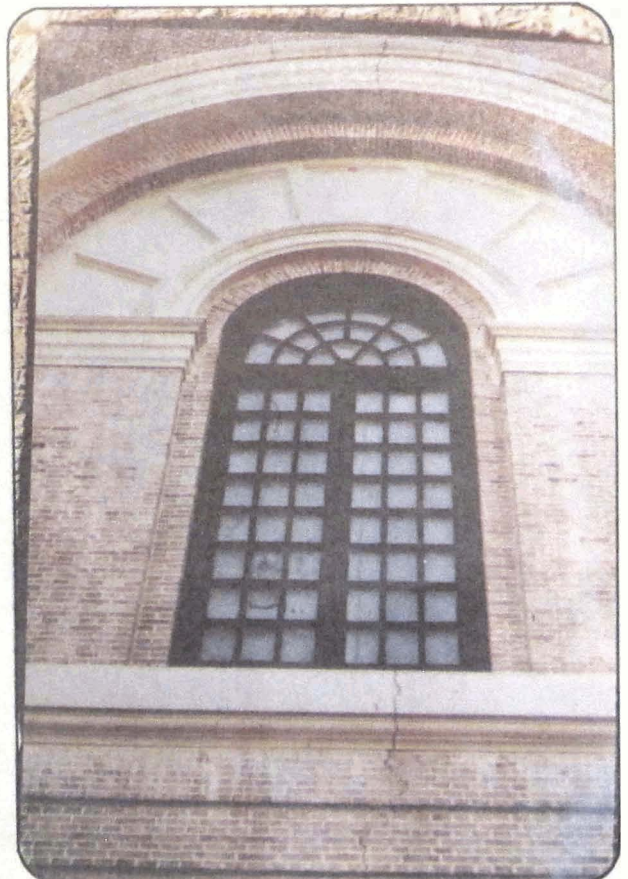
Photo 96 *Cracks in the arch and sill portion, in the rear wall of FRI building.*

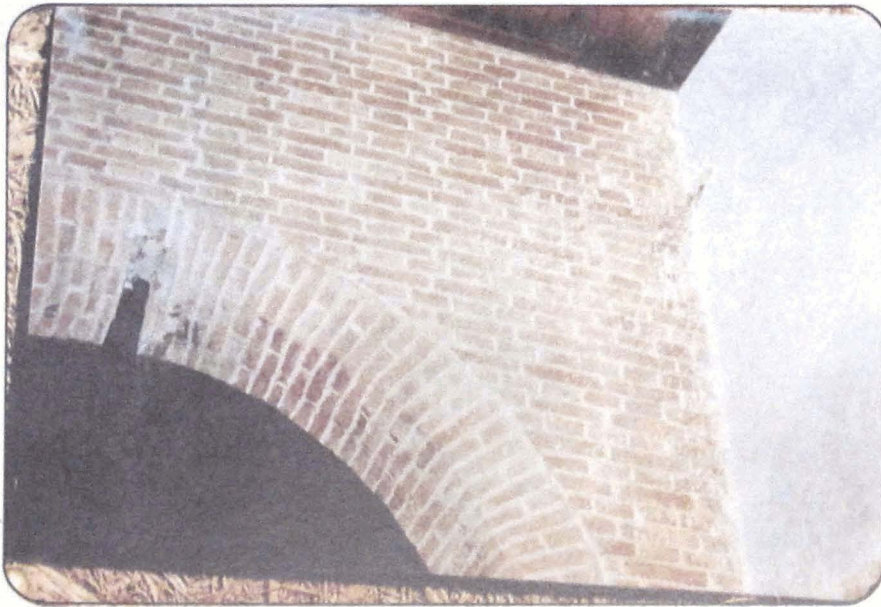
Photo 97 *Dislodged brick from the centre of the arch portion of the first floor corridor-FRI building Dehradun.*

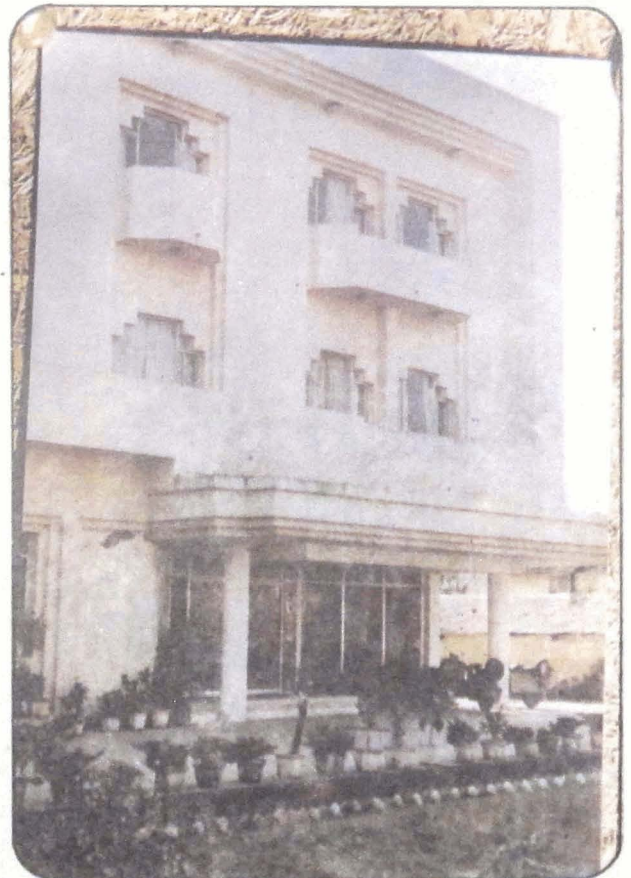
Photo 98 *Fall of plaster and development of cracks in the panel wall adjacent to the porch-Hilton Hotel, Dehradun.*

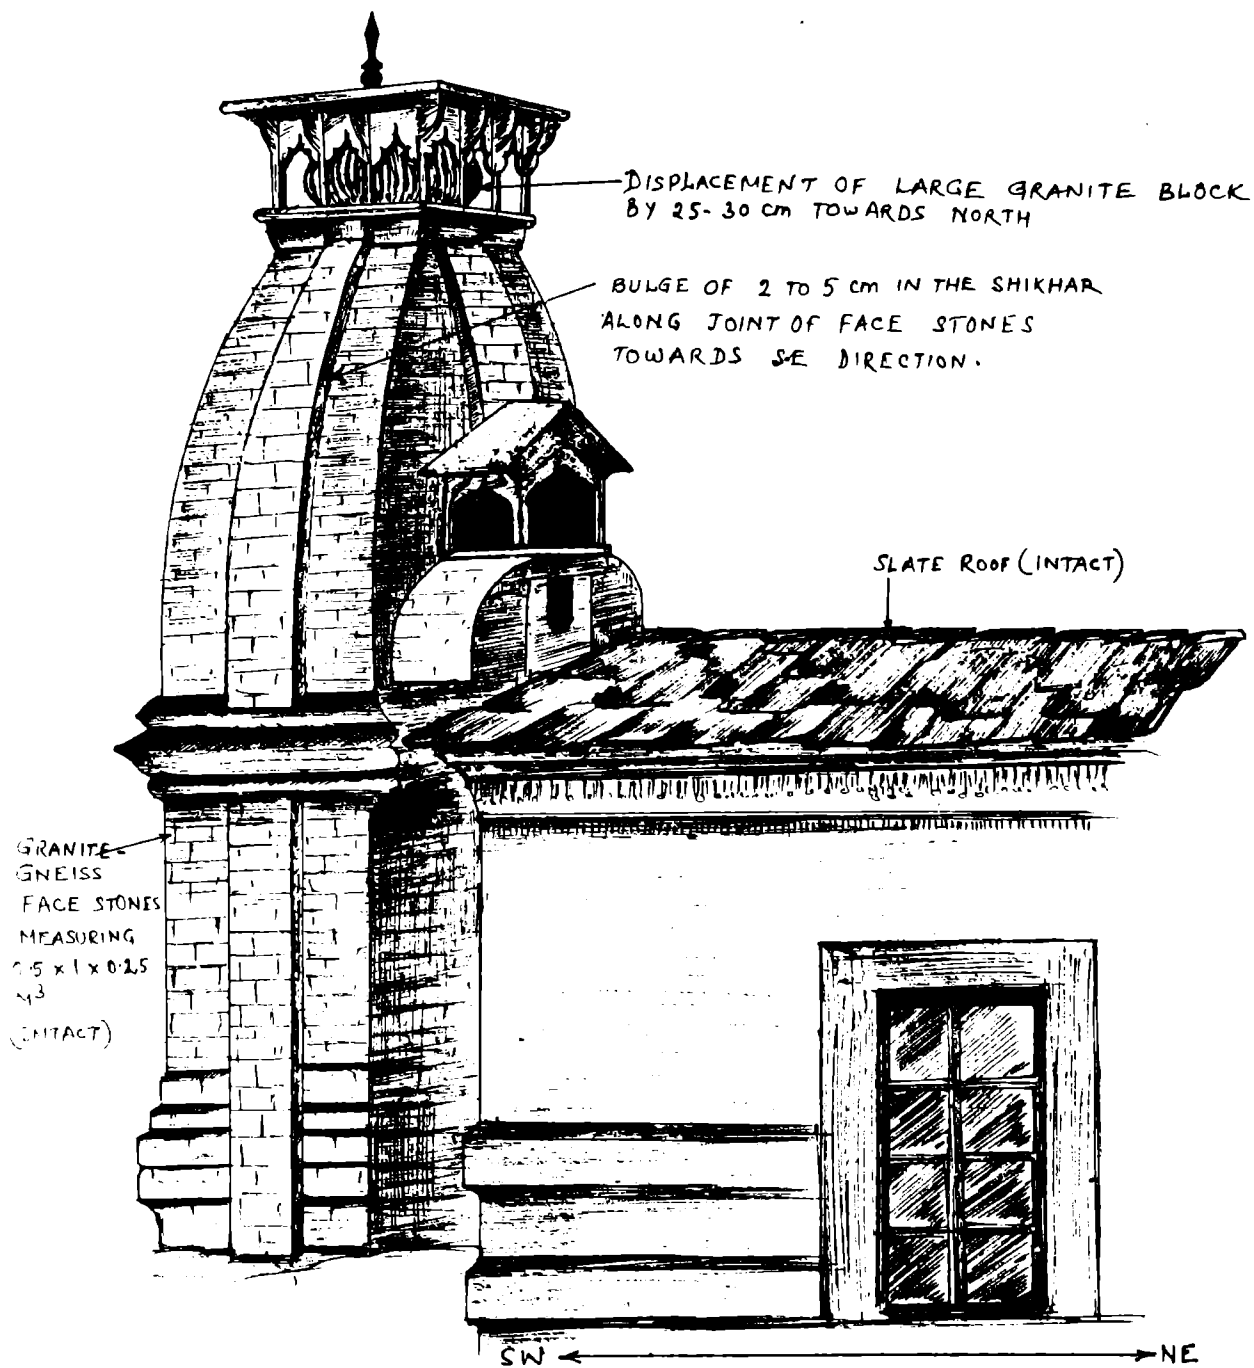
Fig 32: SKETCH SHOWING BULGE IN THE SHIKHAR AND DISPLACEMENT OF AMBLAKH OF TRIYUGI NARAYAN TEMPLE, CHAMOLI DISTRICT (SKETCH BY P. PANDE)

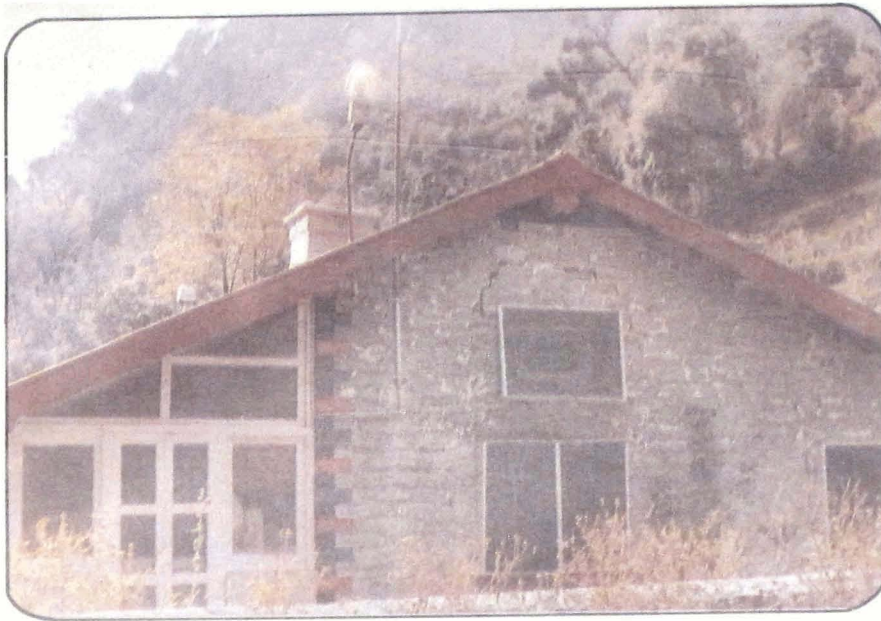
Photo 112 *Bulging and cracking around the ventilator and partial collapse of the gable portion of the PWD Rest house, Gaurikund.*

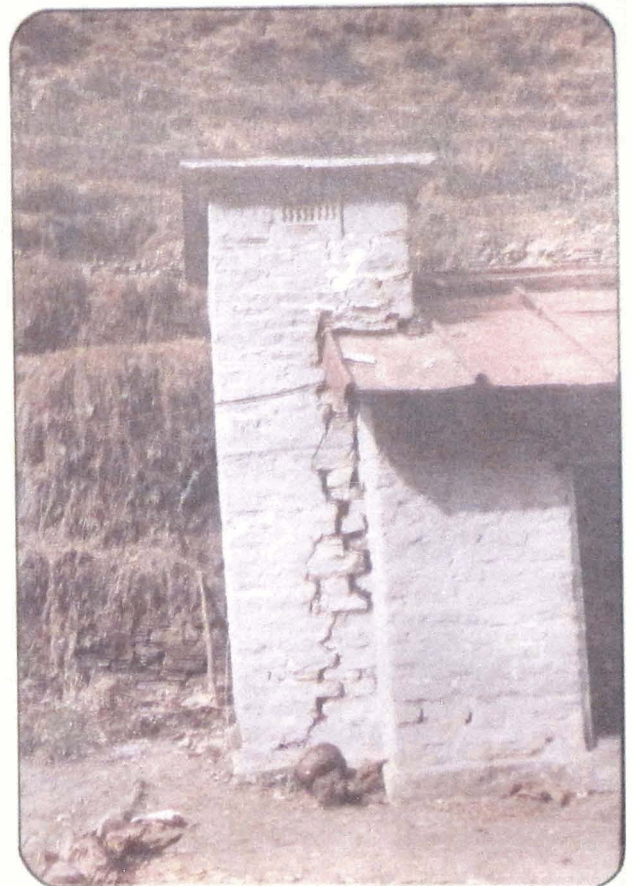
Photo 113 *Separation and cracking of chimney in the out house of PWD Rest House, Gaurikund.*

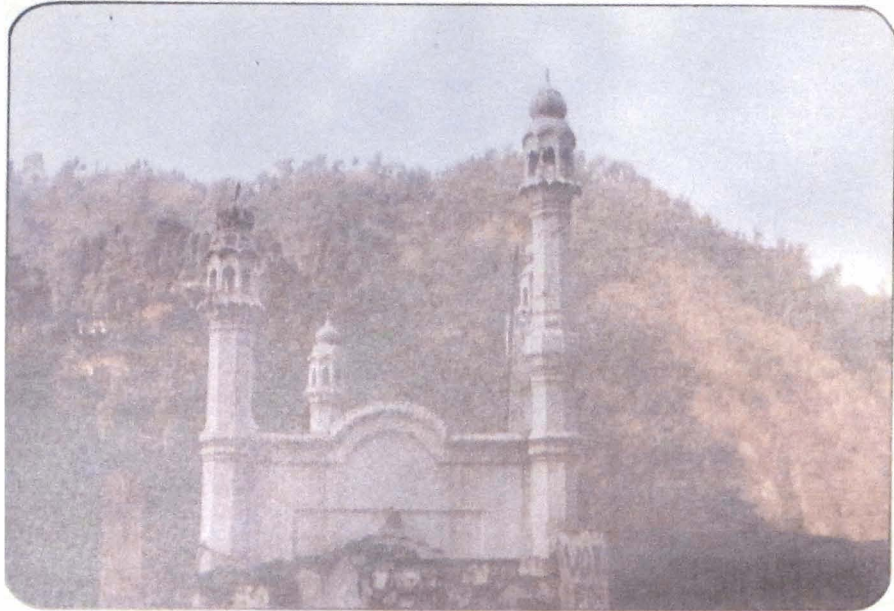
Photo 114 *Horizontally cracked minaret of a mosque, Dugadda.*

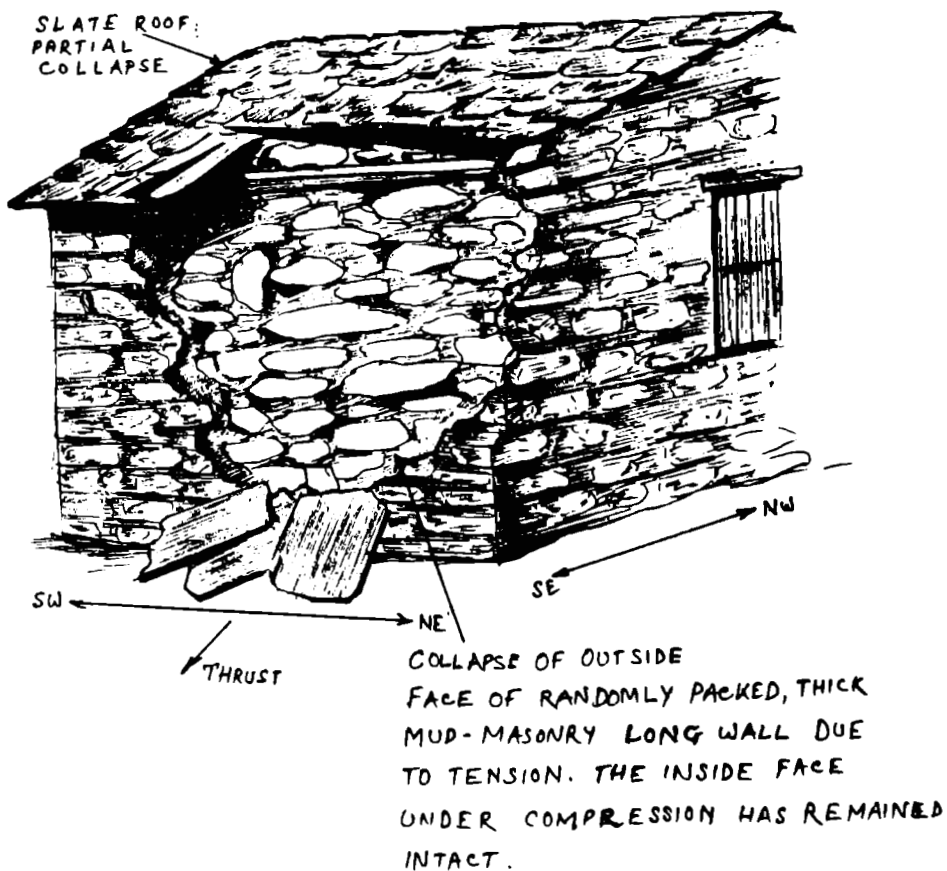
Fig. 37: PARTIAL COLLAPSE OF MUD MASONRY WALL UNDER TENSION, GAURI GRAM, DUGADDA (SKETCH BY P. PANDE)
