**REPORT ON THE CHONG KUMDUN DAM
AND THE SHYOK FLOOD
OF 1929.**

J. P. GUNN,

Executive Engineer.

This paper is a Technical one, issued for the information mainly of the Public Works Department, by the Punjab Government. The statements made, and the opinions expressed, are those of the writer, and are not necessarily those of the Punjab Government.

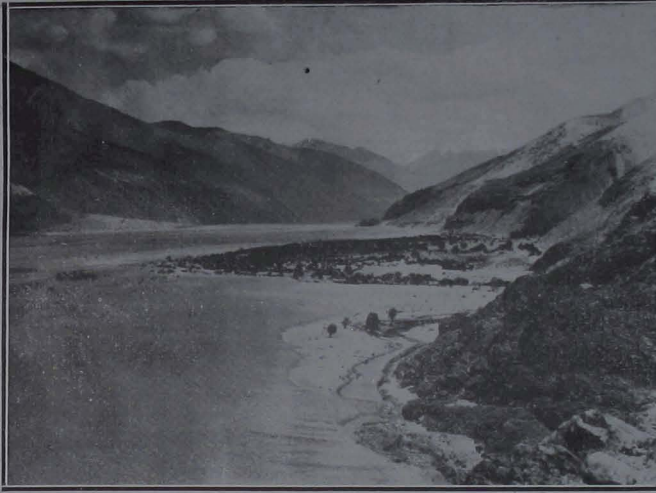
Fig. 2. Khardung fan before flood.

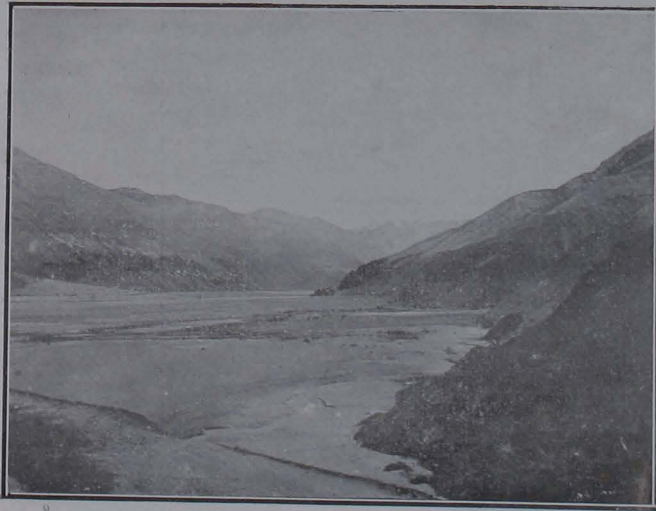
Fig. 3. Khardung fan after flood.

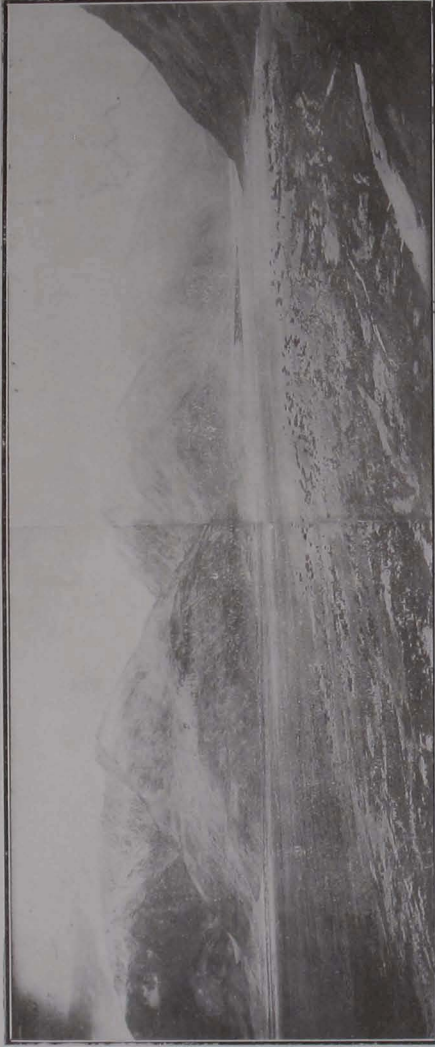
Fig. 6. Shyok from Diskit shewing Thiri fan on right and channels through bushes cut by 1926 flood.

Opposite Thirit the Shyok Valley opens out and the river runs along sidelong ground cut up by nalas. Cross sections show that depressions exist along the foot of the hills on both sides of the river bed and that it is the flood water spilling into these that causes the damage at Diskit and Liekzun. Fig. 6 taken from above Diskit looking up the Shyok shows the spill channels torn through the shrubs by the 1926 flood and shows the way in which the water that damaged Diskit reached the village.

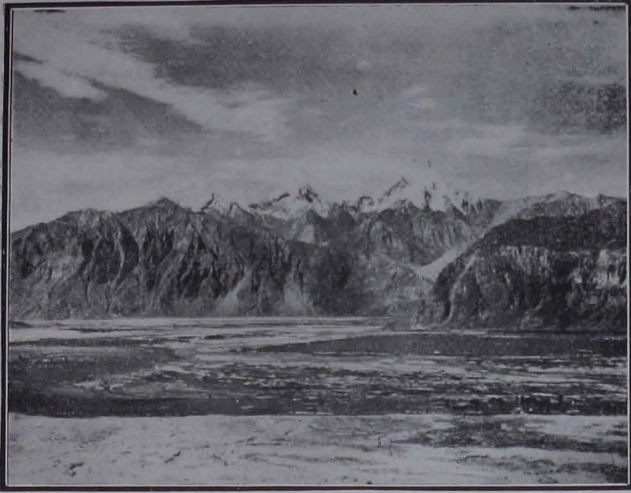
Fig. 7. Nubra Valley looking towards the Shyok from Teggur.

The valley of the Nubra shown in Figs. 7 and 8 is of much the same nature as that of the Shyok. The slope however is about twelve feet per mile and it has not been subjected to the same disastrous floods. A small flood occurred about 1914, apparently caused by a small transverse type glacier effecting a junction with the main Siachen glacier and holding up some water, in much the same way as the Chong Kumdun glacier blocks the Shyok, but the local people said it was a small affair and did no damage to speak of.

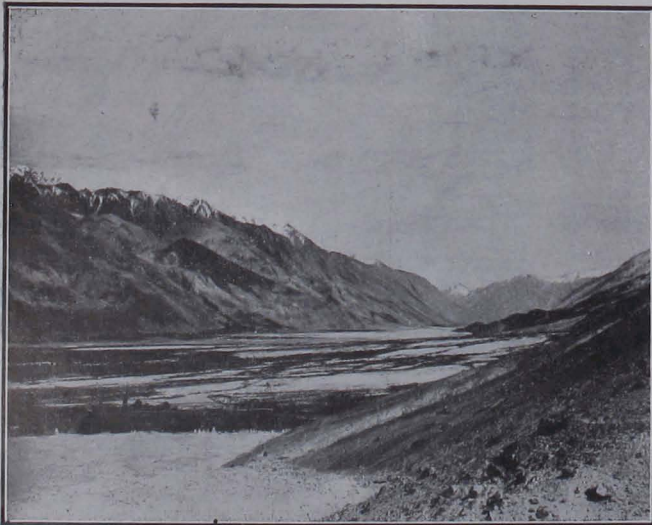
Fig. 8. Nubra Valley looking north from Teggur.

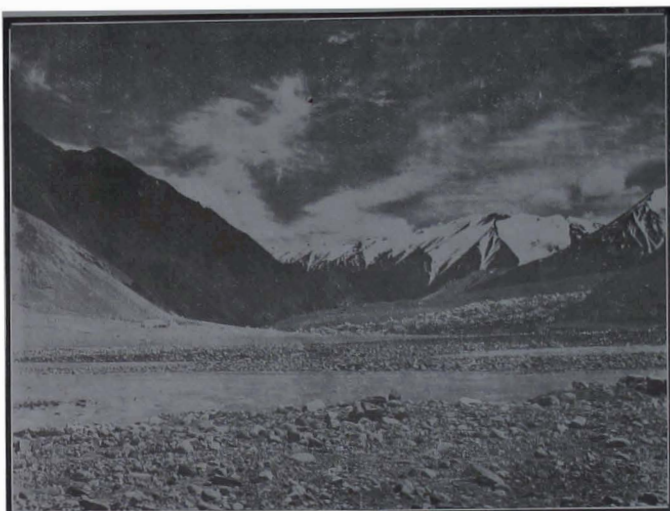
Fig. 9. Shyok Valley from near the Kichik Kumdun before flood.

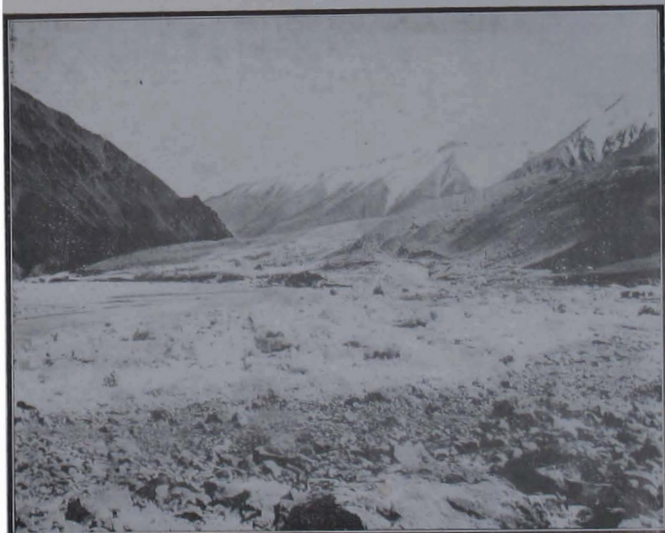
Fig. 10. Shyok Valley from near Kichik Kumdun after flood shewing the eroded snout of the Aktash Glacier.

From the conditions at the Aktash I infer that the glacier has been in retreat since 1927. It is the smallest of the glaciers examined and is probably the most sensitive to variations of snowfall.

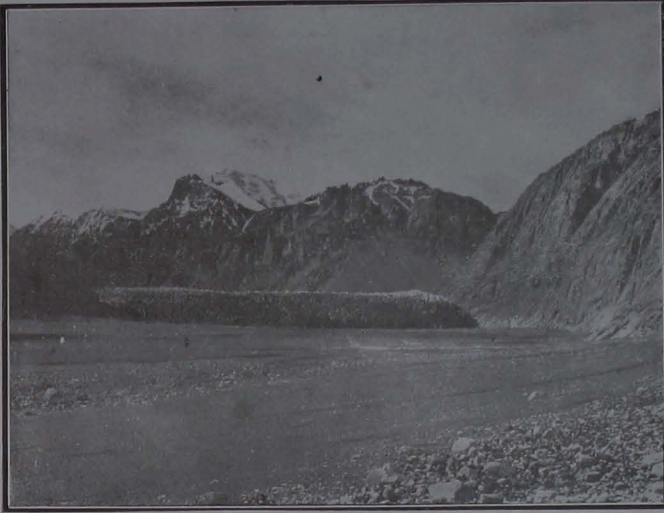
The glacier which actually blocked the river is the Chong Kumdun, a photograph taken from a distance of about two miles is shown in Fig. 11. It issues from a side valley of considerable width at a place where the hills on both sides of the river approach much nearer than is the case at the Aktash or Kichick Kumdun. The valley above the dam continues narrow for about four miles and then widens out considerably, with the result that the top hundred foot depth of water in the lake this year had a volume over twice that of the lower portion, the total depth at the dam being in the region of four hundred feet.

Fig. 11. Distant view of Chong Kumdun Glacier.

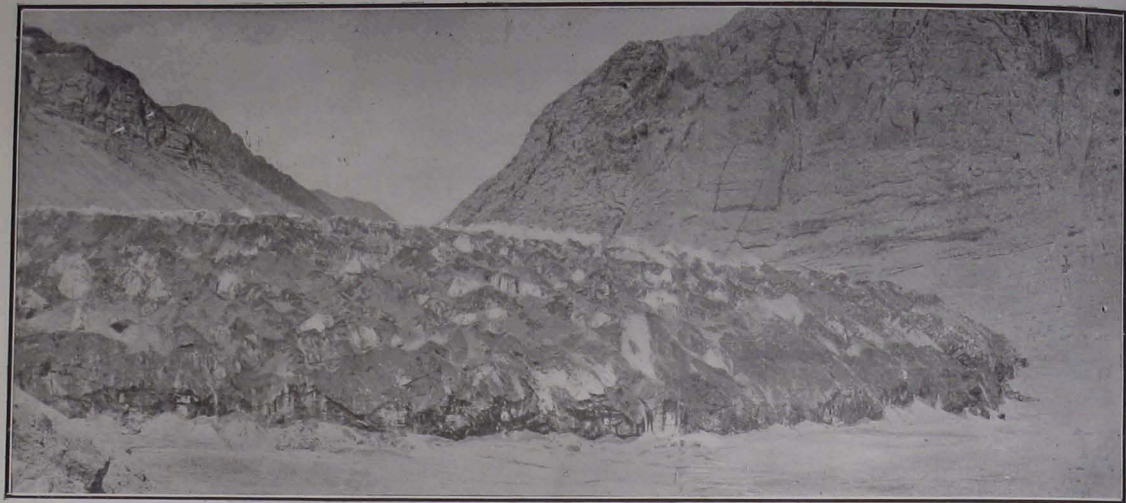
Fig. 13. Chong Kumdun snout before burst.

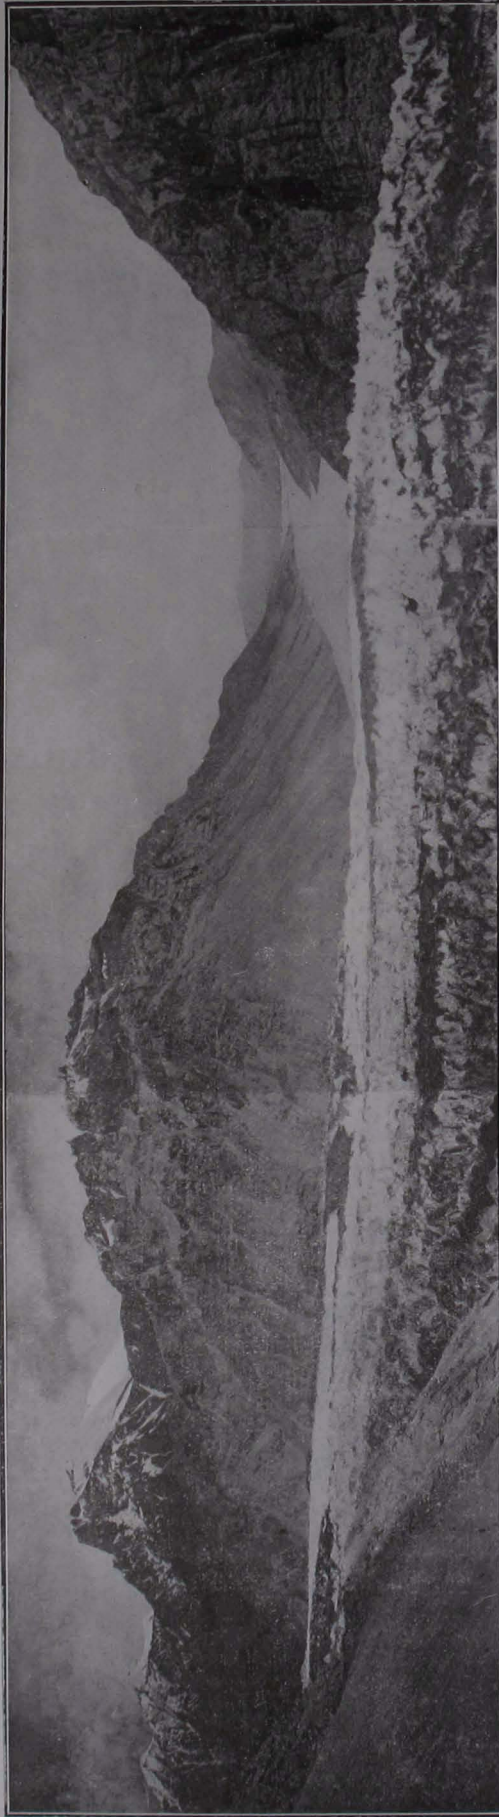
Fig. 15. Gapshan lake from point " U " with Chong Kumdun Glacier in foreground.

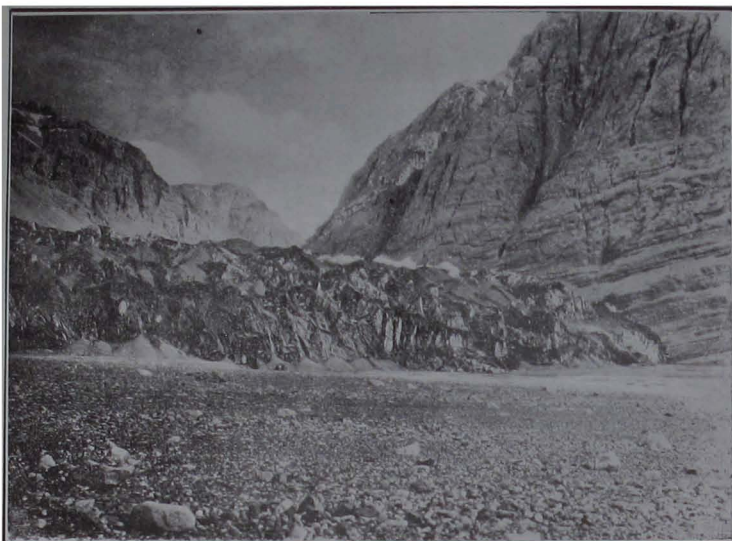
Fig. 17. General view of snout of Chong Kumdun.

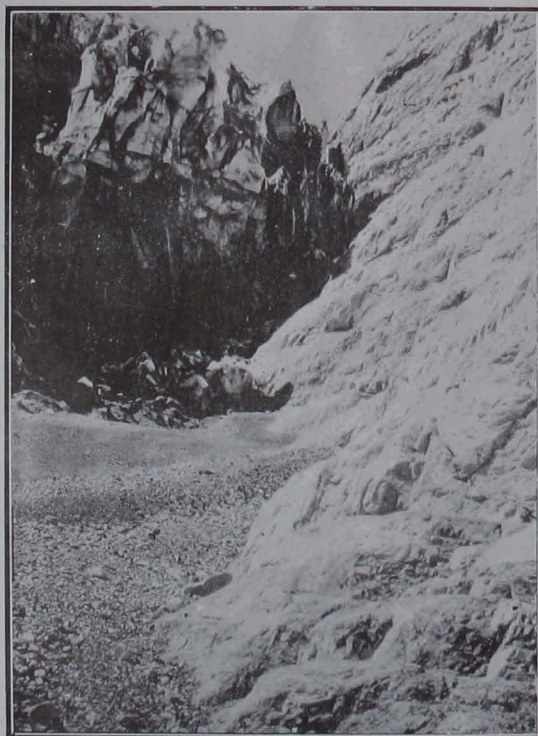
Fig. 18. Detail of Gully.

It also appeared probable that the heat reflected by the cliffs at the snout might have caused the gully to deepen itself, and as the water did not appear to be far off the bottom of the gully it was decided to push on with the surveys of the lake.

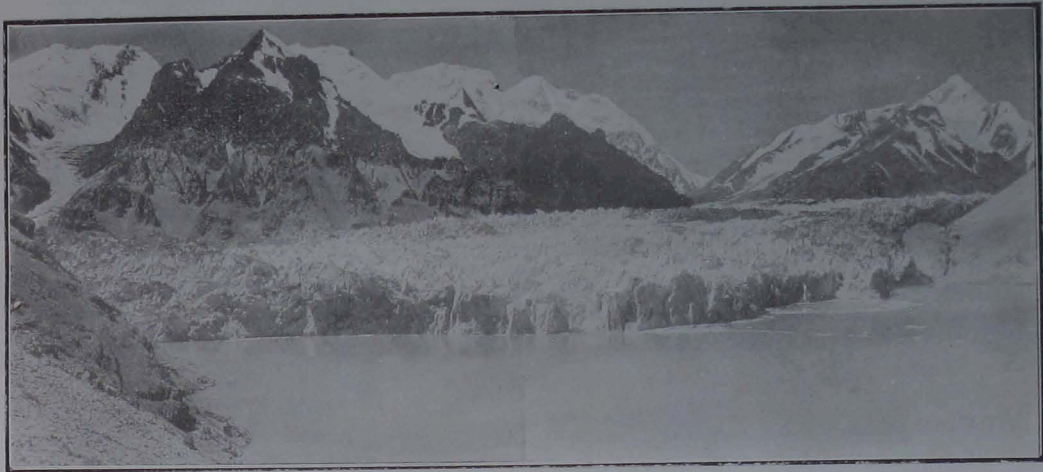
Fig. 19. Dam from above with lake in foreground.

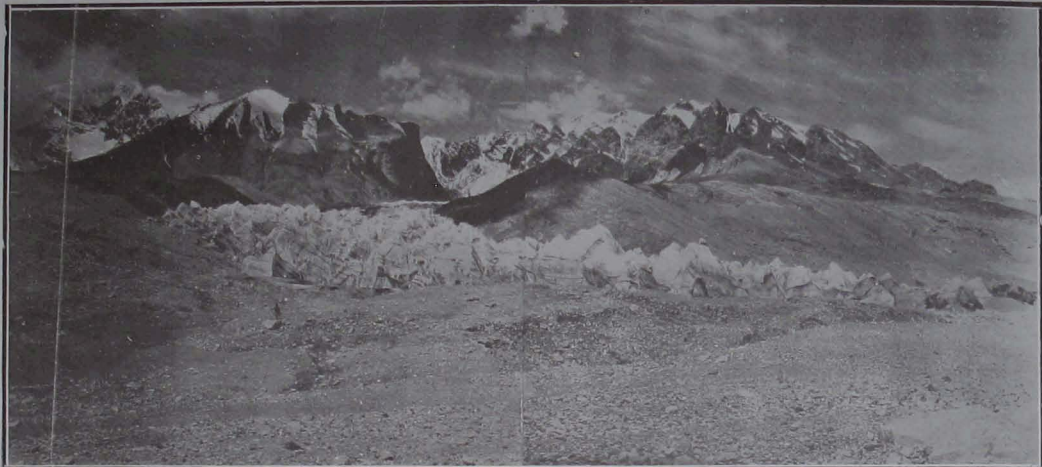
Fig. 23. Terminal pinnacles of Aktash Glacier before flood.

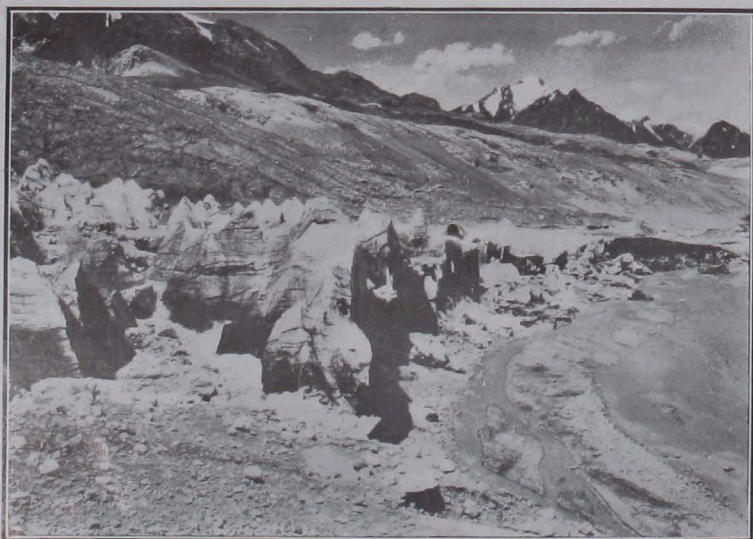
Fig. 24. Aktash from right lateral moraine after flood shewing erosion of terminal pinnacles.

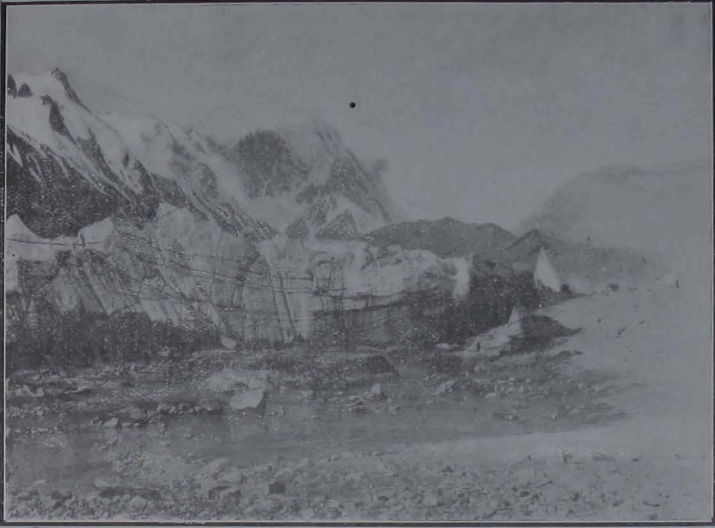
Fig. 25. Terminal pinacles of Kichik Kumdun Glacier shewing fresh shingle deposits.

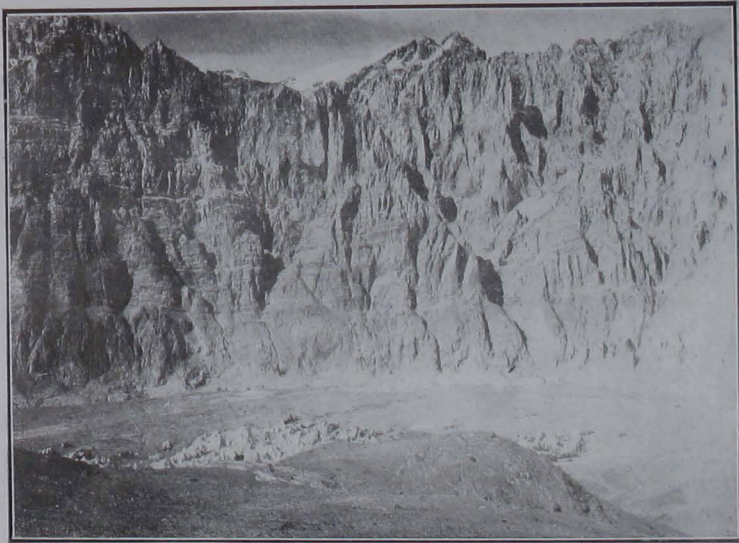
Fig. 28. Kichik Kumdun snout from above with river bed at foot of Cliffs.
