REPORT  
ON  
THE GEOLOGICAL STRUCTURE AND STABILITY  
OF  
THE HILL SLOPES AROUND NAINI TAL.

BY  
T. H. HOLLAND, A.R.C.S., F.G.S.,  
OFFICIATING SUPERINTENDENT, GEOLOGICAL SURVEY OF INDIA.

CALCUTTA:  
OFFICE OF THE SUPERINTENDENT OF GOVERNMENT PRINTING, INDIA.  
1897.

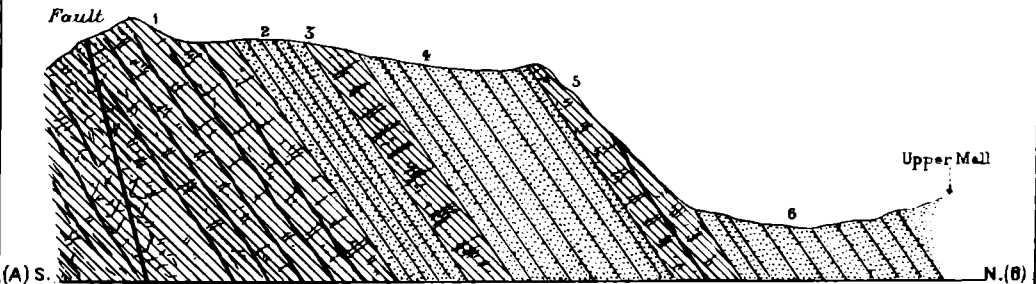
Fig 3. Section along A.B.

The structure of this site has already been explained (§ 131). It is an interesting case of settlement in a compound formation, where there is no possibility of a free landslip (class D, § 100). Figure 1 is a diagrammatic section showing the way in which, by the dwindling of a dolomitic sandstone, the interbedded dolomitic bands collapse and show local faulting; and by the weathering at the surface the blocks falling from the ridges of the harder dolomite obscure the outcrop of sandstone. Figure 2 is a contoured map, reduced from one prepared by the Public Works Department, on which I have entered the geological details showing massive dolomite on the south side, succeeded by a band of dolomitic sandstone and marl with an interbedded thin band of dolomite. The dolomite shown on the north side forms the top of the cliff shown in figure 3, which is a continuation of the section along the line A.B. as far as the Upper Ayarpatha Mall.
