REPORTS OF LIETENANT-COLONEL C. H. HASWELL, R. E.,
ON THE FORTS ROADS ETC., IN THE GILGIT AGENCY.

Subject. Reports on Gilgit Forts.

REPORT
ON
GILGIT FORT

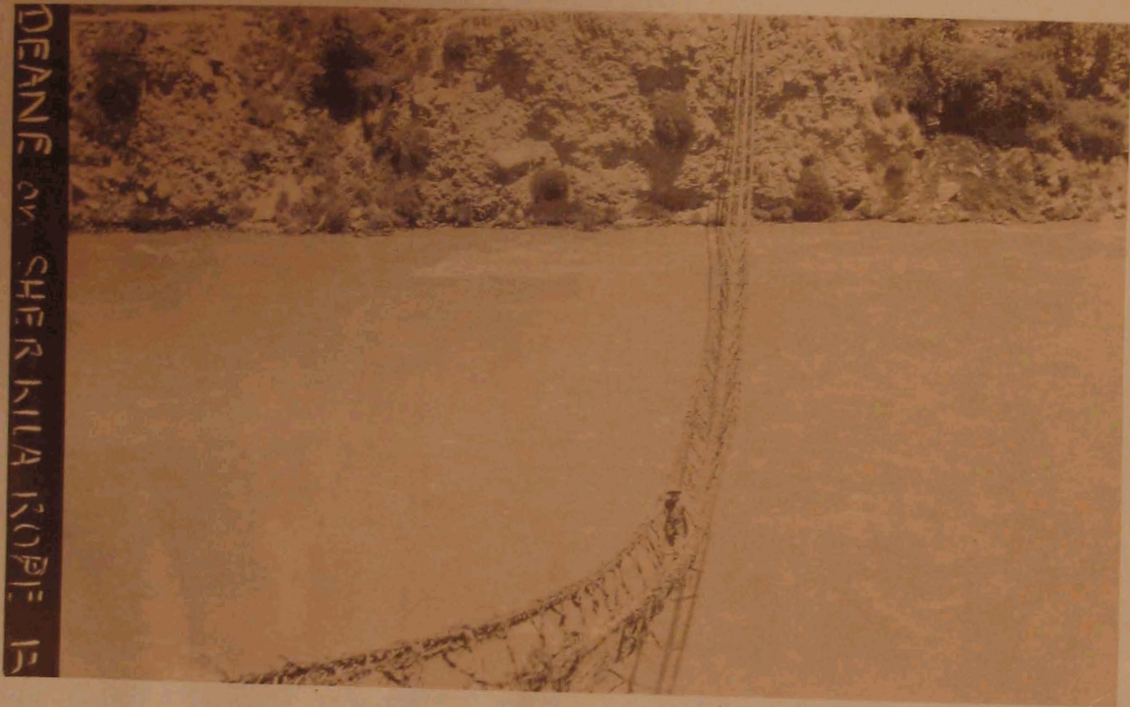
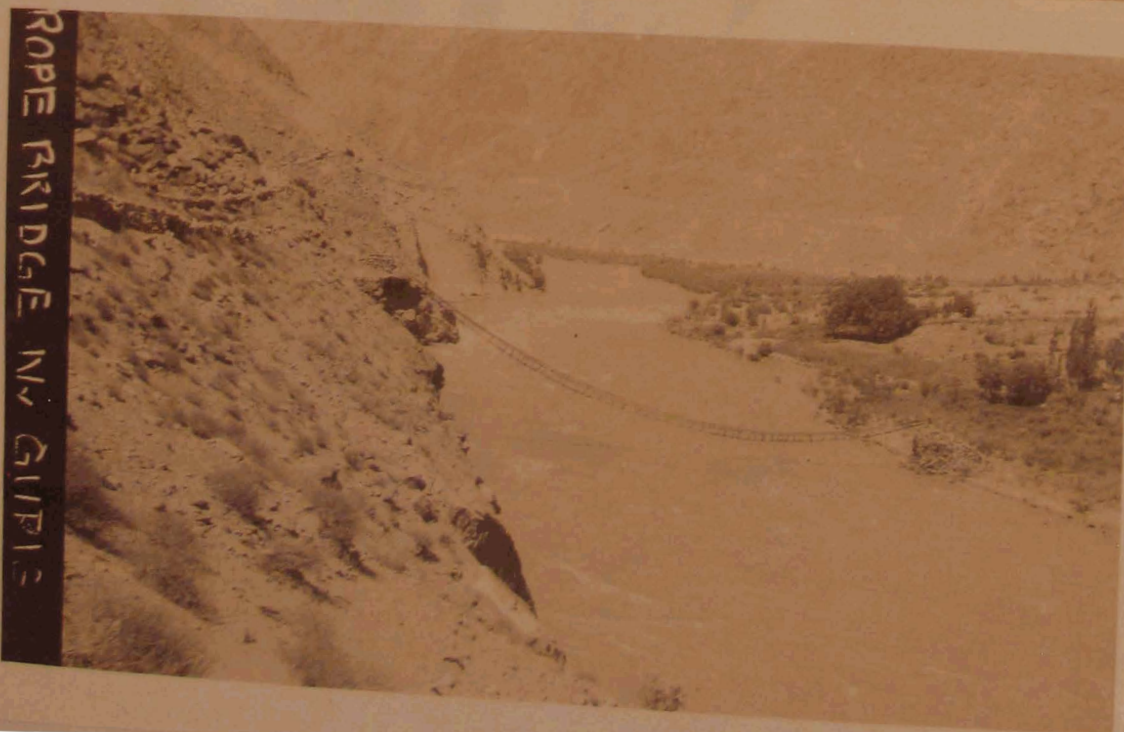
By building a bridge over the river at Gullipur the big village of Sher Kila would be given communication with the main road. Sher Kila is the headquarters of the Rajah of Punial and is a very important village. The only communication there is at present is the Rope Bridge as shown in the Photo

As this bridge would serve Civil purposes as well, it might be possible to obtain a contribution from the State.
