UTTARKASHI EARTHQUAKE

OCTOBER, 20, 1991

GEOLOGICAL SURVEY OF INDIA
SPECIAL PUBLICATION NO. 30
1992

SPECIAL PUBLICATION NO. 30

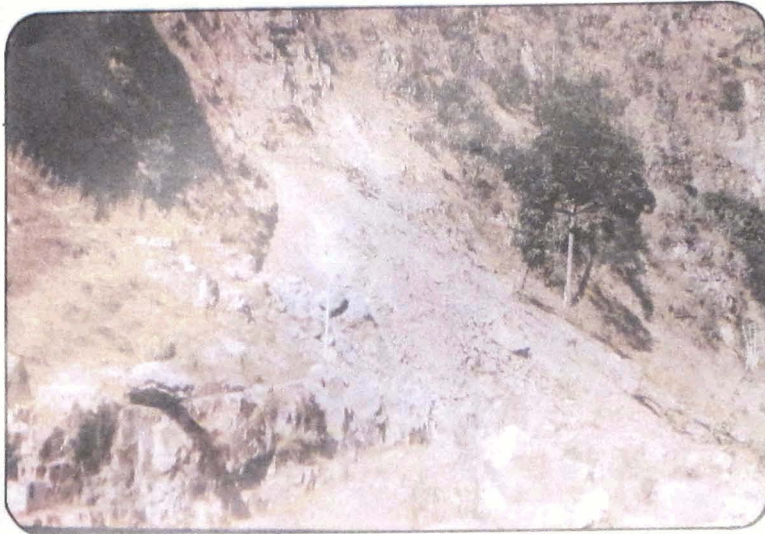
Photo 1 *Rock fall cum debris slide initiated in quartzites upslope of the road about a km before Maneri. Note uprooting of a telephone pole in the toe portion of the slide.*

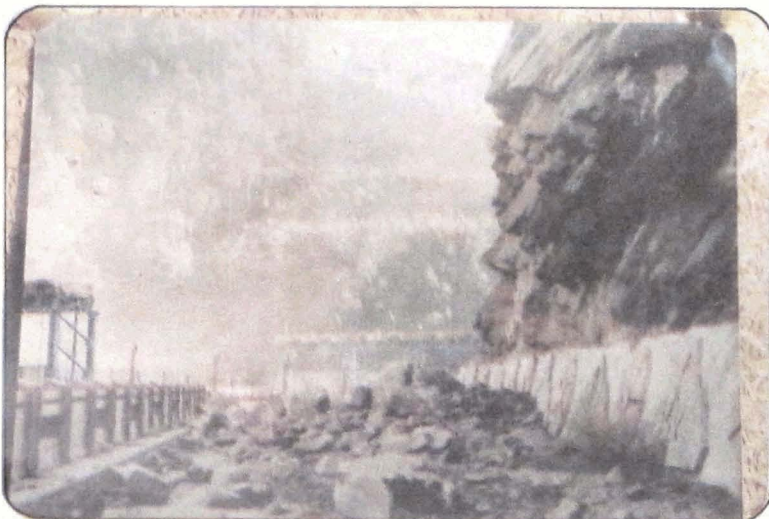
Photo 3 *Rock fall in blocky quartzites. Note large rock blocks lying on the approach road to intake structure of the Maneri dam.*

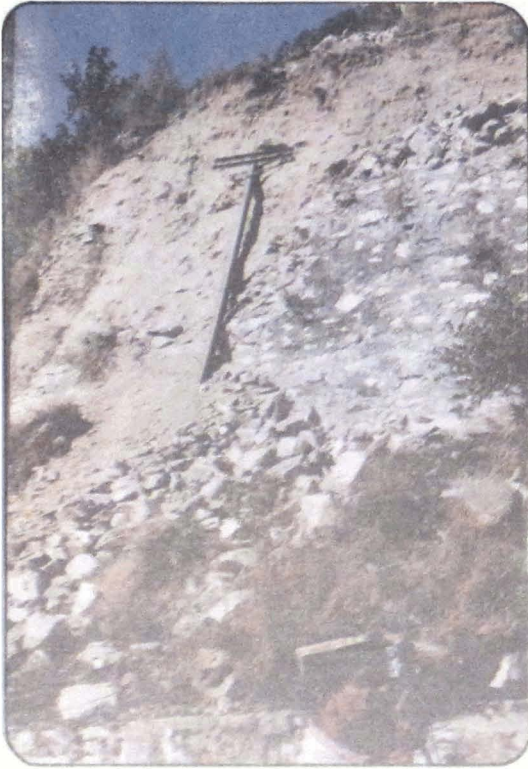
Photo 3A *Failure of breast wall leading to collapse of telegraph pole near Gawana gad bridge.*

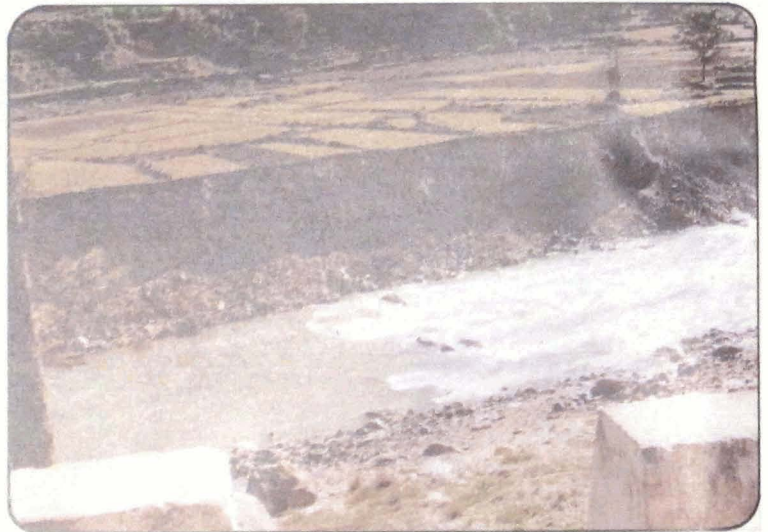
In whole of this sector the formation cut of the road has been extensively damaged, the maximum damage being between km. 6 from Uttarkashi and near Pala village where slumps have taken place in the river side slopes. Wide open fissures have developed on the road which are aligned along as well as across the road and numerous retaining walls and breast walls (Photo 3A) have collapsed even on overall gentle slopes. In certain reaches more than half of the road formation as well as painted road surface has been damaged by these fissures. A remarkable feature has been observed on the left bank of River Bhagirathi near Heena where the T-3 terrace, the lowest one, has been shaved for a length of about 400m. The nearly 15m high terrace has apparently failed parallel to the river face as is evidenced by the fresh near vertical cut (Photo 4). Similar terrace shaving has also been observed near village Dedsari.

Photo 4 *Shaving of the nearly 15 m. high river terrace on the left bank of river Bhagirathi at Kamar gad confluence.*

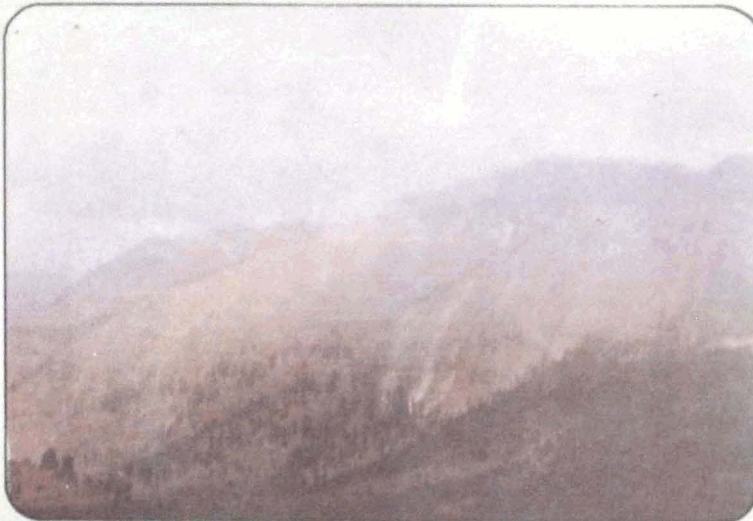
upto 100m height from the nala bed and rolling of boulders and sliding caused lot of dust clouds to rise in the horizon, often mistaken for smoke by local people, in the closed valley of Aassi Ganga (Photo 5).

Photo 5 *Dust clouds bellowing out of the closed Aasi Ganga valley as a result of landslides.*

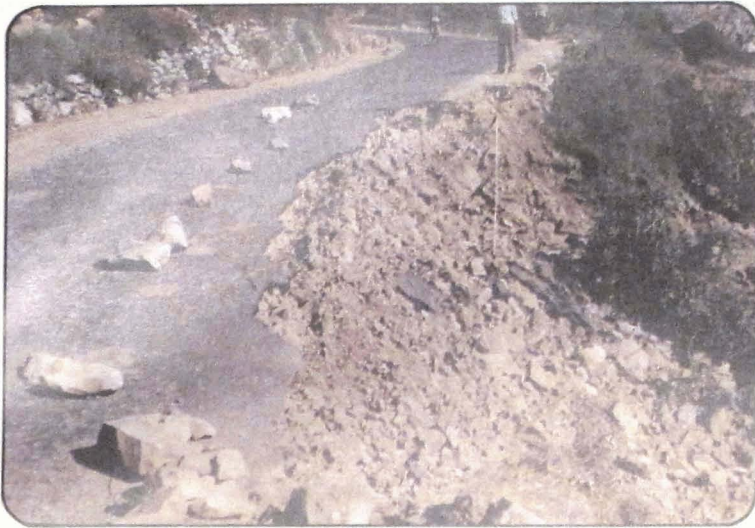
Photo 6 *Failure of the valley side portion of block top road near Mannpur.*

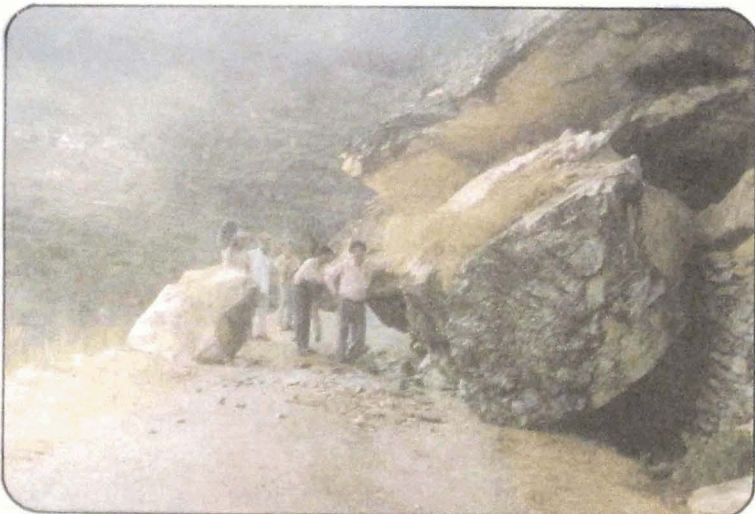
In this road sector no landslides or dislodgements are recorded between Bhaldiana and Lambgaon but from Lambgaon to Dhauntri a number of rock dislodgements have been noticed. Between Lambgaon and 5km. beyond the Jalkur nala bridge, 31 dislodgements of rock blocks varying in size from 1m³ to 10m³ (Photo 8) as well as 10 rock slides have been recorded which have been caused by this event. An old landslide on the left bank of a bridge near Thati Remoli has got reactivated. All these dislodgements and slides are located in the Chamoli quartzites. Between Dhauntri and Suknidhar and the Dunda sector similar dislodgements have been recorded. Between Chakone and Suknidhar a

Photo 8 *Rock dislodgement on Lambagaon-Rautaldhar road section.*

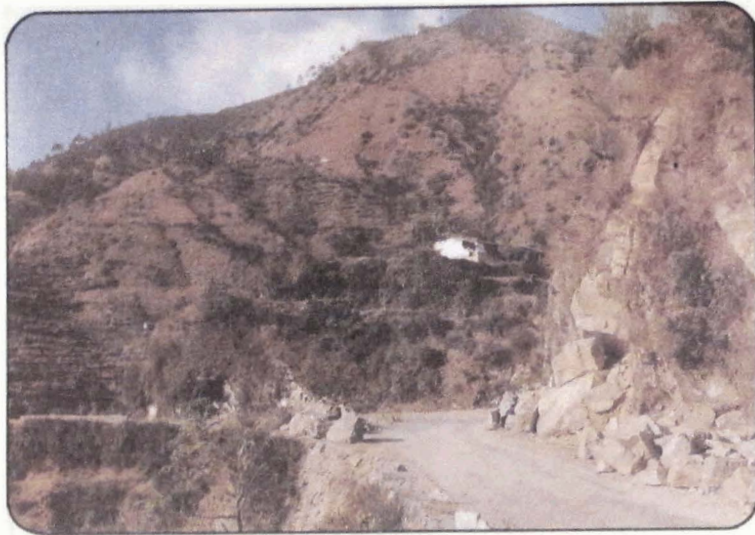
The road sector between Tilwara in Mandakani valley and Chirbatia water divide of Bhilangana catchment is marked by isolated rock dislodgements. These dislodgements, prominent between Tilwara and Mayali village, are confined to the highly jointed basic rock constituents within the gneissic and granitic rock complex. The dislodgement incidences increase considerably from Mayali towards Gorthi village and infact, in a distance of about 2km., more than 15 dislodgements have been seen in a basic rock exposure near Mayali. Incidentally the boundary of isoseismal VII passes very close to this location. Dislodgements have also been seen in the gneisses exposed in the vicinity of Gorthi village, located on a spur (Photo 9).

Photo 9 *Dislodgement of rock blocks near Gorthi village. Partial collapse of the short wall of a village house in the background.*

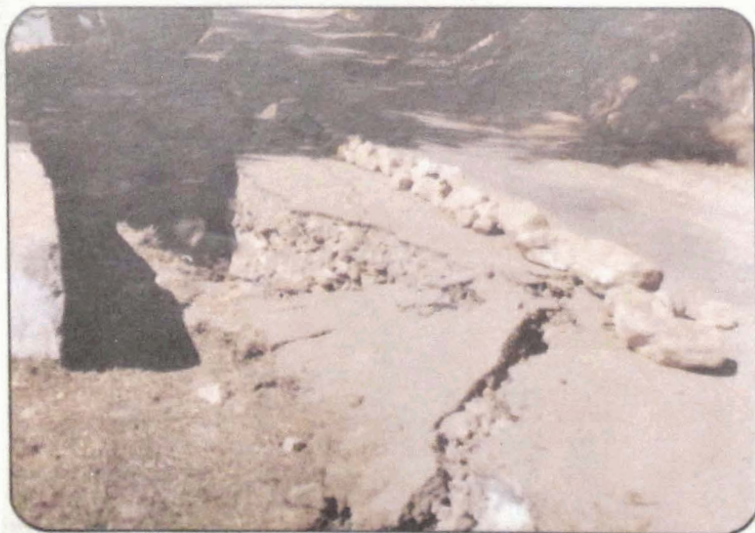
| Sl. No. | Location | Locality | Orientation | Length (in m.) | Opening (in cm.) | Remarks |
|---|--|---|---|---|---|--|
| 3 | 6 km NE of Uttarkashi on Uttarkashi Gangotri road | +VIII | WNW-ESE | 100 | 20-40 | Debris slope & fill material. Displacement of the order of 30 to 50 cm. (normal) (Photo 11) |

Photo 11 *Open fissures in oberburden material showing 50 cm. valley side slumping, 6 km. upstream of Uttarkashi on the road to Maneri.*

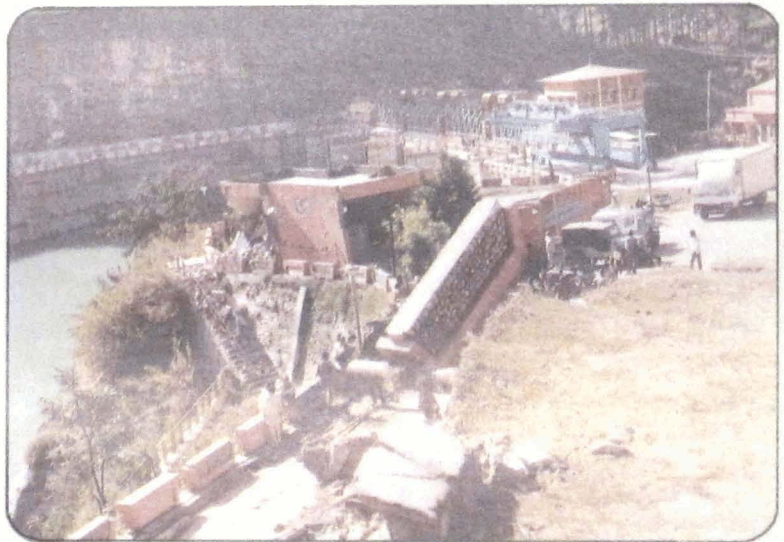
Photo 16 *Wall collapses and gaping cracks in type B construction and failure of retaining wall just upstream of Maneri dam.*

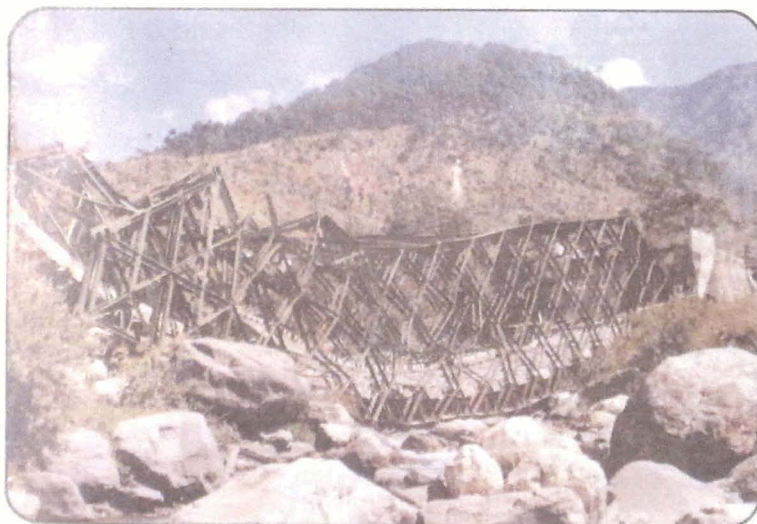
Photo 17 *Collapsed Gawana gad bridge in Uttarkashi Maneri road sector.*

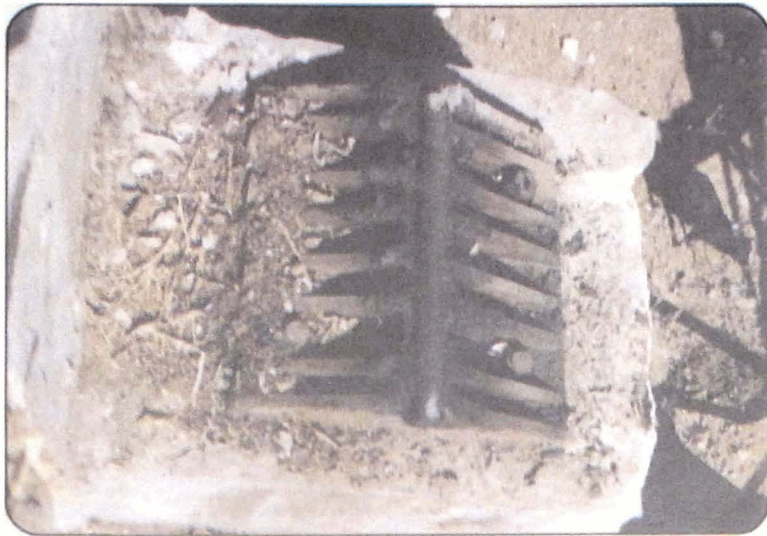
Photo 18 *Intact base plate of the rocker on the Uttarkashi side of the Gawana bridge.*

The concrete abutments of the bridge are found intact. The two base plates affixed over concrete pedestals in the right abutment do not show any distress. The anchor bolts as well as the rockers are intact (Photo 18). The counterpart plates attached to the collapsed super structure are also found intact.

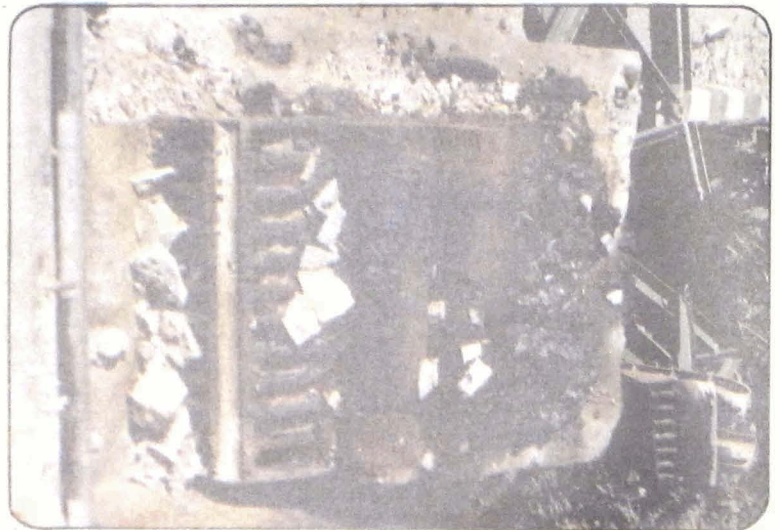
Photo 19 *Upstream end intact base plate on the Maneri end of the Gawana bridge. Note rollers in place and slipped roller plate and coupling rod in the foreground.*

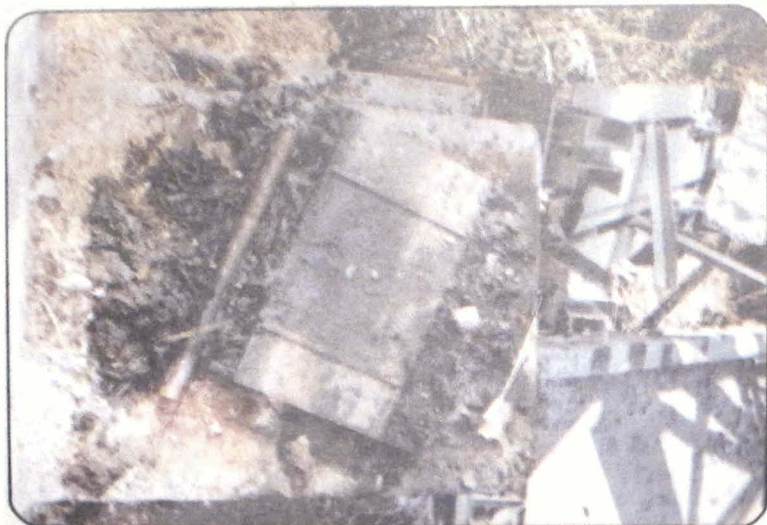
Photo 19 A *Clockwise rotation of the downstream end baseplate, Maneri side of Gawana bridge. Rollers and roller plate not seen as they have been thrown in the river below.*

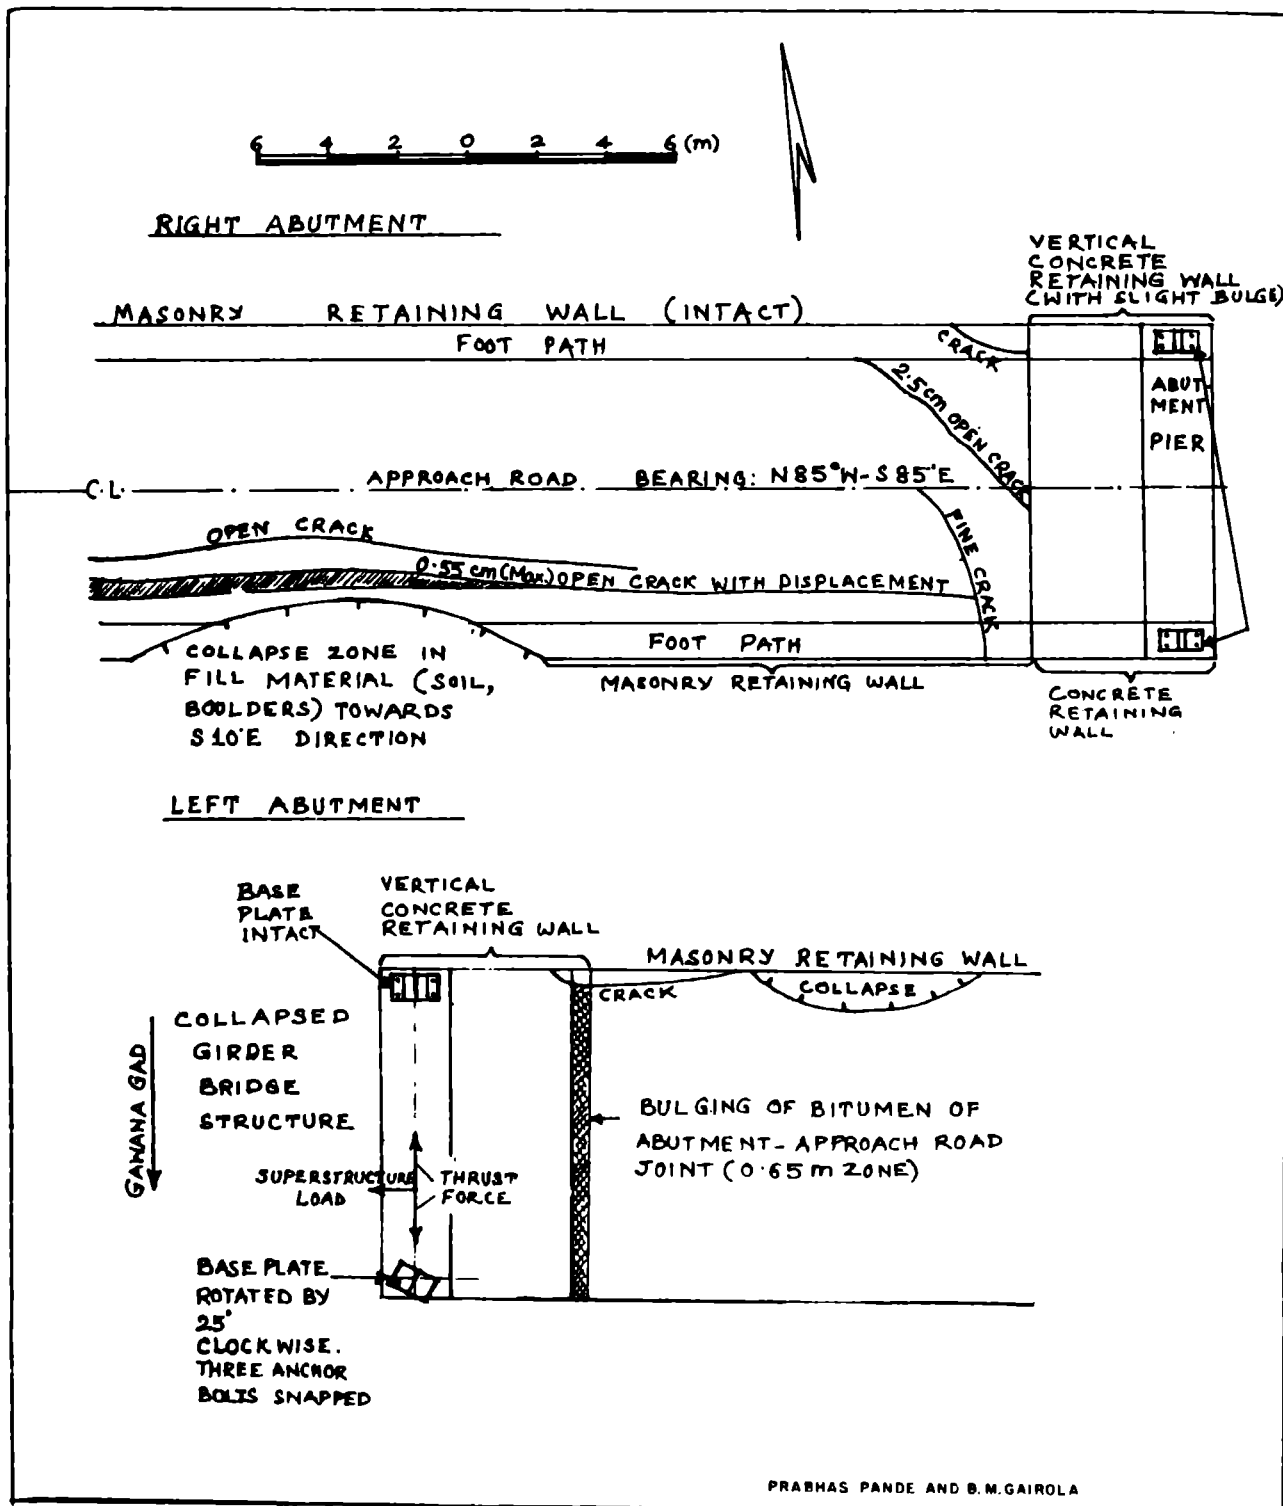
Fig. 4: Map of approach roads, Gawana Gad bridge, Km. 155-386, Rishikesh - Gangotri road U.P.

The left approach road is marked by an arcuate crack of 5.5m length, roughly parallel to the northern edge. Part of the fill material in a 6.6m section on the northern edge has also slumped. The bitumen coating, covering the approach road-abutment pier joint has bulged out in a 0.65m zone.

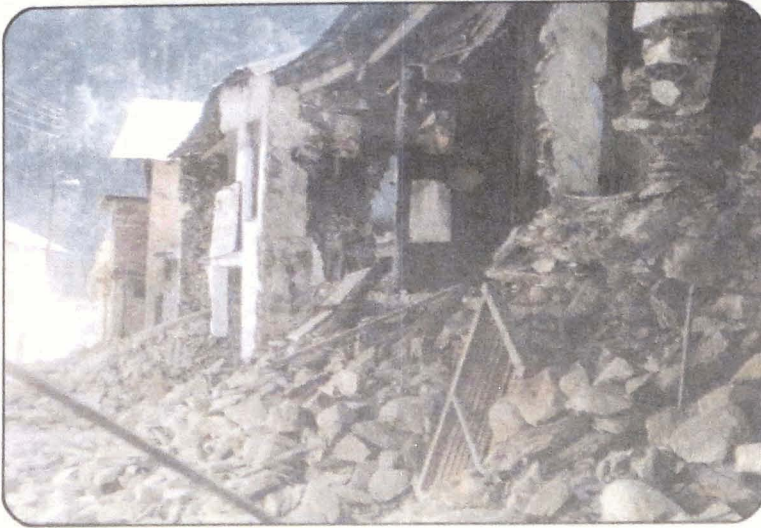
Photo 20 *A view of collapsed house of Shri Ram Lal, adjacent to the Nagar palika building is Uttarkashi town.*

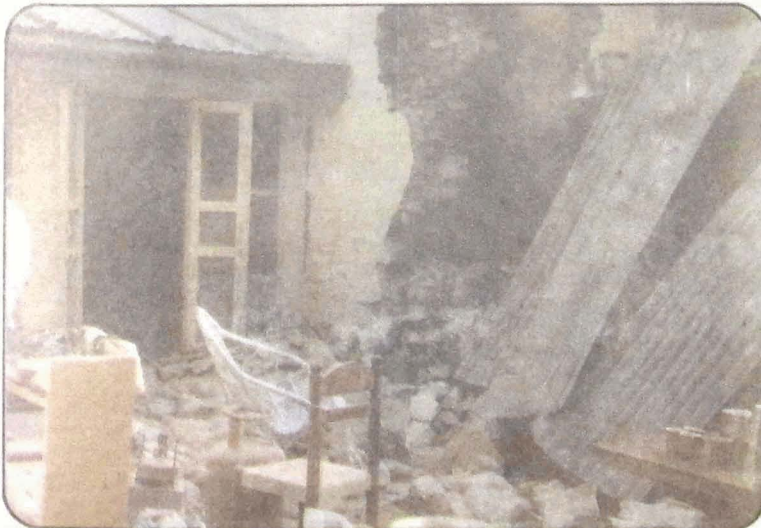
Photo 21 *Collapsed back portion of the house of Superintendent of Police, Uttarkashi.*

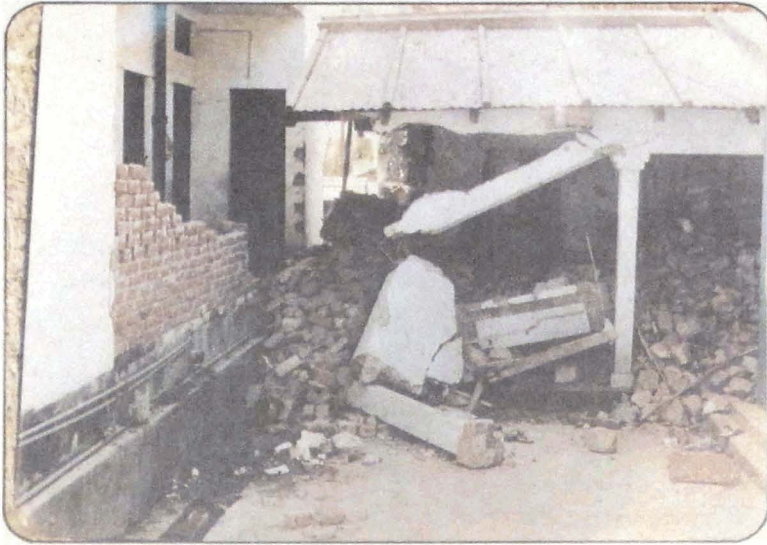
Photo 22 *Collapse of pillar and beam of the verandah of a house in Police Lines, Uttarkashi.*

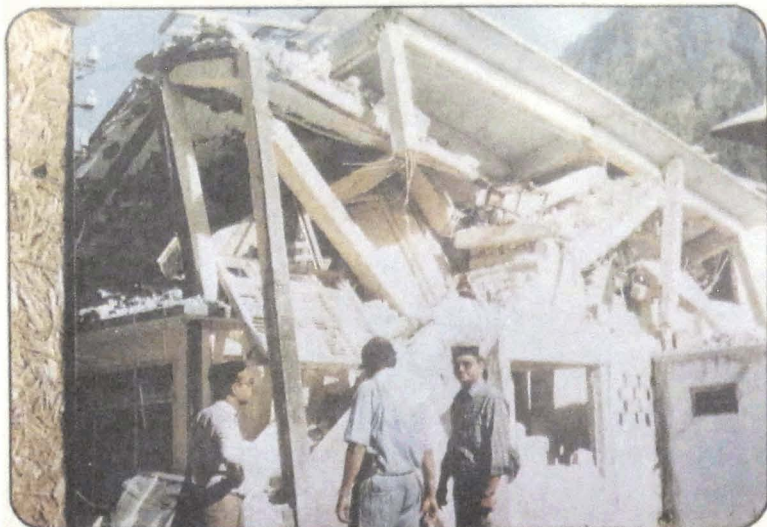
Photo 24 *Collapse of the first floor of RCC, State Bank of India building in Uttarkashi.*

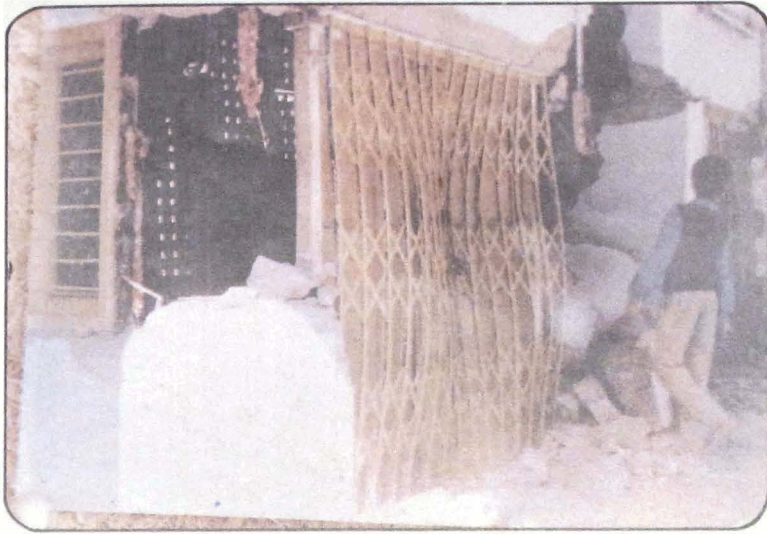
Photo 28 A *Collapsed walls and buckled shutters of the temple in Maneri project colony. (Photo NGRI).*

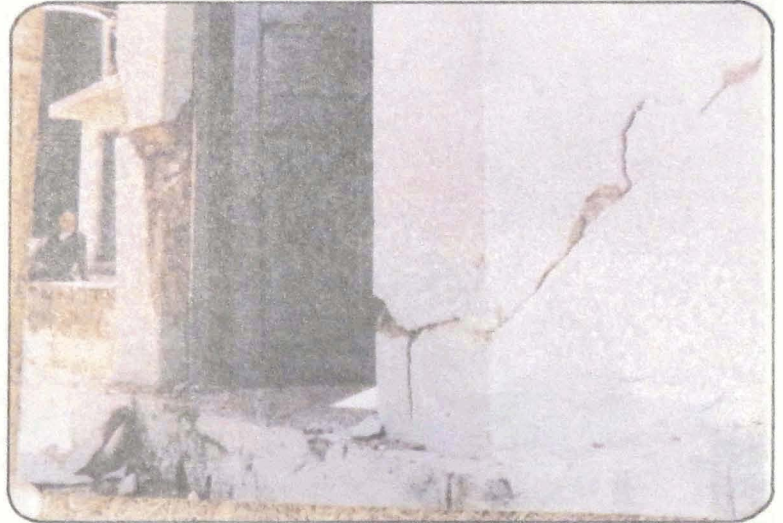
Photo 28 B *Shear cracks in one of the houses in Maneri colony. (Photo NGRI).*

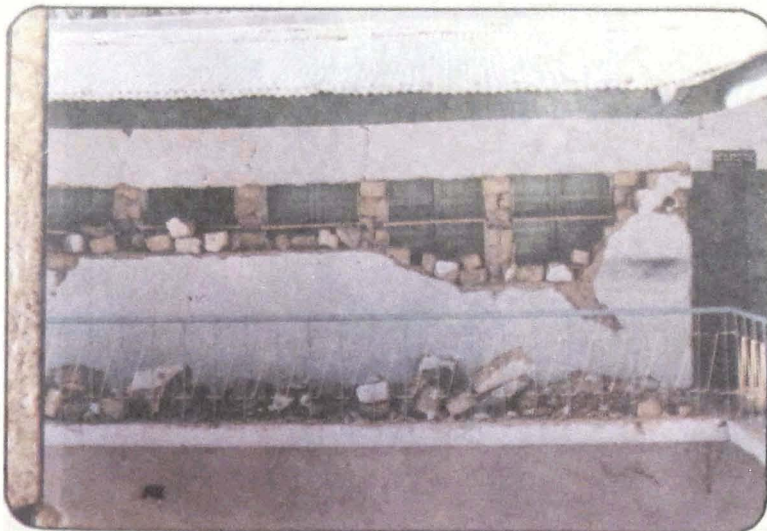
Photo 29 *Wall collapses in the first floor of the project engineer's office in Maneri colony.*

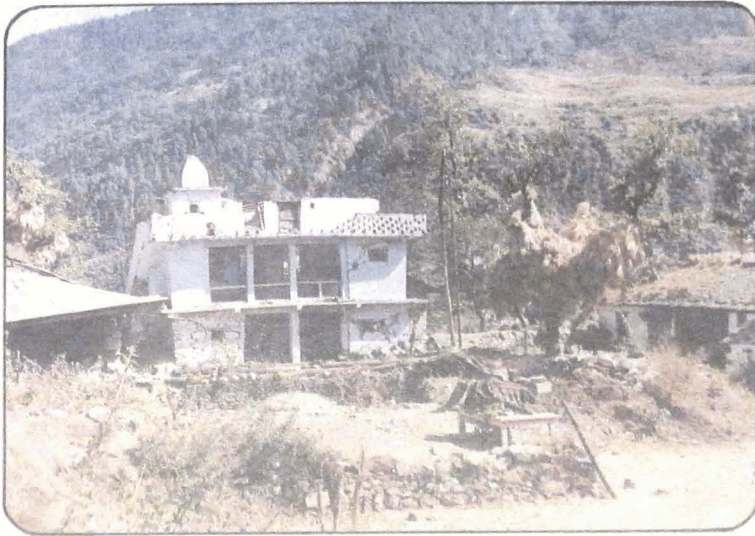
Photo 32 *Shear cracks in the ground and first floors of a house in Ghorsali village.*

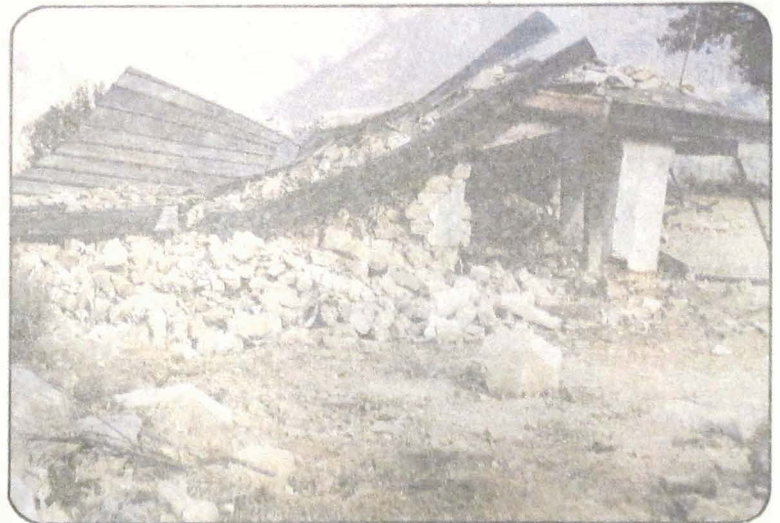
Photo 33 *Complete collapse of a school building in Jakhol village.*

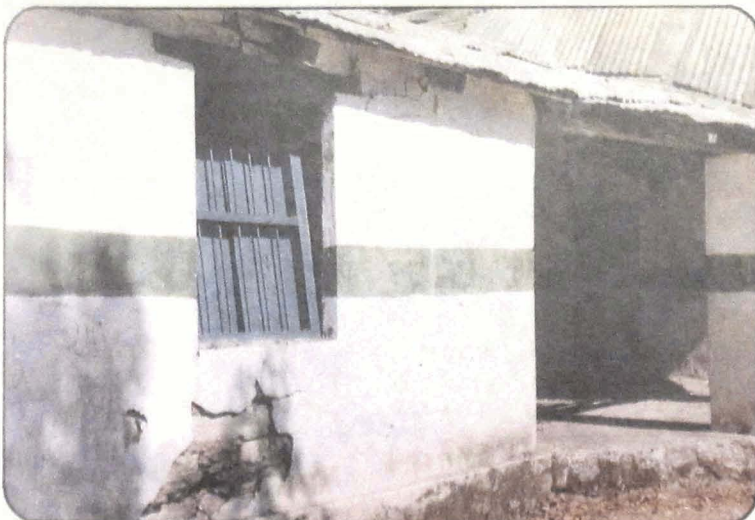
Photo 34 *Tilted window of a school at Aghora and partial collapse of partition walls.*

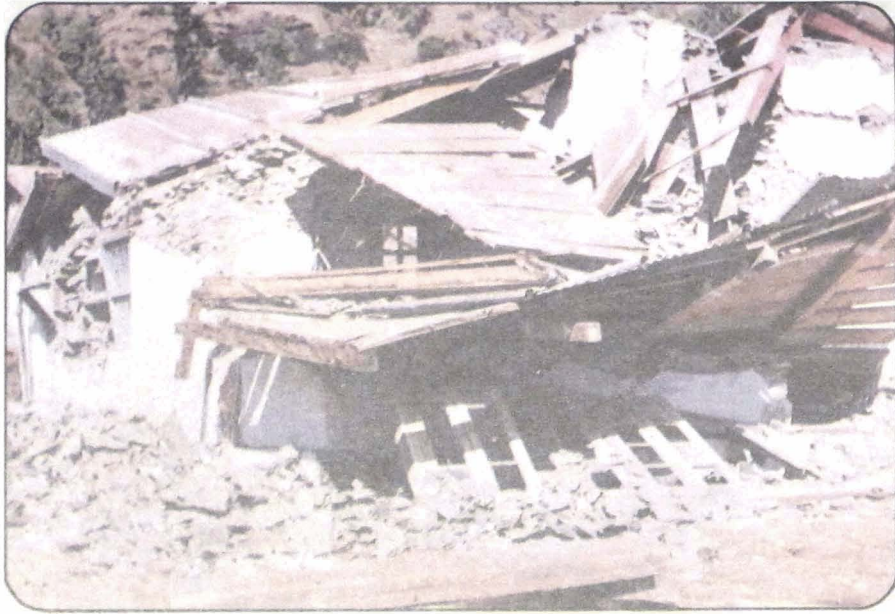
Photo 35 *Complete collapse of forest rest house at Aghora.*

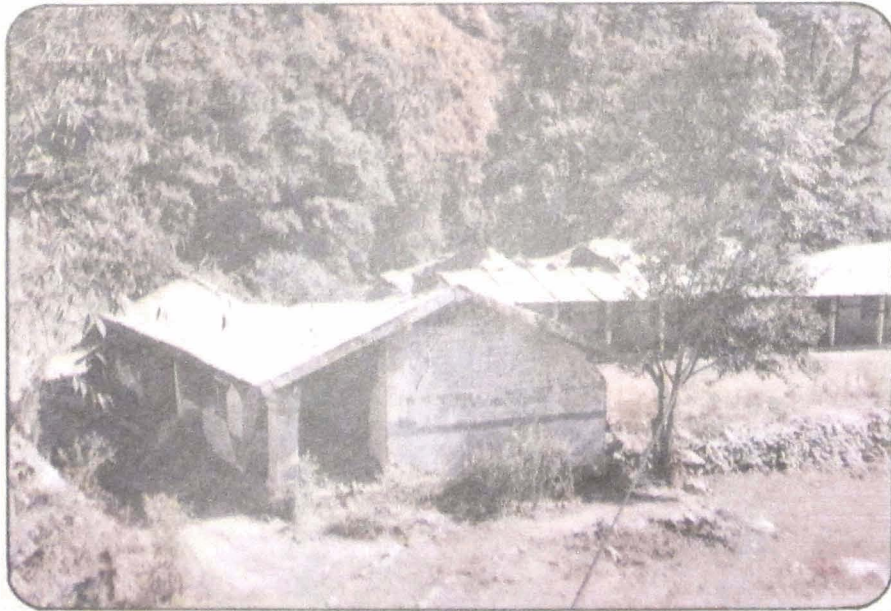
Photo 36 *Collapse of the northern wall of a school building at Kalyani.*

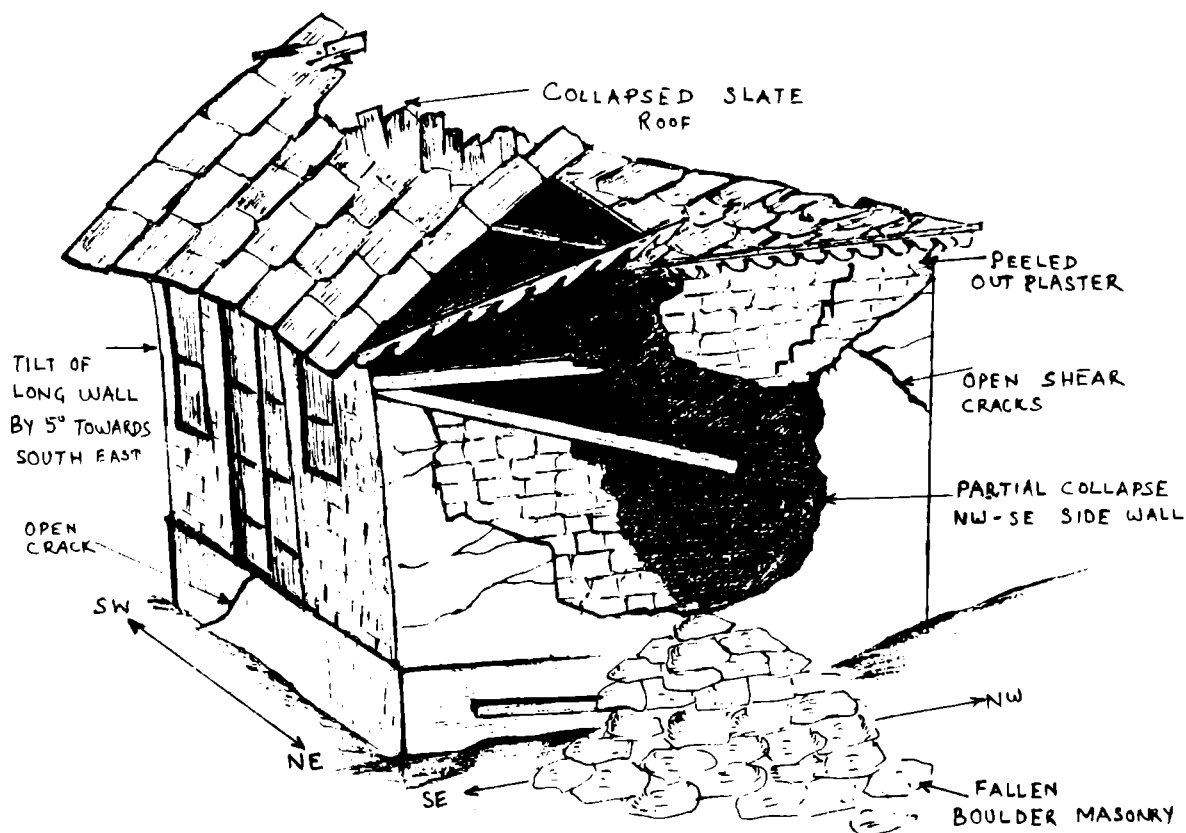
Fig. 10 : DAMAGE PATTERNS IN THE HOUSE OF PUSHKAR SINGH, KAMAR VILLAGE,
(SKETCH BY P. PANDE)

The house of Pushkar Singh Chauhan, located at the edge of a sloping ridge has been analysed in detail (Fig.10). The NE-SW trending long wall of the damaged house has tilted by 5° towards SE direction. The NW-SE trending side wall of mud masonry has suffered partial collapse. Part of the slate roof and the wooden beam resting over the collapsed side and partition walls have thereby caved in. Shear cracks and peeling of plaster is also evident on the side wall.

TYPE OF CONSTRUCTION: MUD-MASONRY WALLS WITH SLATE ROOFING
(TYPE-A CONSTRUCTION)

DIRECTION OF WAVE MOTION : FROM N TO S

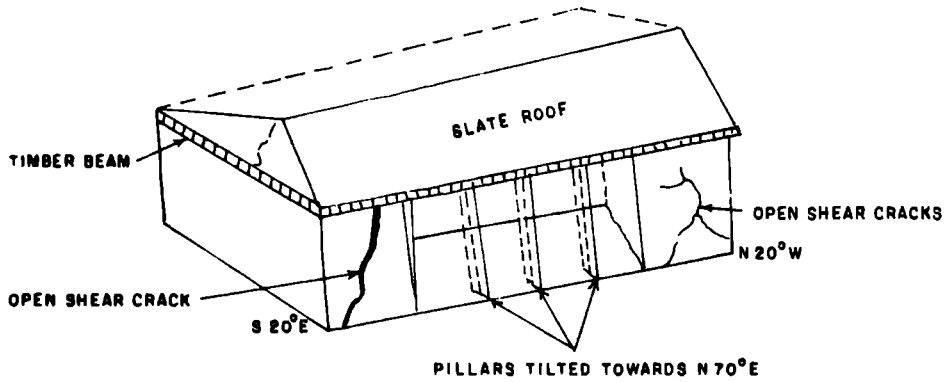
Fig. 12: DAMAGES IN THE HOUSE OF SRI SURAT SINGH VILLAGE NALD.

The house of Shri Surat Singh is a Kutchha house constructed from stone masonry with mud plaster and slate roof (Fig.12). The pillars in the varandah are also of mud stone masonry structures. The walls have timber partition. The long wall of the house is aligned in $N20^\circ W-S20^\circ E$ direction. The NE-SW trending wall has developed vertical open cracks. The pillars in the varandah have tilted towards $N70^\circ E$ and displacement at the top is of the order of 10cm. The cracks developed on long wall are of open nature and plaster has peeled off at number of places. Slight displacement and some bulge were noticed in this wall. No wall has collapsed but both structural elements (pillars) and non structural elements (walls) have suffered damage. However, the north eastern and south western walls have escaped with minor cracks.

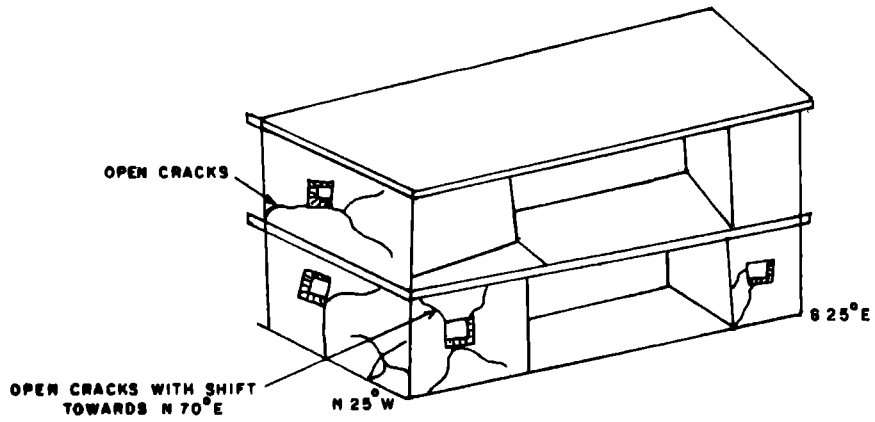
Fig. 13: HOUSE OF SRI RAM CHANDRA VILLAGE NALD.

Similarly, the house of Shri Ram Chandra with long walls aligned in $N20^\circ W-S20^\circ E$ direction and constructed with mud-masonry and cement plaster has developed shear cracks on NW walls and bulge in north-eastern walls (Fig.13). The pillars resting on RCC slab on first floor have tilted towards $N70^\circ E$. The house of Shri

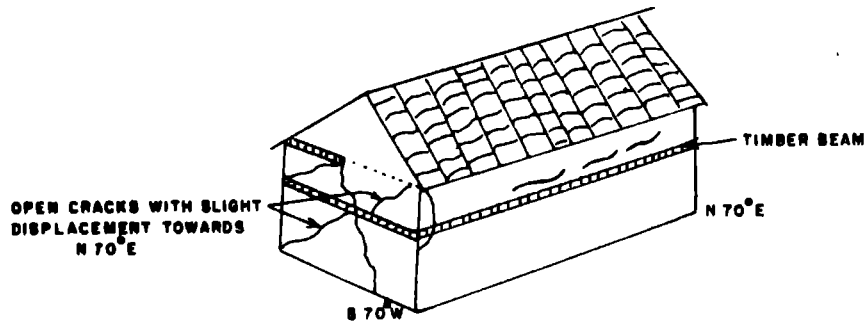
Fig. 14: HOUSE OF SRI PREM SINGH VILLAGE NALD.

Prem Singh, constructed of mud-stone masonry with slate roof and aligned in N70°E-S70°W direction has escaped with open cracks which are vertical and inclined on both N70°E-S70°W and N20°W-S20°E aligned walls (Fig.14). These cracks are open but no bulging was observed in the building except for small displacements in S wall. This displacement was also towards N70°E.

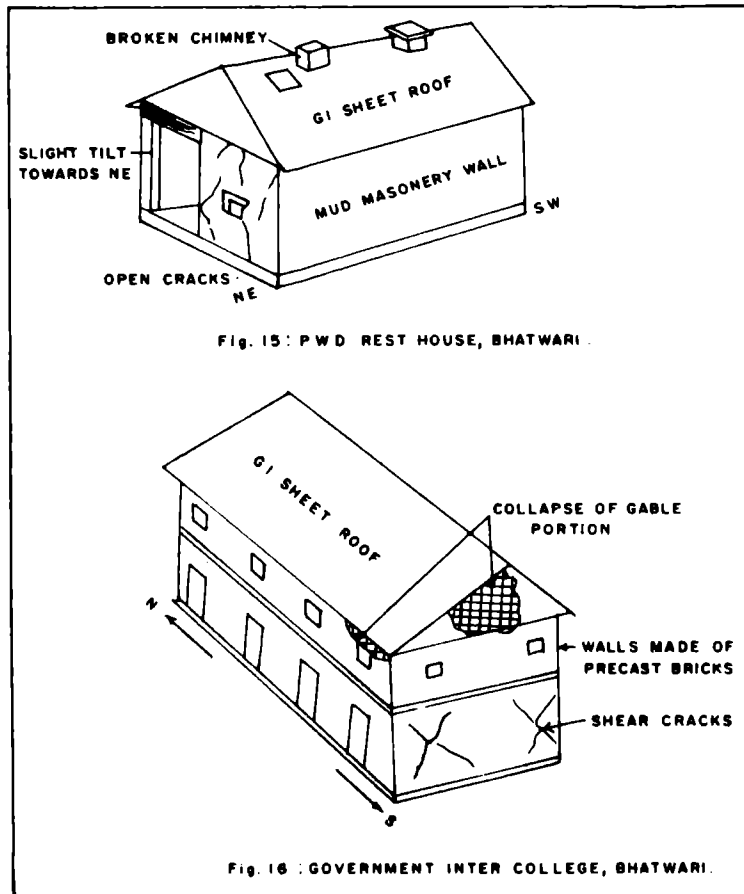
In case of Govt. Inter College located on a terrace on left bank of Bhagirathi, the gable portion of western and southern walls has suffered collapses (Fig.16). This N-W aligned building is a two storey complex constructed with hollow bricks and cement.

There are cracks in northern wall. Similarly, few houses in the village having their long walls aligned either in E-W direction or in NW-SE direction have suffered collapses in short walls and open cracks in long wall in a few cases.

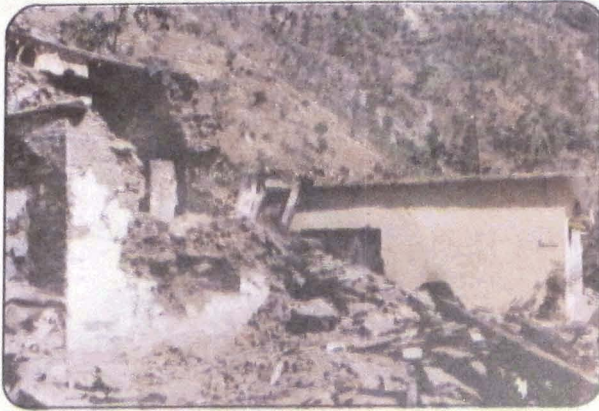
Photo 37 Collapse of a kutch house of Ganeshpur village. The adjoining brick masonry house has suffered much less damage.

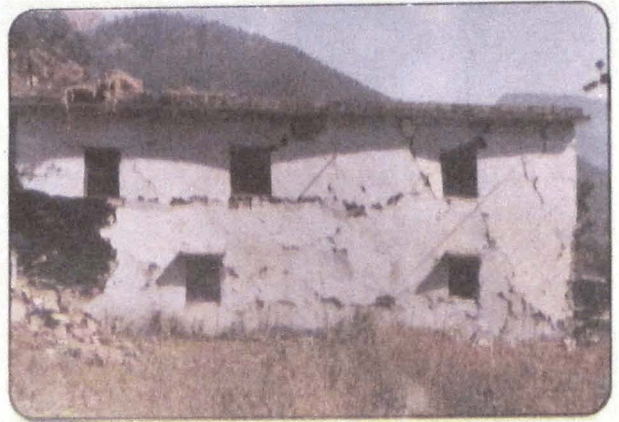
Photo 38 Collapse and cracks in the long walls of a house in Ganeshpur village.

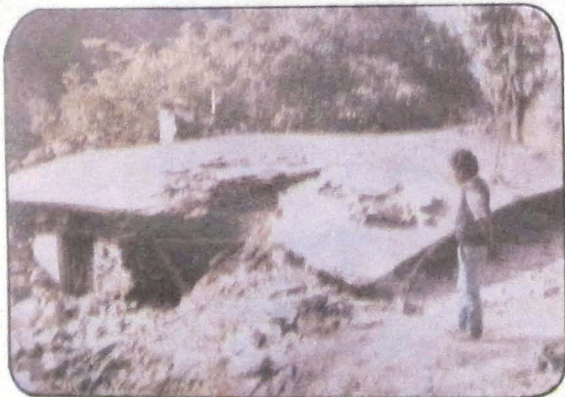
Photo 39 Collapse of a house in Netala village. Note bending of the RCC slab.

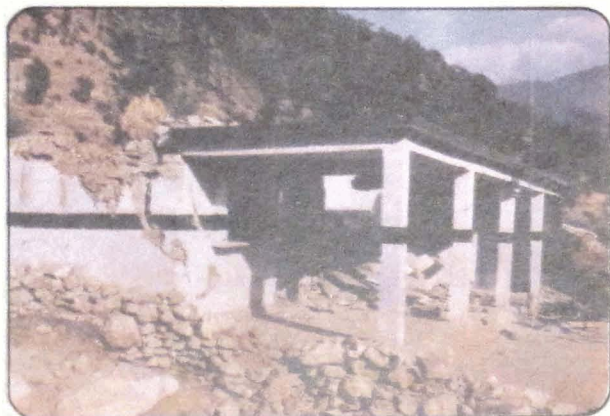
Photo 41 *Severely damaged school building in Heena.*

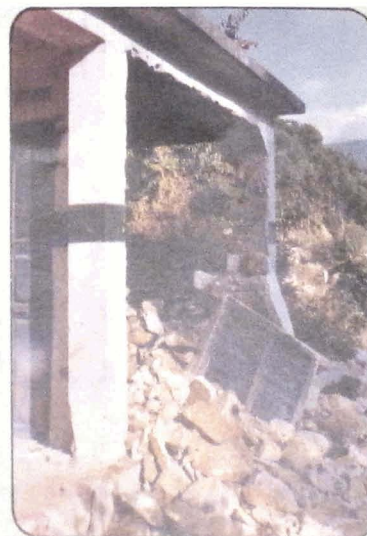
Photo 42 *Complete collapse of a non-load-bearing masonry wall of Heena School.*

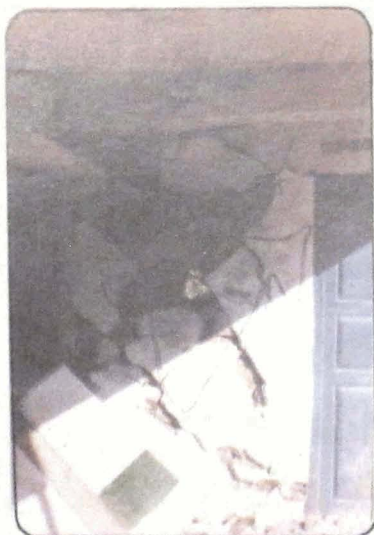
Photo 43 *Prominent shear cracks in the side wall of Heena school.*

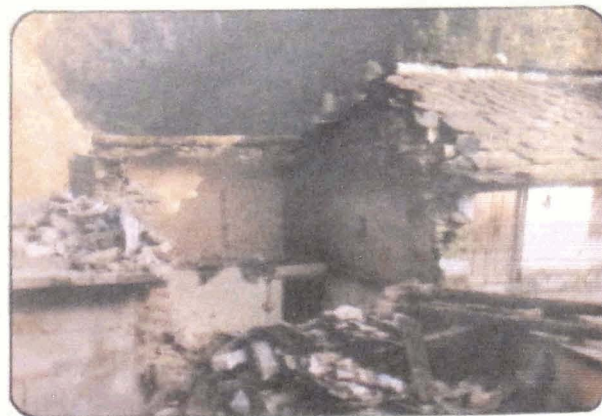
Photo 44 *Collapse of a kutch house (types A) in Malla village.*

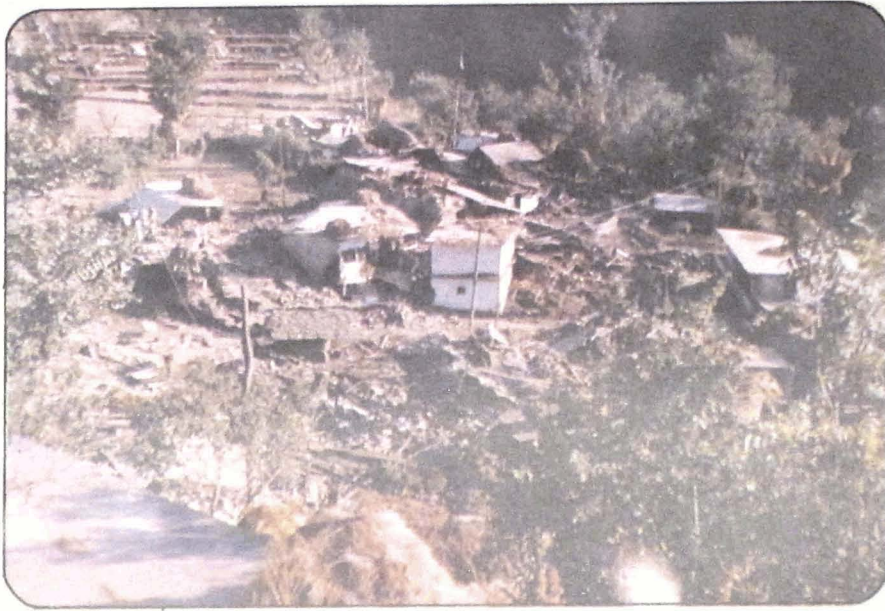
The village is located on a high level alluvial deposit of an abandoned channel, on the left bank of river Bhagirathi, at a distance of 0.5 km south east of Maneri dam. Jamak bore the maximum brunt of the 20th October earthquake, where 70 persons got killed and almost all the remaining were injured. The intensity of ground motions was so high that nearly 90% of the dwellings were either razed to the ground or suffered heavy damage, making them unfit and unsafe for habitation. The village thus bears a deserted look with all the inmates having moved to the neighbouring fields in make shift hutments (Photo 45).

Photo 45 *Devastated Jamak village.*

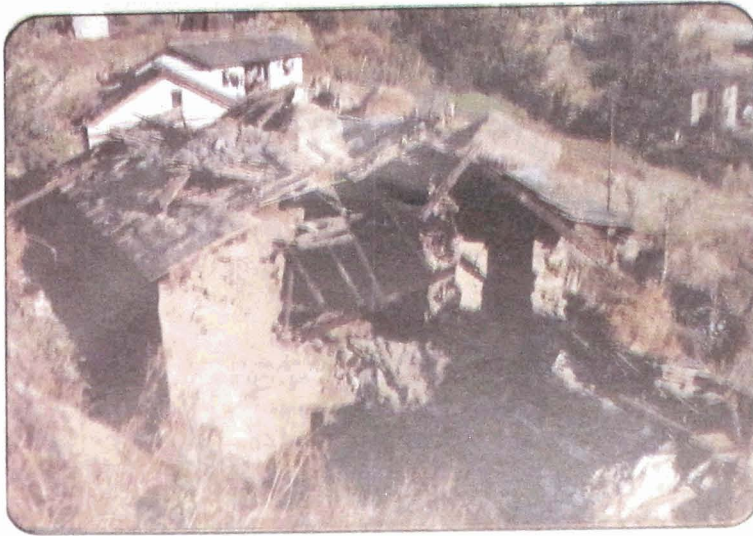
The damages to houses are quite extensive and severe. The thick masonry walls have suffered partial to total collapses (Photo 49). In most of the cases the heavy stone or RCC roof slab, supported on masonry walls, have caved in. Open shear cracks, accompanied with displacement and peeling of plaster are very common.

Photo 49 *Partial to total collapse of thick mud masonry walls in Kamar village.*

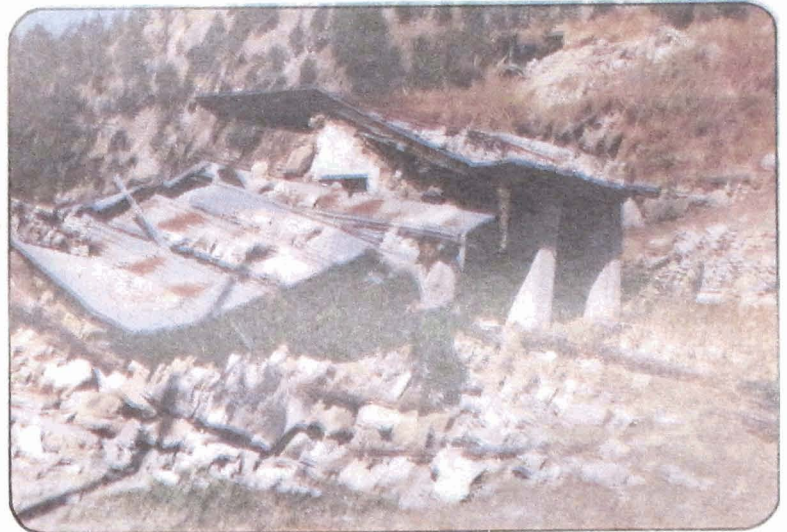
Photo 50 *Complete collapse of Kamar school building made of mud masonry with GI sheet roofings.*

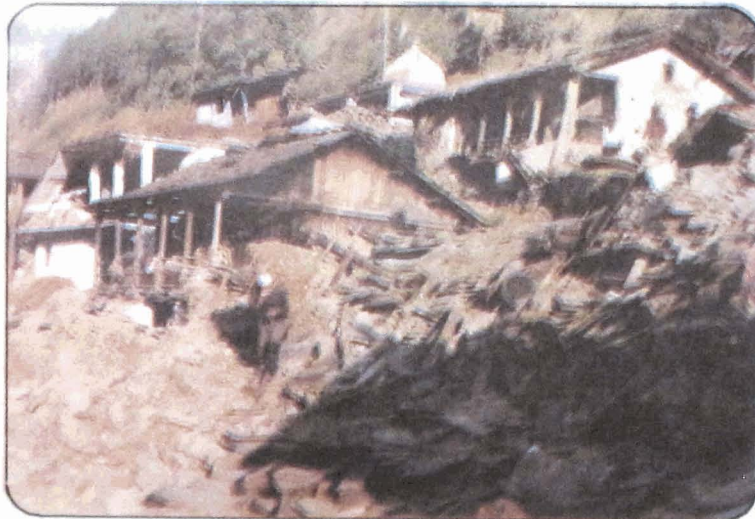
Photo 51 *Partial to complete collapse of houses in Dedsari village. Note an intact house made of timber logs and planks.*

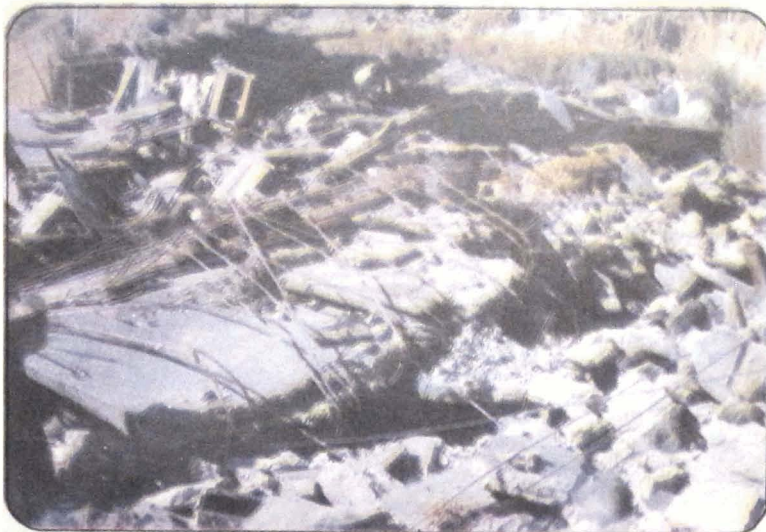
Photo 53 A *Complete collapse of type A houses in Dedsari village. RCC roof slab damaged because of wall collapses in one of the houses.*

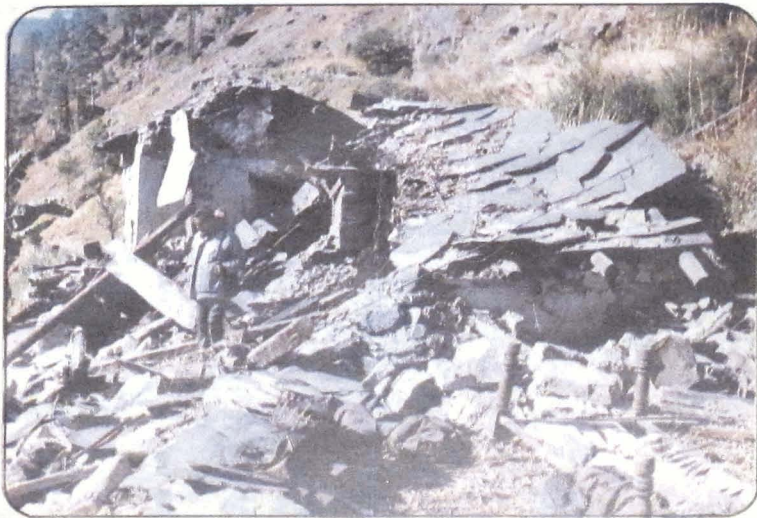
Photo 54 *Households scattered around collapsed type-A house in Sanglai village.*
