UTTARKASHI EARTHQUAKE

OCTOBER, 20, 1991

GEOLOGICAL SURVEY OF INDIA
SPECIAL PUBLICATION NO. 30
1992

SPECIAL PUBLICATION NO. 30

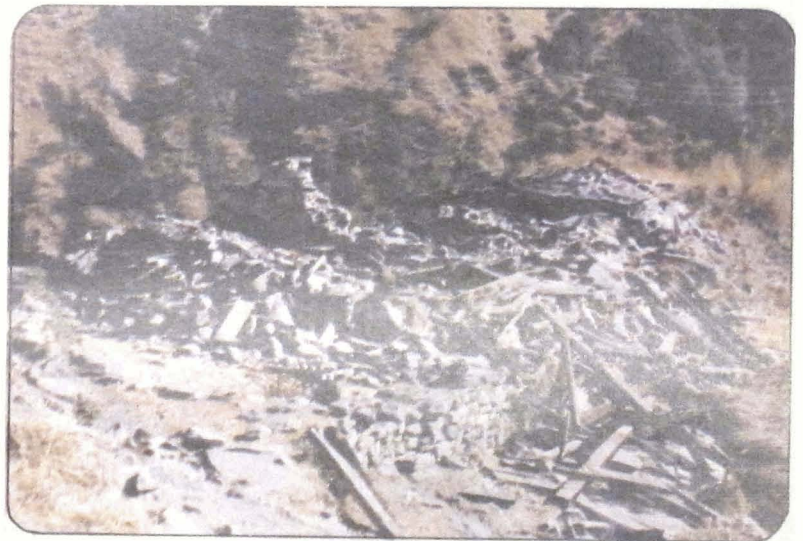
The houses have been constructed of thick mud masonry walls with stone slab, RCC slab or GI sheet roofings. The intensity of damage to houses located at lower levels is found to be less severe than those located at higher levels. A cluster of poorly constructed type-A buildings having long wall direction as N50°E-S60°W have suffered near total collapse (Photo 54). Here the direction of fall is seen to be governed by the slope conditions. A cluster of type-A houses, located on a N60°W-S60°E trending narrow ridge have suffered total destruction (Photo 54A).

Photo 54 A *Destruction of a cluster of type-A houses located on a $N60^{\circ}W-S60^{\circ}E$ trending narrow ridge in Sanglai village.*

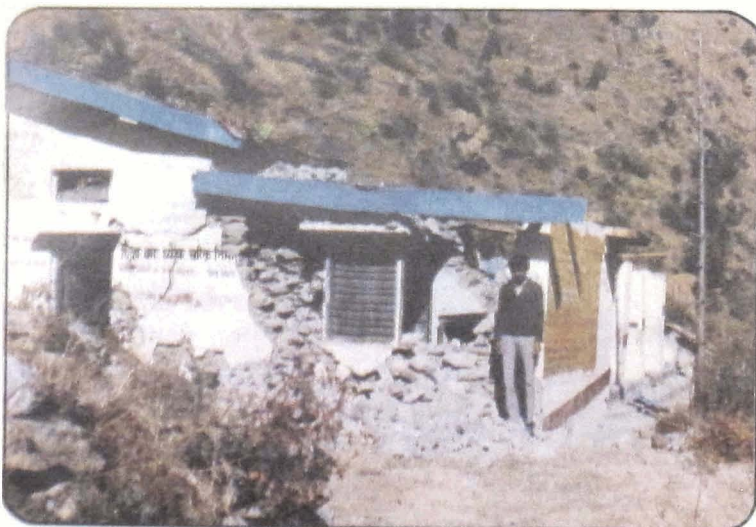
A Junior High School building has been studied in detail (Photo 55). The structure is constructed of thick mud masonry walls with masonry columns in front, supporting the varandah roof. G.I. sheets have been used for the roofing. The long wall direction is N-S and the side wall E-W. The southern end side wall has developed shear cracks and has partially failed towards south. Some of the front pillars have sheared and collapsed towards eastern side.

Photo 55 *Collapsed school building in Sanglai village.*

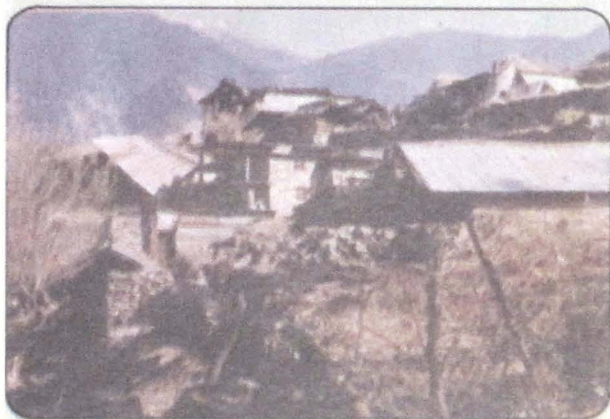
Photo 56 *A distant view of damages in Raithal village.*

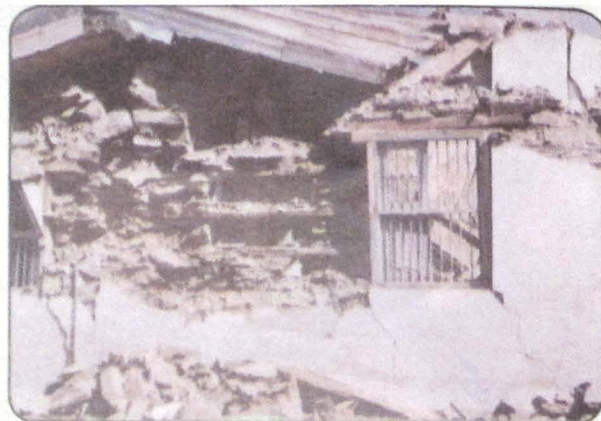
Photo 57 *Partial collapse of mud masonry side walls of school building in Raithal village.*

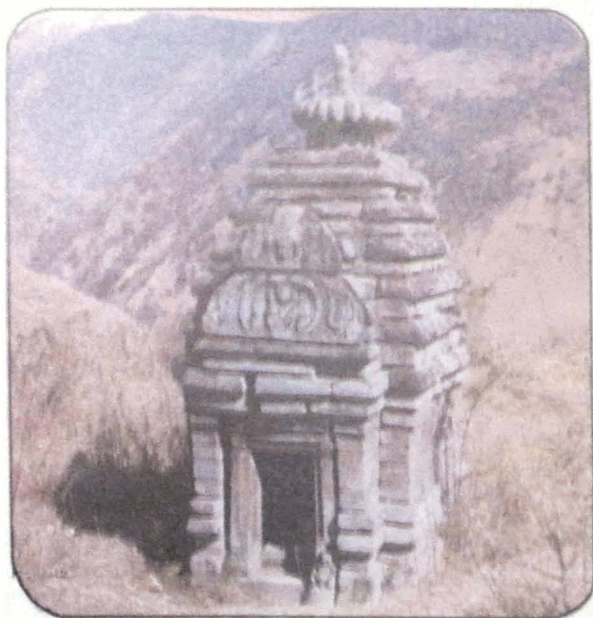
A group of old temples (about 1000 years old) has also suffered damage. Out of 4 temples, one has completely collapsed and Kalas on one has moved towards S (Photo 57A). These are masonry structures constructed of dressed stones without any cementing material and are of small height (upto 2m).

Photo 57 A *Old temple near Raithal village, displaying shifting of top cupola (kalash).*

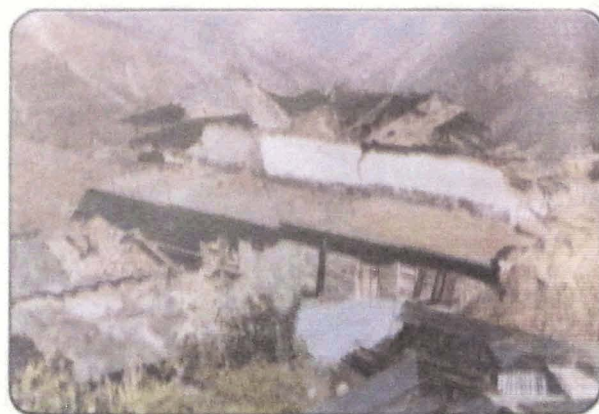
Although there was report of big cracks in Raithal village, none could be observed either in the village or on the slopes above it. Some slump cracks might have developed which probably later got filled up due to rain. However, a few landslide scars have been observed there in the NW part of the village on other slope of nala. Similarly, in Kiar, most of the houses have suffered damage due to cracks. Even in buildings constructed of stone masonry with cement plaster & RCC slabs, walls have developed shear cracks. 6 Kutcha houses have suffered wall collapses (Photo 58) which are confined to western and northern sides in N-S aligned houses.

Photo 58 *Extensive damage to conventional type-A houses. Collapse of walls and resultant breaking of concrete slab in one of the houses in Raithal village.*

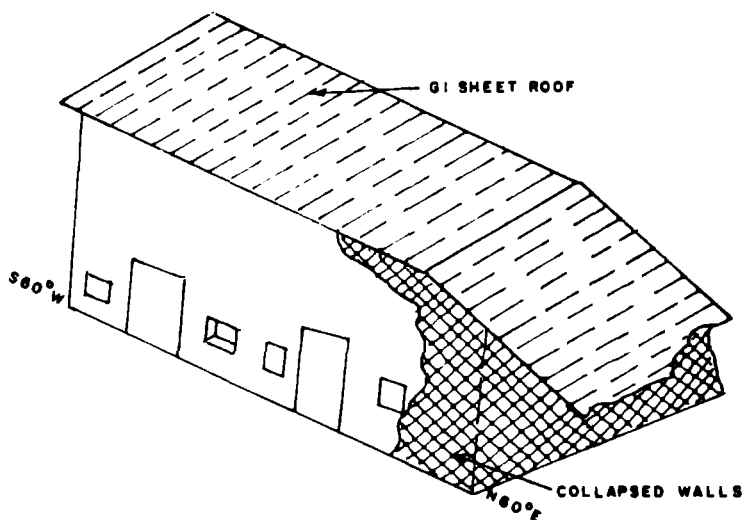
Fig. 16: PRIMARY SCHOOL BUILDING, PALA

The Primary School building, located on a small terrace is a single storey, mud stone masonry structure with GI sheet roof (Fig.18). It has also its long wall aligned in $N60^{\circ}E-S60^{\circ}W$ direction. The failure of NW and SE corners has resulted in complete collapse of NE wall (Fig. 18). A closer examination indicates the damage of wall might have initiated in the gable portion.

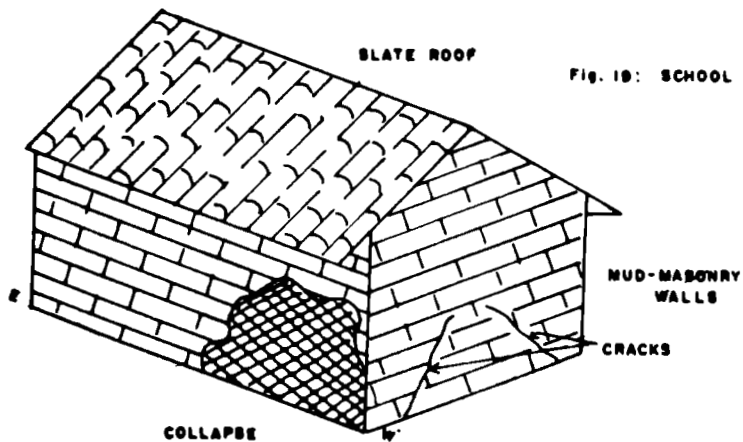
Fig. 20: KUTCHMA (MUD-MASONRY) HOUSE SUKI

Suki village is located on hill slopes, on right bank of Bhagirathi river at an altitude of about 2500m, occupied by debris of a dormant land slide. The buildings in the village are either Kutcha mud stone masonry houses with slate roofs or pucca mud stone masonry walls with cement sand plaster and GI sheet or slate roofs (Figs.19,20&21). A few wall collapses and wide open cracks were observed in Kutcha houses. The bulges and open cracks are confined to northeastern short walls of N30°E-S30°W aligned houses. In the school building open cracks (upto 5.0cm) with slight bulge towards NE have been recorded (Fig. 19). The long wall of this building is aligned in N30°E-S30°W. The other walls of this building have escaped damage. In case of Kutcha houses with long wall aligned in E-W direction, a few partial collapses on northern walls were observed (Fig. 20). The northern walls of these houses have bulged towards north.

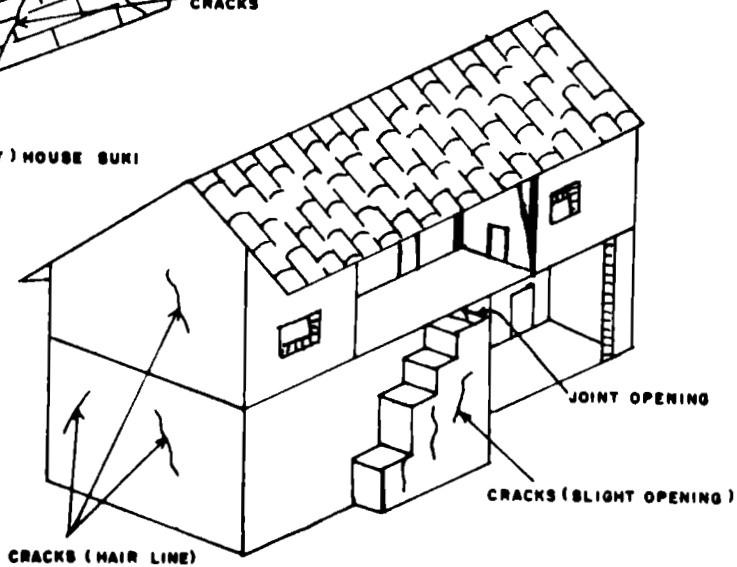
Fig. 21: PUCCA HOUSE - SUKI

In case of houses constructed using mud stone masonry walls with sand and cement plaster and GI sheet or slate roofs, damage is confined to development of hair fine cracks and peeling of plaster of southwestern walls. The projections like the stairs, have suffered more damage in form of opening up of joints and development of open cracks (Fig. 21).

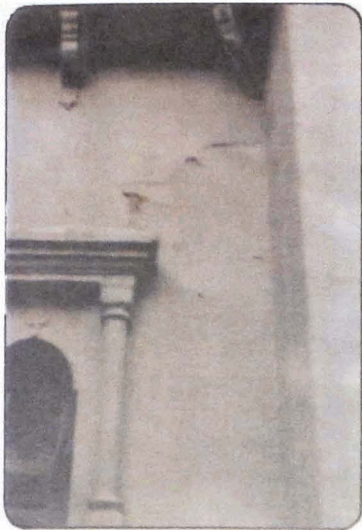
Photo 63 *Fine cracks in the outer masonry wall of Gangotri temple.*

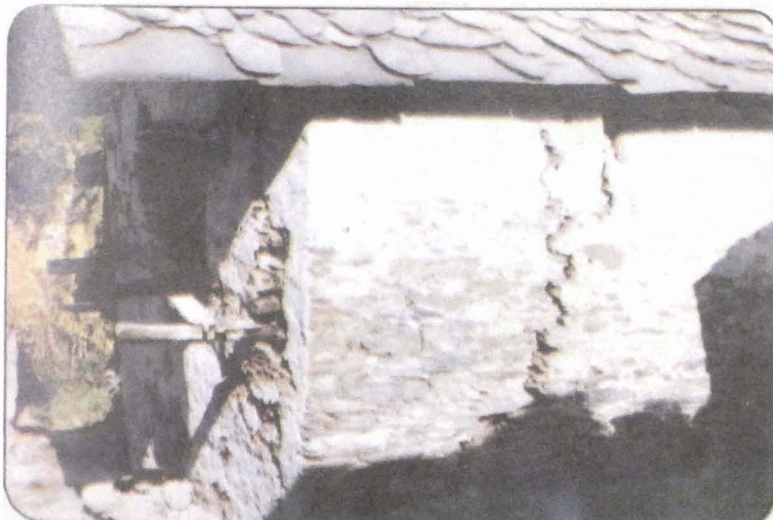
Photo 65 *Bulging and cracking of thick masonry walls of a house in Siror village.*

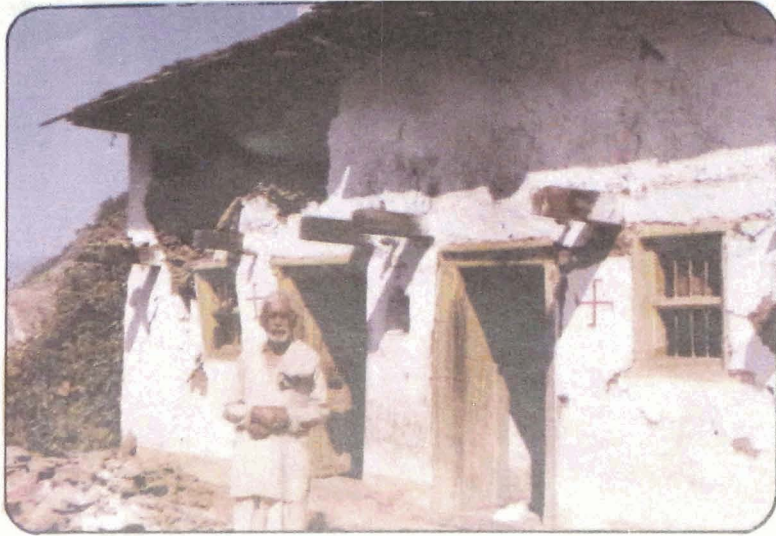
Photo 69 *Partial collapse of the roof corner of the first floor of a house in Thalán village.*

A poorly constructed type A double storey house has its long wall oriented in E-W direction. The long wall has developed shear cracks and the upper corner of this wall has collapsed towards south (Photo 69).

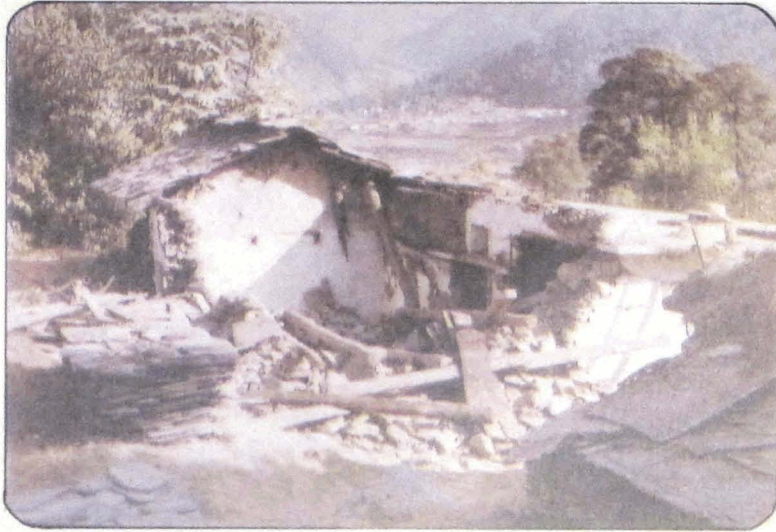
Photo 72 *Collapse of cluster of houses in Gyansu village.*

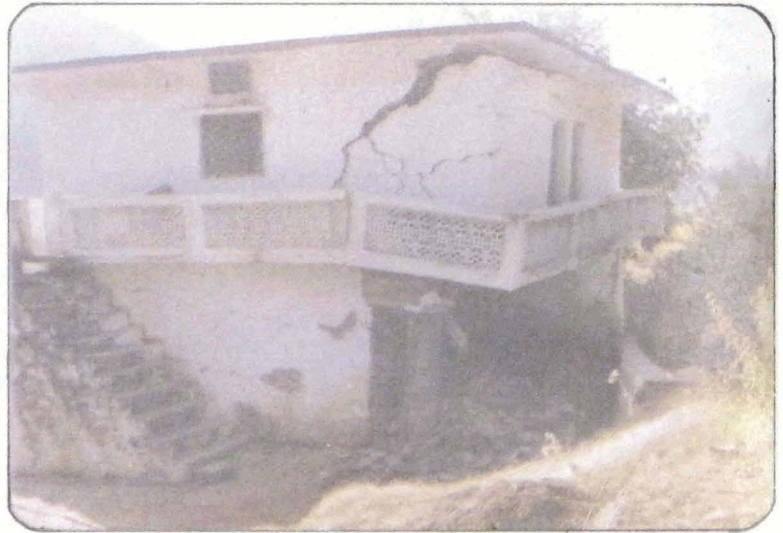
Photo 73 *Tilting of the first floor frontage of a double storey house because of the collapse of the ground floor wall in village Gyansu.*

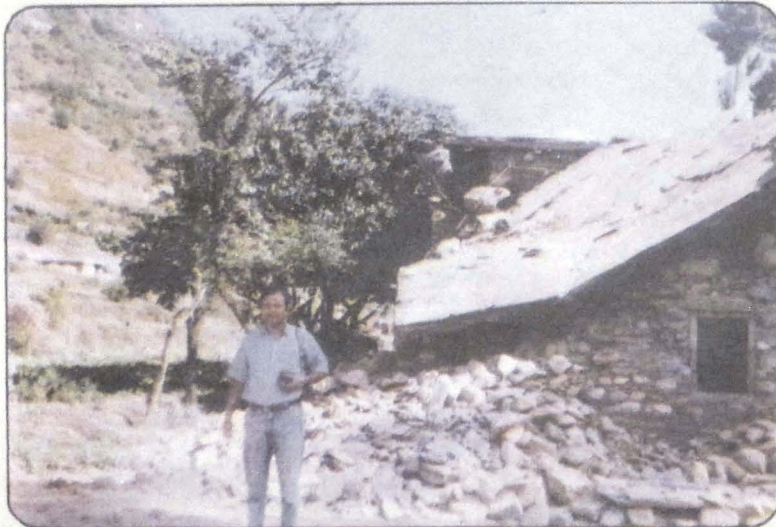
Photo 74 *Failure of the stone masonry wall leading to sagging and partial collapse of a RCC roof slab in Matti village.*

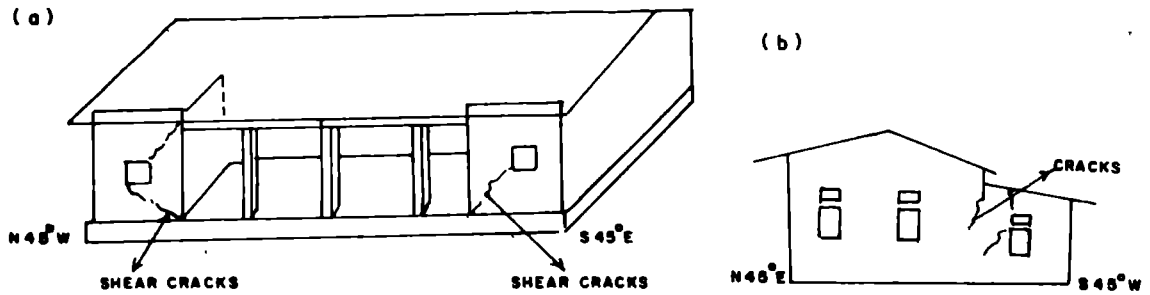
Fig. 22: (a) BAINGA SCHOOL BUILDING SHOWING SHEAR CRACKS IN THE CUBICLES ON THE SIDES OF THE VARANDAH. (b) ELEVATION OF NW SIDE WALL SHOWING STEEP CRACKS IN THE SAME BUILDING.

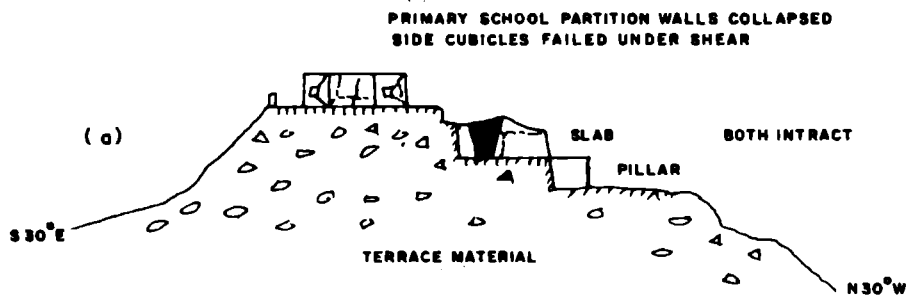
The village proper is located on the upper terrace and is a conglomeration of mud masonry houses and a few cement masonry houses some of which are with conventional sloping roofs with tiles and others with RCC slabs on masonry walls (Fig.23&24). All the mud masonry and old mud adobe houses have suffered the damage in form of open cracks and a few partition walls have collapsed. One housing complex belonging to four brothers Jataru Lal, Sirdaru Lal, Uttam Lal and Tara Lal aligned in the N60°E-S60°W has collapsed taking a toll of 6 lives. This house is located near the village Primary School which is aligned across the direction of long wall side of the collapsed house. The Primary School building has also suffered major damage in the form of collapse of partition walls. A fissure trending in N15°W-S15°E direction has developed in the school compound.

Fig. 23: SKETCH SECTION OF THE NOSE ON WHICH BAINGA VILLAGE IS LOCATED. (a) COLLAPSED PORTION OF THE NE-SW ALIGNED HOUSE BUILT IN MUD MORTAR AND STONE (SHALE) PACKING, LIVES LOST IN THIS COLLAPSE.

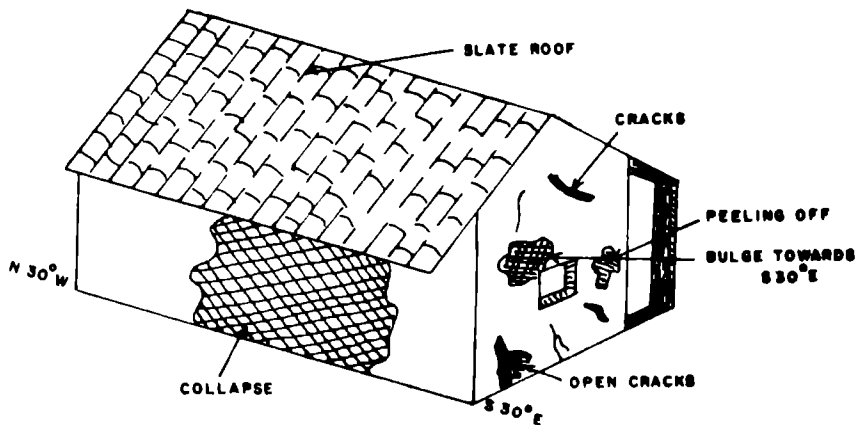
Fig. 25: DAMAGE OF KUTCHA HOUSE, JAKH

Out of 200 houses in the village, 28 houses are reported to have suffered damage in the form of cracks in the walls and six of them have suffered wall collapses.

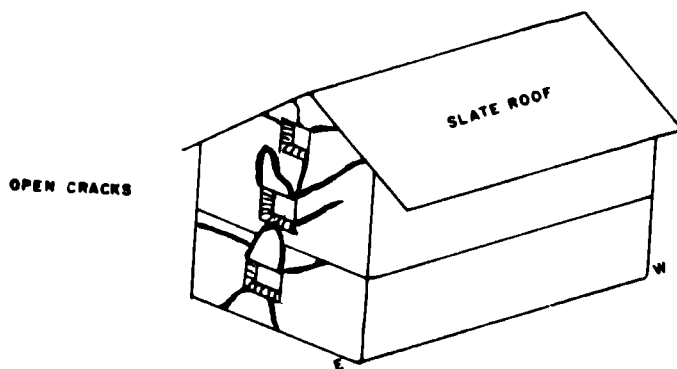
Fig. 27: DAMAGE OF E-W ALIGNED KUTCHHA HOUSE - AGONDA

are mud stone masonry constructions with slate roofs (Figs.26,27&28) and a few masonry houses with cement sand plaster and GI sheet roofs. About 80% of the houses have suffered damages ranging from cracks in walls to wall collapses.

In case of mud stone masonry houses with slate roofs and long walls aligned in N-S direction, open shear cracks (upto 5mm opening) have developed on the southern short walls (aligned E-W) and collapses have occurred in eastern long walls. These collapses are partial and mostly confined to upper storey and upper portions of ground floor. Partition walls have also collapsed in some cases. Houses with long walls aligned in E-W direction, have withstood the shock. However, in E-W aligned side walls, particularly the eastern ends have suffered damage in the form of cracks which extend from gable portion to the base of the building. In some cases the cracks are more intensely developed near the openings in the walls like windows etc. But long walls in such cases have escaped without any damage. The protruding portions like stairs have suffered more damage in form of cracks when located on southern side of E-W aligned houses. Cracks were also observed on northern walls of similarly aligned houses in few cases.

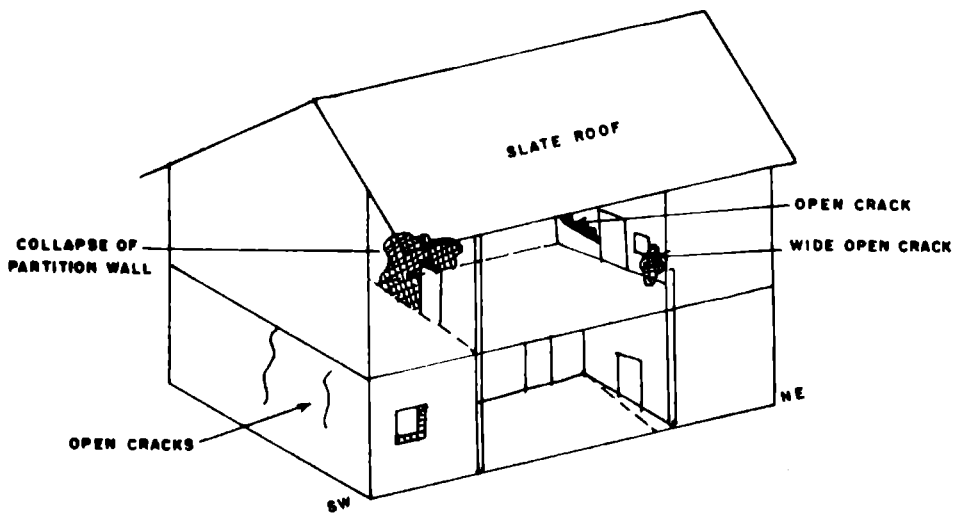
Fig. 28: DAMAGE OF KUTCHHA HOUSE - AGONDA

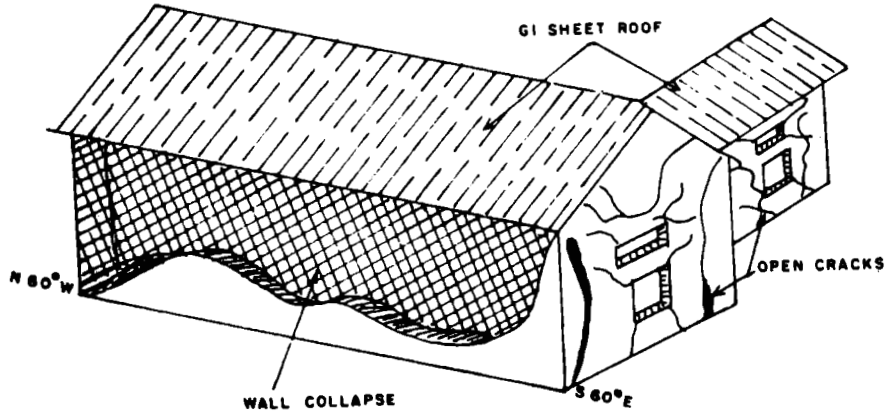
Jakholi village is located on the southwestern and eastern slopes of a ridge trending N30°W-S30°E at an altitude of about 1500m. The Government buildings like Block offices and residences of Block officials have suffered considerable damages where as houses and buildings located on southwestern slopes of this ridge have escaped with minor damages like hair line cracks and peeling off of plaster in upper portions.

FIG. 30: VETERINARY HOSPITAL - JAKHOLI

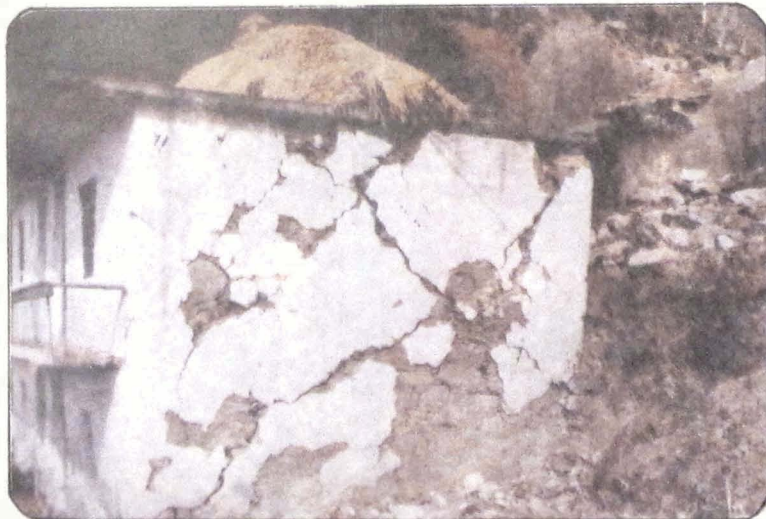
Photo 83 *Heavily sheared side walls of a house in Gorthi village.*

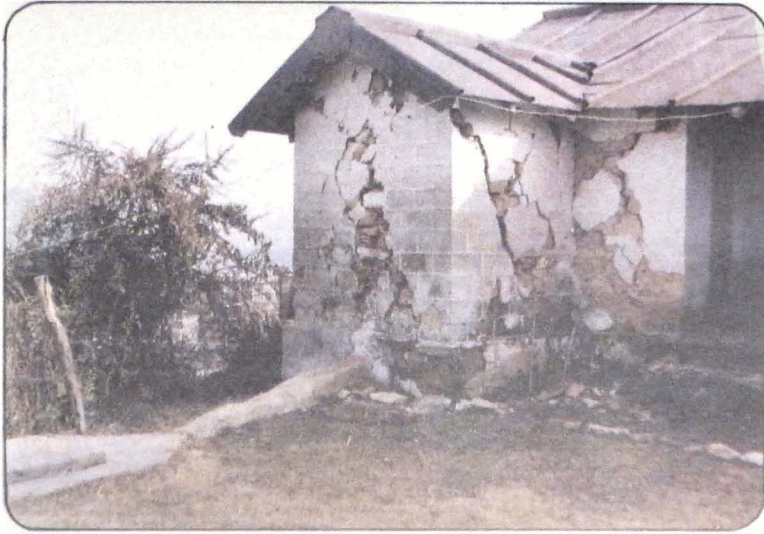
Photo 84 *Damaged residence of doctor in Jakheli village.*

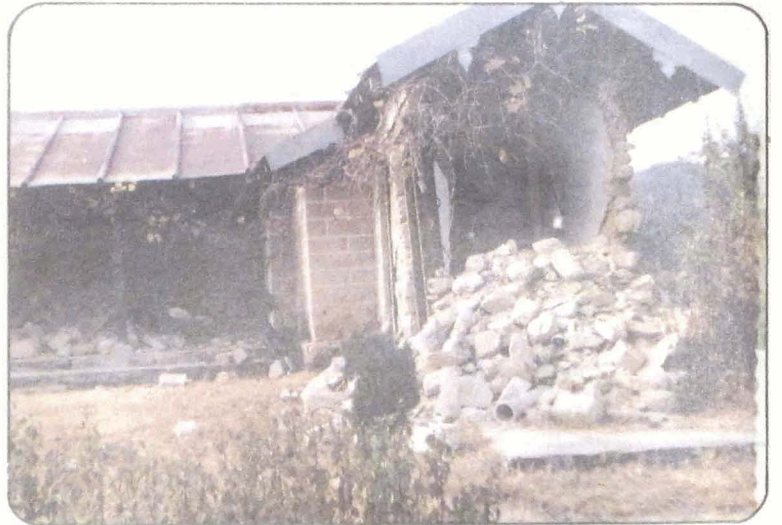
Photo 85 *Collapse of a type-B house in Jakholi village located on a spur.*

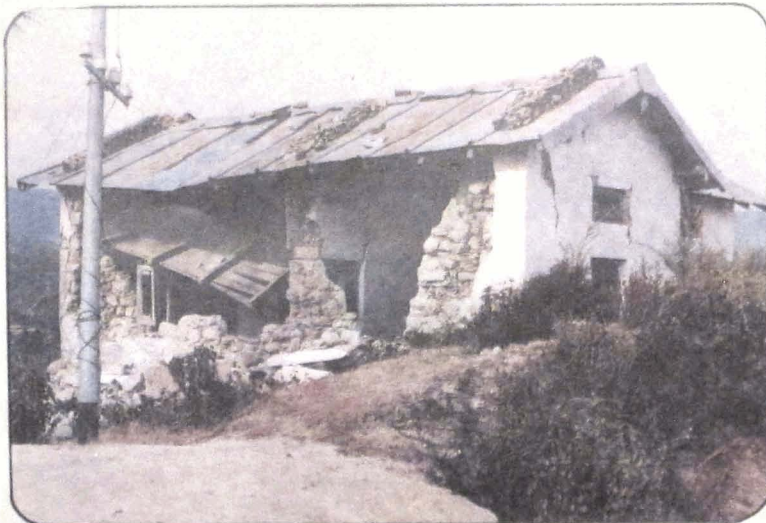
Photo 86 *Collapsed veterinary hospital in Jakholi village.*

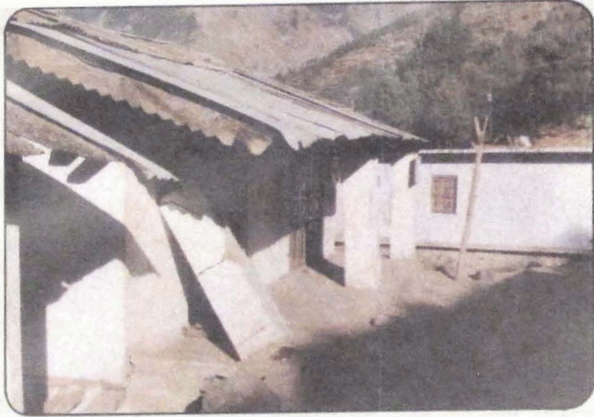
Photo 87 *Tilting and collapse of pillars of a house in Rana village.*

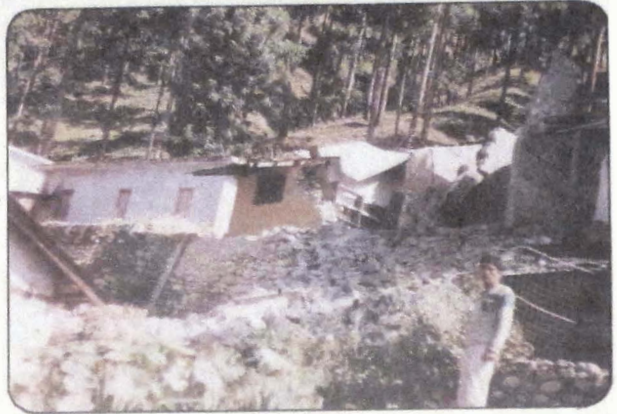
Photo 88 *Damage to cluster of houses in Gangani village.*

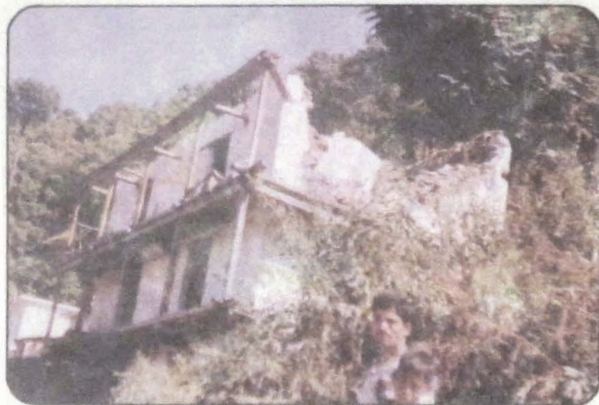
Photo 89 *Collapse of first floor of a conventional house in Gangani village.*

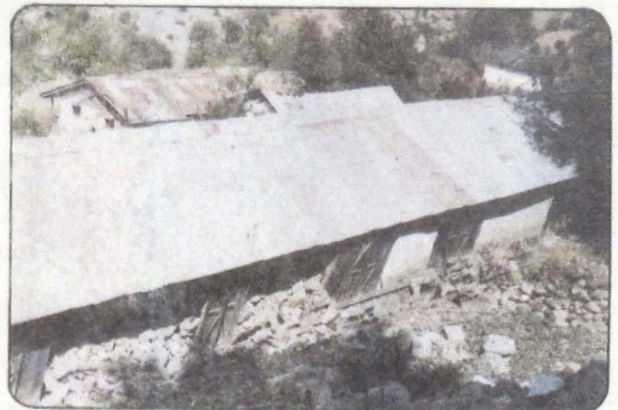
Photo 91 *Tilting of the eastern long wall of a conventional house in Gangani village.*

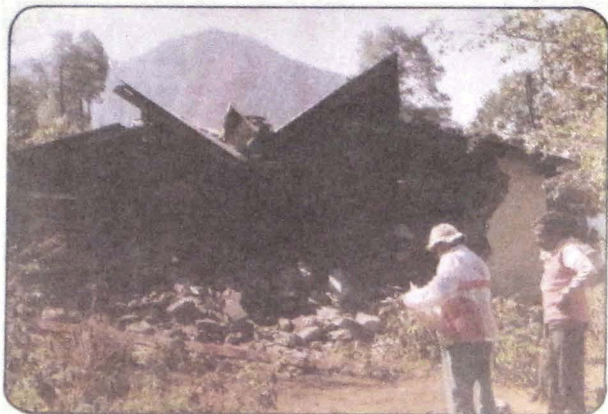
Photo 92 *Caving in of the roof of a conventional construction because of partial collapse of supporting walls, Gangani village.*

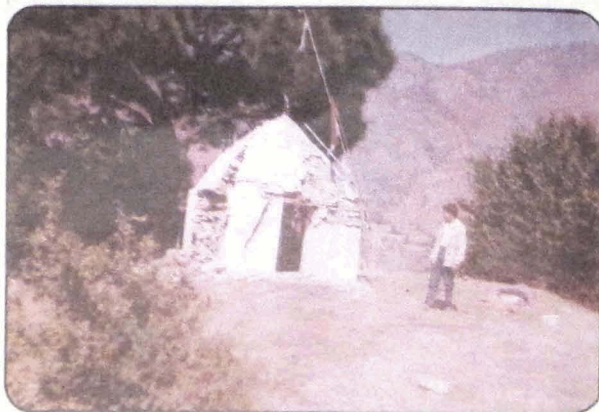
Photo 92 A *Damaged lowrise roadside temple, a few km before Barkot along Kalsi-Barkot road.*

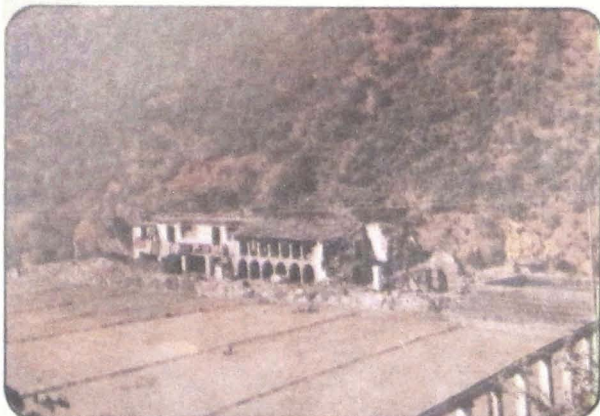
Photo 93 *Partial collapse of an old house located on Yamuna terrace. Small water channel supported on high pillars has escaped damage.*

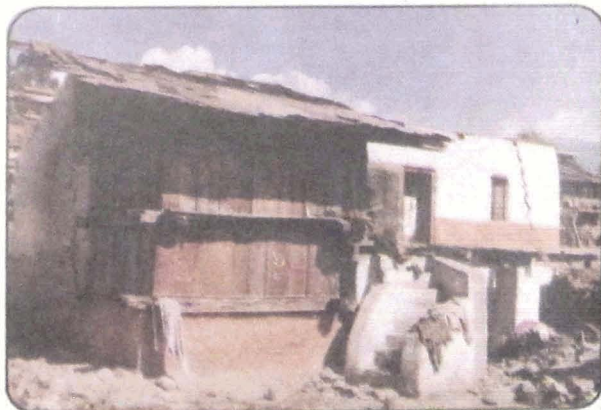
Photo 94 *Bulging and cracking of walls of a house in Purola village.*

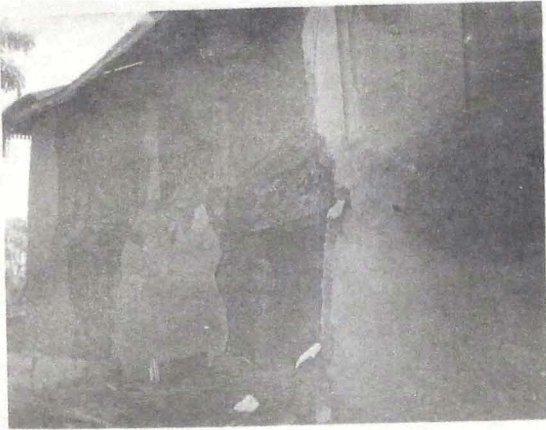
The earthquake has caused severe damage to about 20 adobe constructions out of which 5-6 houses have demonstrated partial collapse of walls. In one, two storey house, built in 1920, both long and short walls have collapsed and gaping cracks have developed all along the length of the walls (Photo 99). The gap in the cracks varies from about 12 cm at the top to 1mm towards the base. In another house the southern short wall has been damaged and a gaping crack with an opening of 5-6cm at the top and pinching out near the bottom has developed near the corner (Photo 100). At the police post construction joints opened up due to the tremor.

Photo 99 *Partial collapse of an old house in Kunihar village.*

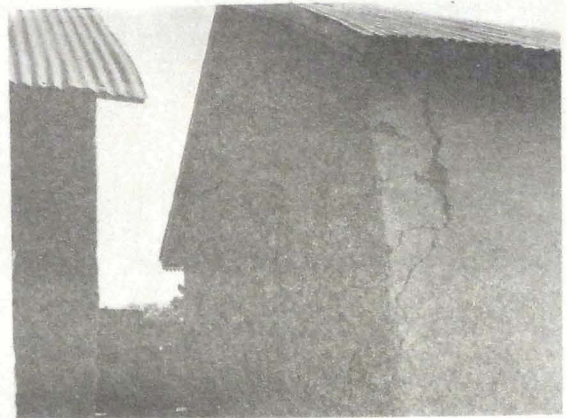
Photo 100 *Vertical crack with 5-6 cm. opening in a kutchha house in Kunihar.*

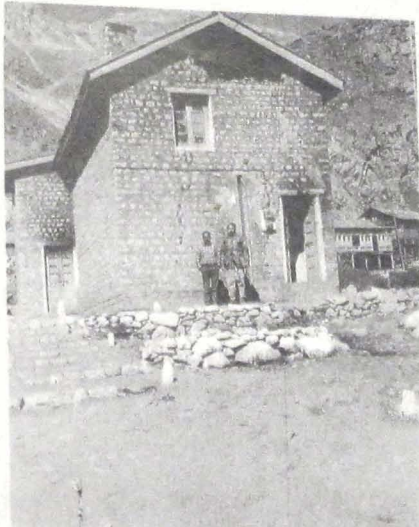
Photo 101 *Partial collapse of gable portion of a type-B construction (dispensary building) at Chitkul.*

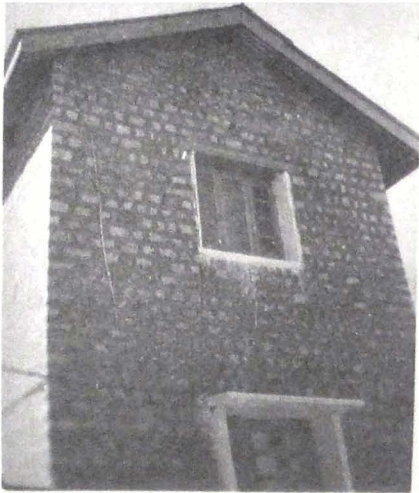
The side walls of the PWD Rest House aligned in the N-S direction show bulging, one in the easterly direction at mid level (Photo 102) and the other bulges towards west. The back long wall aligned in the E-W direction has developed horizontal crack as well as few subvertical cracks near the top of the wall. The slab of the chimney of the PWD stone building has rotated.

Photo 102 *Bulging of the west wall of double storey Rest house at Chitkul.*

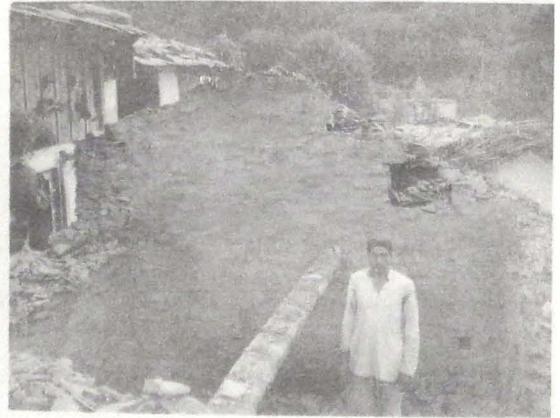
Timbi area reportedly experienced three shocks in a span of 30-50 seconds, the first shock being severest and of longest duration. All the people were awakened, frightened and rushed out of houses. The village Pradhan reported that as he tried to come out he fell in the N20°W direction. Rattling of windows and doors was reported by all, utensils fell from the shelves and two directions of wave propagation, one in N70°E-S70°W and the other in N30°W-S30°E, were reported. Three Kutcha houses collapsed. Long wall of a house, constructed of stacked cement stone and plastered with mud, collapsed in N20°W direction (Photo 104). The western side wall of another house, under construction, also collapsed in S70°W direction.

Photo 104 *Collapsed house in Timbi village.*

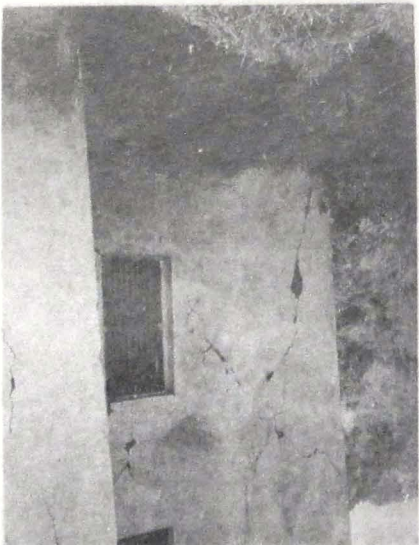
At Baldwa located near Kamrao a double storey B-type house has developed shear cracks in the side walls oriented in the N20°E-S20°W and even the partition walls parallel to the side walls have developed similar cracks. The long walls of this house do not show any significant cracks (Photo 105). It was

Photo 105 *Shear cracks in a type-B, double storey house in Baldwa village.*

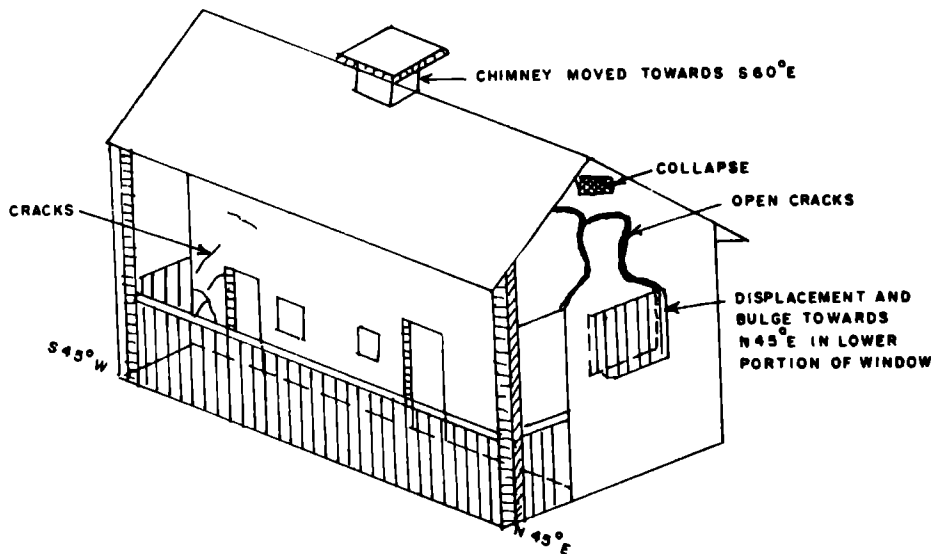
The PWD Rest House is an old building constructed in 1928 of mud stone masonry walls with cement plaster and GI sheet roof (Fig.34). It has its long walls aligned in N45°E-S45°W. The long walls of this building from inside (i.e. NE-SW aligned walls in rooms) have developed shear cracks which originate from plinth level. The damage to long walls is more pronounced on SW side of the building. The NE side wall which is aligned in NW-SE direction has collapsed in the gable portion damaging the false ceiling, furniture etc. in the room. From outside, this wall has developed cracks which are wide open and a very prominent bulge towards NE. The window has tilted by about 20° as a result of this bulge (Photo 112).

Fig. 34: PWD REST HOUSE - GAURIKUND

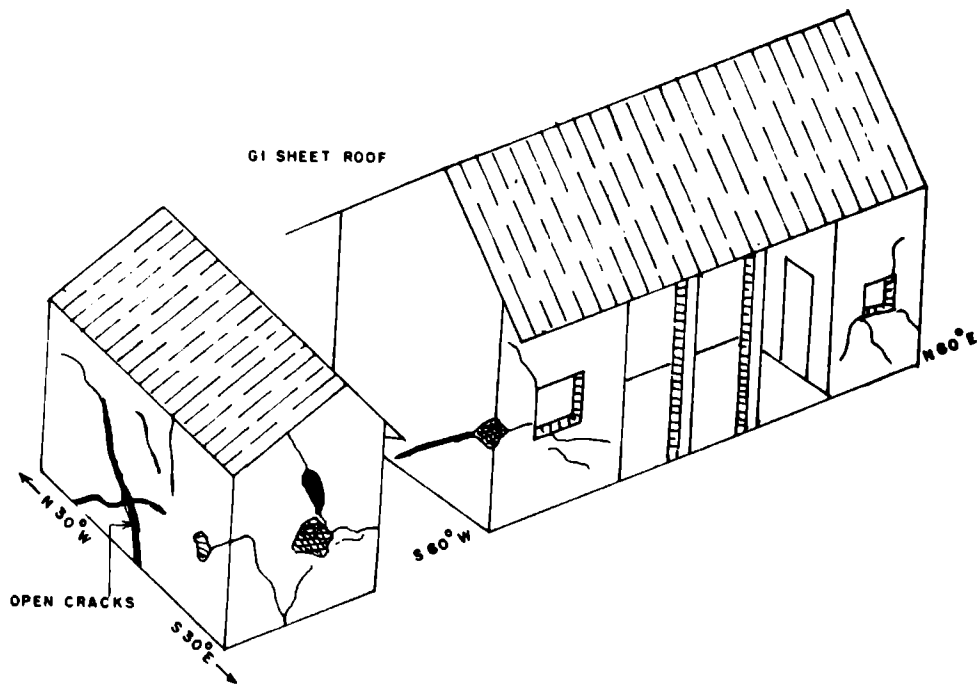
The main building of Police Post (mud stone masonry with cement plastered walls), aligned in N60°E-S60°W direction, small cracks have developed on SW and SE walls and plaster has peeled off from SE corner of the building (Fig.33). The crack on SW wall rises from plinth level to window height and extends towards window on SE wall. The cracks have also developed on SE end walls. But in case of annexe building which has been constructed adjacent to the main building with long walls aligned in N30°W-S30°E direction, the intensity of damage is much severe. In this case open cracks have developed on SW short wall (aligned N60°E-S60°W). These cracks show opening upto 1.0cm near the middle portion. Diagonal cracks, starting from top and extending to plinth level have developed on NE-SW trending long walls. These cracks are open. The projected parts have also cracked but not collapsed.

Fig. 33: POLICE POST - GAURIKUND

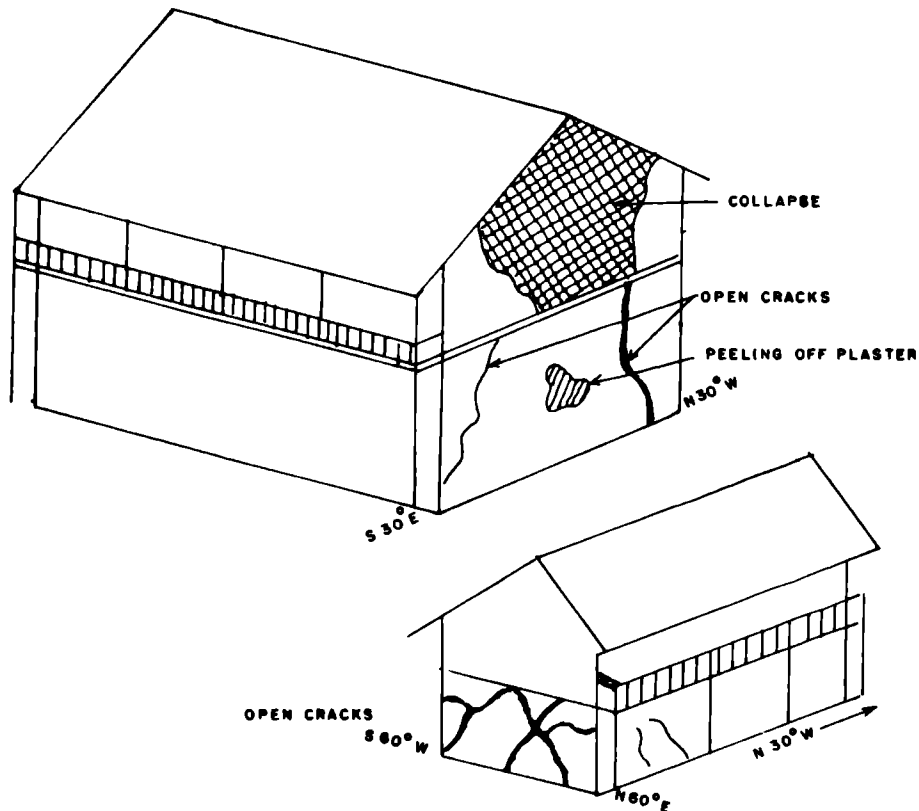
Fig. 35: HOUSE IN GAURIKUND VILLAGE

Similar pattern of damage was observed in Gaurikund village which is located about 50m above the PWD Rest House (Fig.35). Most of the houses are aligned either in NE-SW direction or $N60^{\circ}E-S60^{\circ}W$ direction. The open cracks, bulges and peeling of plaster were observed on NE side walls i.e. short walls aligned NW-SE and cracks on long walls. Partial collapses of some houses have also taken place.

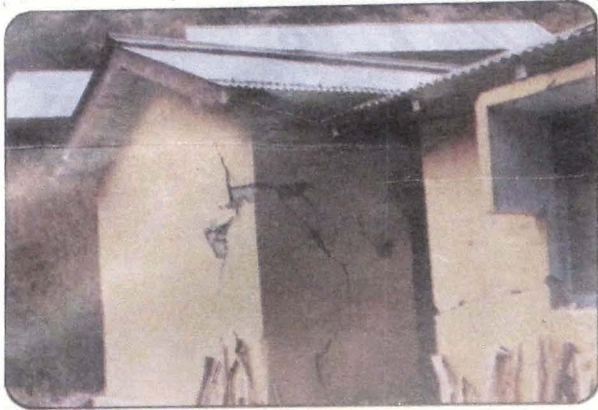
Photo 106 *Cracks in walls of the staff quarters of Okhimath Public Health Centre.*

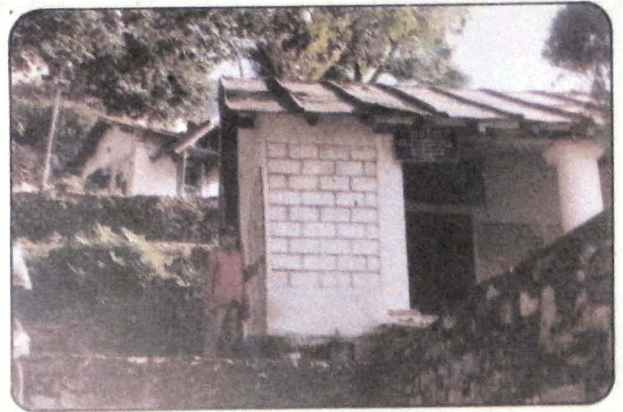
Photo 107 *Northward bulging in short wall of Okhimath Public Health Centre.*

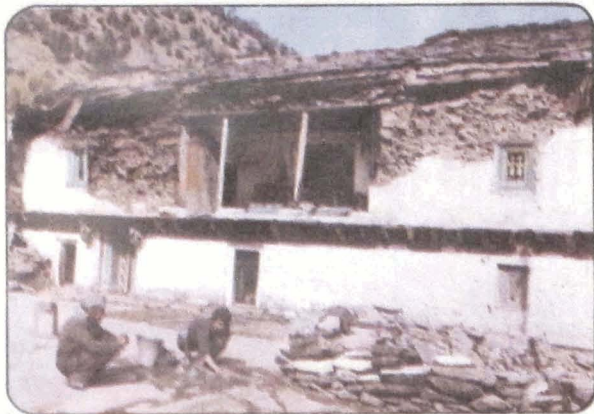
The influence of the 20th October earthquake was quite severe in the area. Almost 80% of the poorly constructed type-A structures, that is houses of thick mud masonry walls with slate roofing developed open cracks and nearly 20% suffered partial collapses, particularly of the gable portion (Photos 108 and 109).

Photo 108 *Partial collapse of first floor long wall of a house in Trijugi Narayan.*

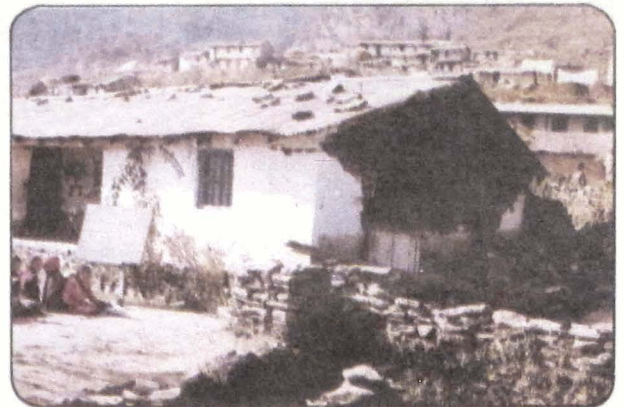
Photo 109 *Collapse of short wall of the School building, Trijugi Narayan.*

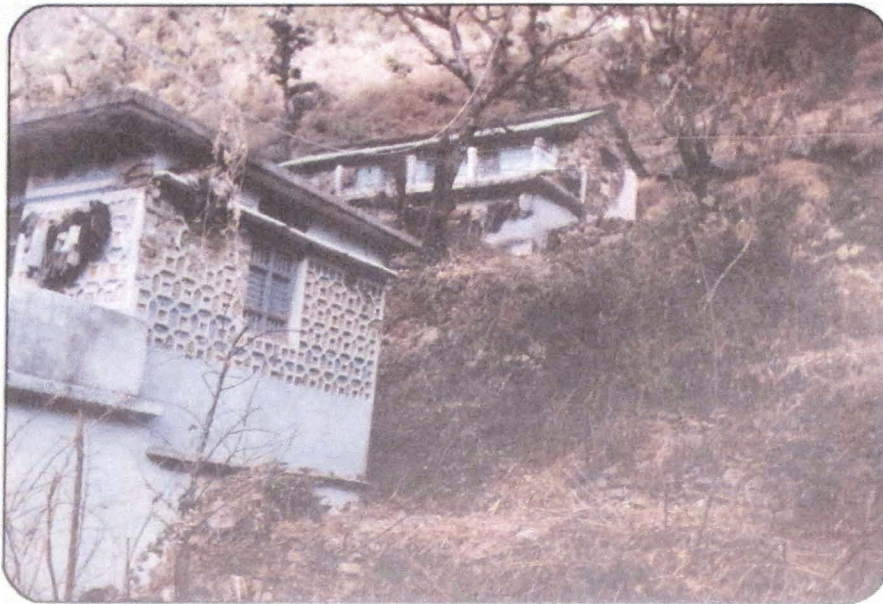
In case of buildings and houses, the damage includes cracks in buildings. These cracks are open in some cases. The crack openings are more pronounced on southwestern walls of NE-SW aligned structures like Rest House of Garhwal Mandal Vikas Nigam. The cracks on SW wall of the NE-SW aligned buildings are open upto 5.0cm near the top portion. The openings gradually decrease towards bottom. Few SW and NE walls of Kutcha houses have collapsed partially (Photo 110 and 111).

Photo 110 *Plaster fall of the house in foreground and partial short wall collapse of the house in the background at Gaurikund.*

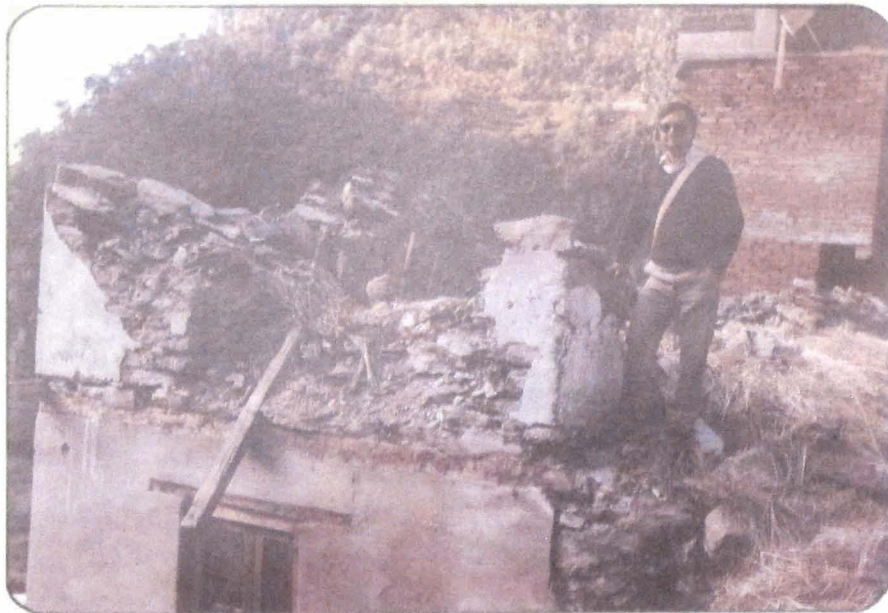
Photo 111 *Total collapse of the first floor type-A house at Gaurikund.*

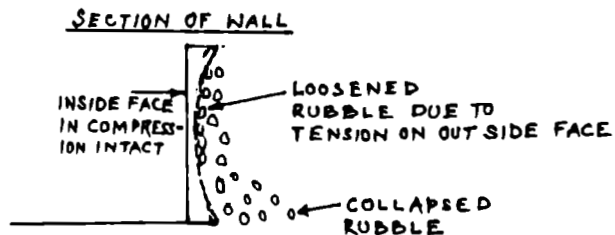
Fig. 37: PARTIAL COLLAPSE OF MUD MASONRY WALL UNDER TENSION, GAURI GRAM, DUGADDA (SKETCH BY P. PANDE)

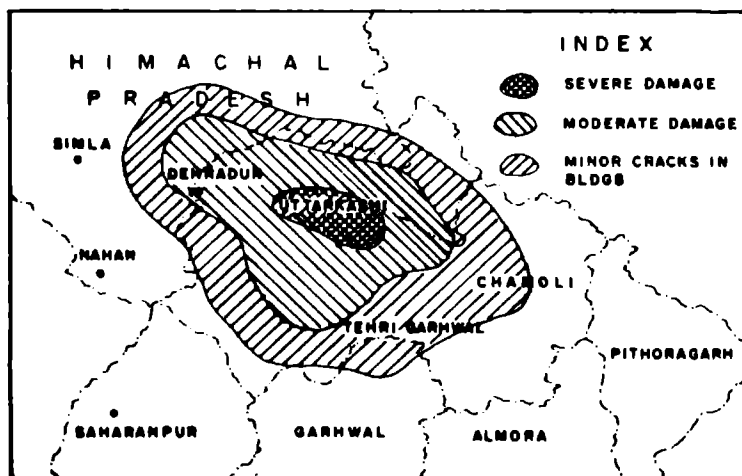
Fig. 1 : DAMAGE CATEGORIES IN THE AFFECTED AREA.

1.3 The area of damage as assessed in the aerial survey is shown in fig.-1. Severe damage occurred in about 2100 sq. km area where as moderate and minor damage in an area of 7,000 and 12,000 sq. km, respectively. In the aerial survey, number of slides were observed near Gopeshwar Town, the headquarters of Chamoli district, which were caused due to heavy rains earlier in August-91. Though large number of slides were seen in the Bhagirathi, Indrawati and Bhilangana valleys, none caused blocked of the major tributaries of the Ganges. Among the engineering structures which suffered maximum damage was an Iron-span bridge at village Gawana (8 km away from Uttarkashi). damage and sinking of abutments caused due to severe agitation resulted in the failure of roller bearings and subsequent collapse of the bridge.
